Nevada Bureau of Mines and Geology Special Publication 36

Wells, Nevada M6.0 Earthquake Impact on the Nevada Department of Transportation

Michael E. Murphy
Nevada Department of Transportation, District III, Elko, NV

2011

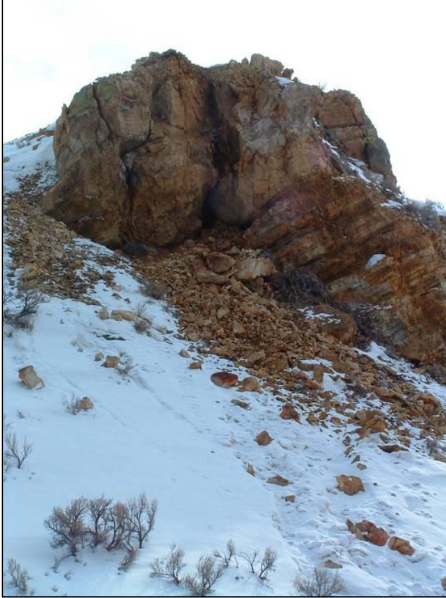
Figure 3. Rock slides near Turner Hill.

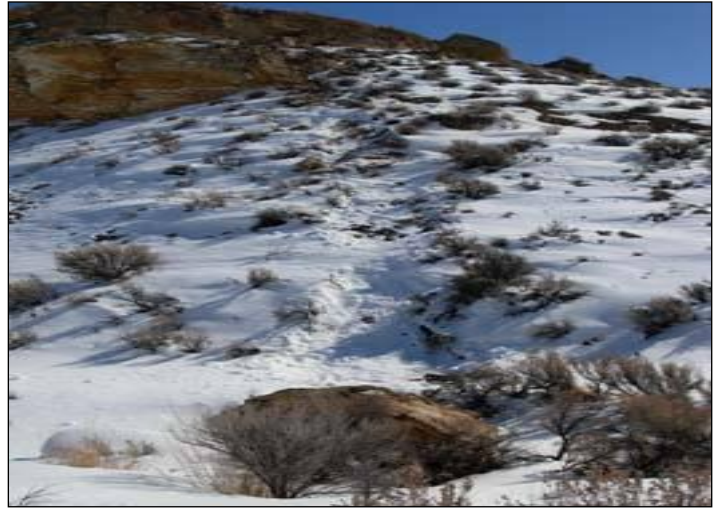
Figure 4. Large rock that became dislodged near the same area.

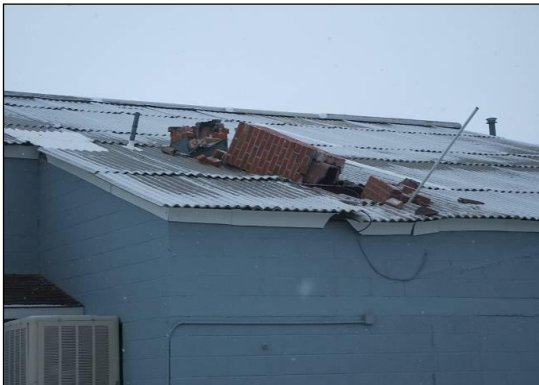
Figure 6. Failed chimney on the Wells Shop.

1. Several concrete or reinforced masonry headers located over openings in the masonry walls were found to be cracked at various locations where the header ties into the walls (see figure 7).
2. Cracking occurred in several locations in the various corners of the building.
3. The abandoned brick masonry chimney failed at the point where it projected through the exterior roof system. The chimney broke in several large pieces and damaged a portion of the roof system. A couple of pieces went

completely through the roof and the ceiling, landing on the interior floor of the facility (see figure 6).

The Wells shop returned to normal use within three to four weeks following the earthquake. Temporary repairs were made to the roof and ceiling. The cracks in the headers were determined not to be structurally significant and no asbestos contamination was found in the interior space.

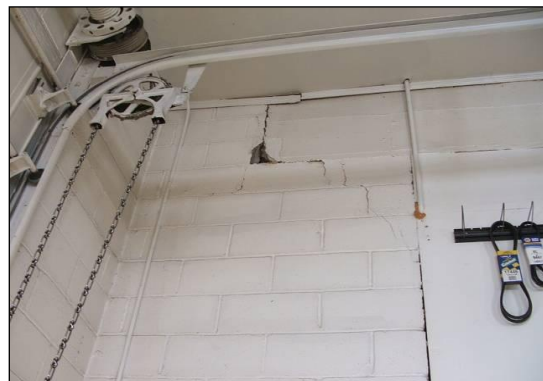
Figure 7. Cracks inside the Wells Shop.

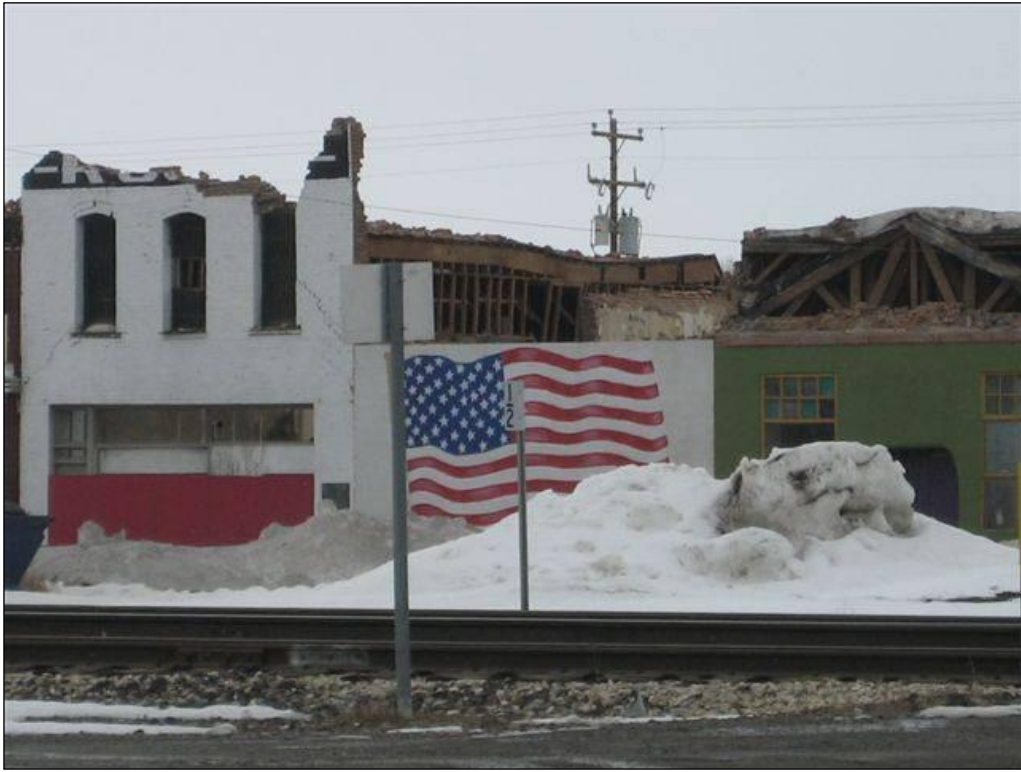
Figure 10. One of the severely damaged structures on Front Street in downtown Wells.
