Nevada Bureau of Mines and Geology Special Publication 36

## **Damage to Residential Houses from the 2008 Wells, Nevada Earthquake**

Craig M. dePolo  
Nevada Bureau of Mines and Geology  
University of Nevada, Reno

2011

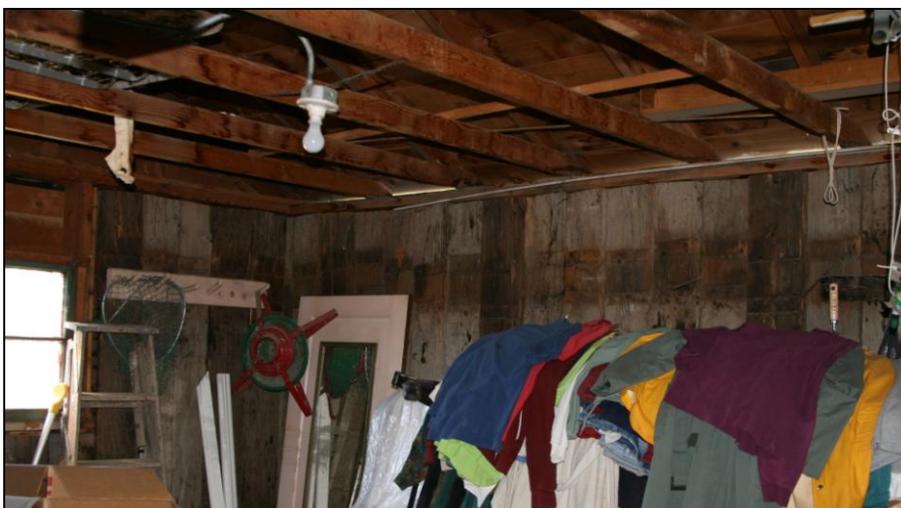
**Figure 1.** Railroad-tie house construction. The ties were placed vertically to make up the walls of this garage. This house was in the Modified Mercalli Intensity VII area but barely had a crack in it from the earthquake.

One well-built, single-story railroad-tie house appeared to have suffered nothing more than minor cracking from the shaking (figure 1). A two-story house constructed with vertically placed 2"x 8" wood planks for the walls reportedly had much larger shaking motions than other homes, but the house itself experienced little damage except for considerable plaster cracking. These examples indicate that these older wood construction homes can survive earthquake ground motion if they are built well.

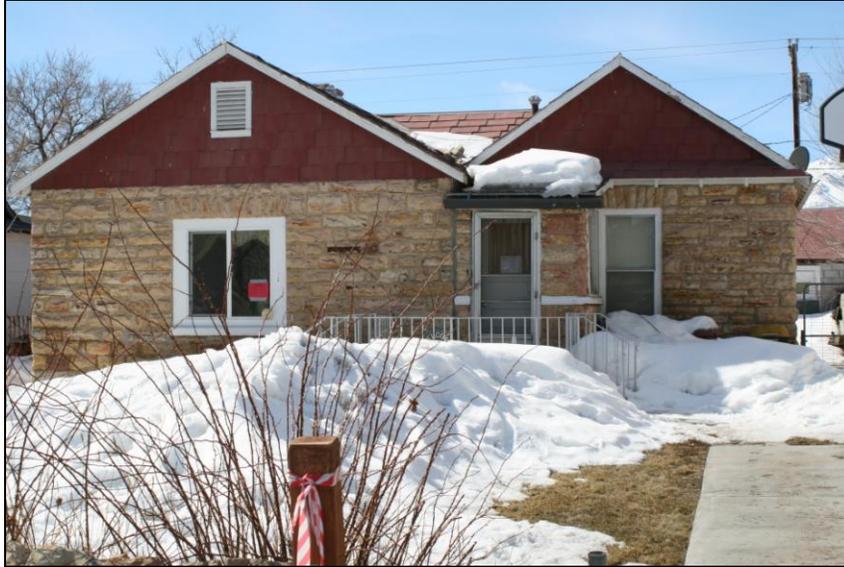
One of the severely damaged houses in Wells was a rock-walled house with a wooden floor and roof structure and a rubble-rock foundation (figure 2). One side wall was separated from the structure at the roof line and some rocks fell out (figure 3). Some large cracks formed around window frames and within the rock walls (figure 4). The most dramatic failure of the house from the earthquake was the collapse of part of a rubble-rock foundation that caused an approximately 4-m-long and 1.5-m-high section of the base of the rock wall to fall into the basement (figures 5, 6, and 7). This failure exposed interior wood boards which had dry rot and deterioration in places (figure 6). The rock house was subsequently torn down and removed and a manufactured home was installed on a new concrete foundation in its place.

**Figure 2.** Rock wall house that was damaged beyond repair. The red “unsafe to occupy” posting can be seen in the window.

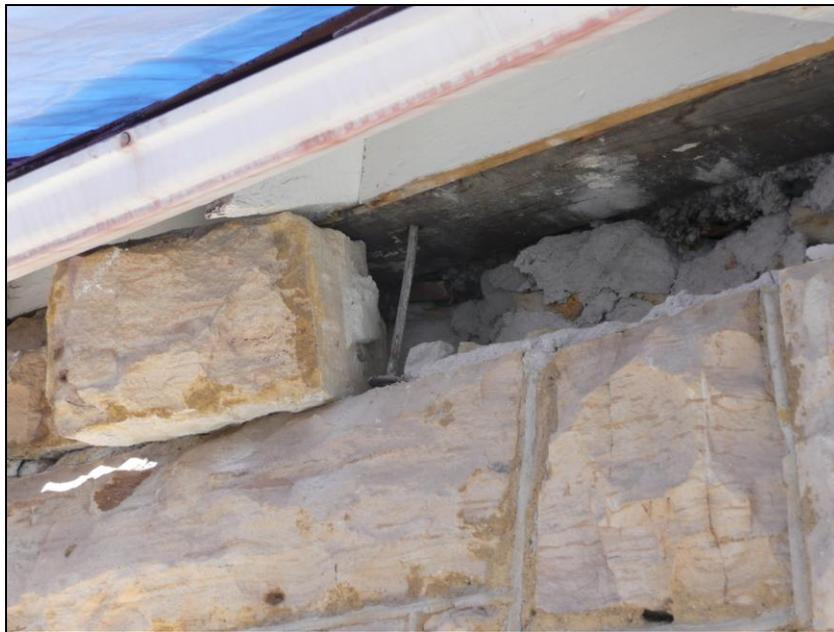
**Figure 3.** Upper part of rock wall where blocks were dislodged at the roof line. *Photo by Glen Palmer*

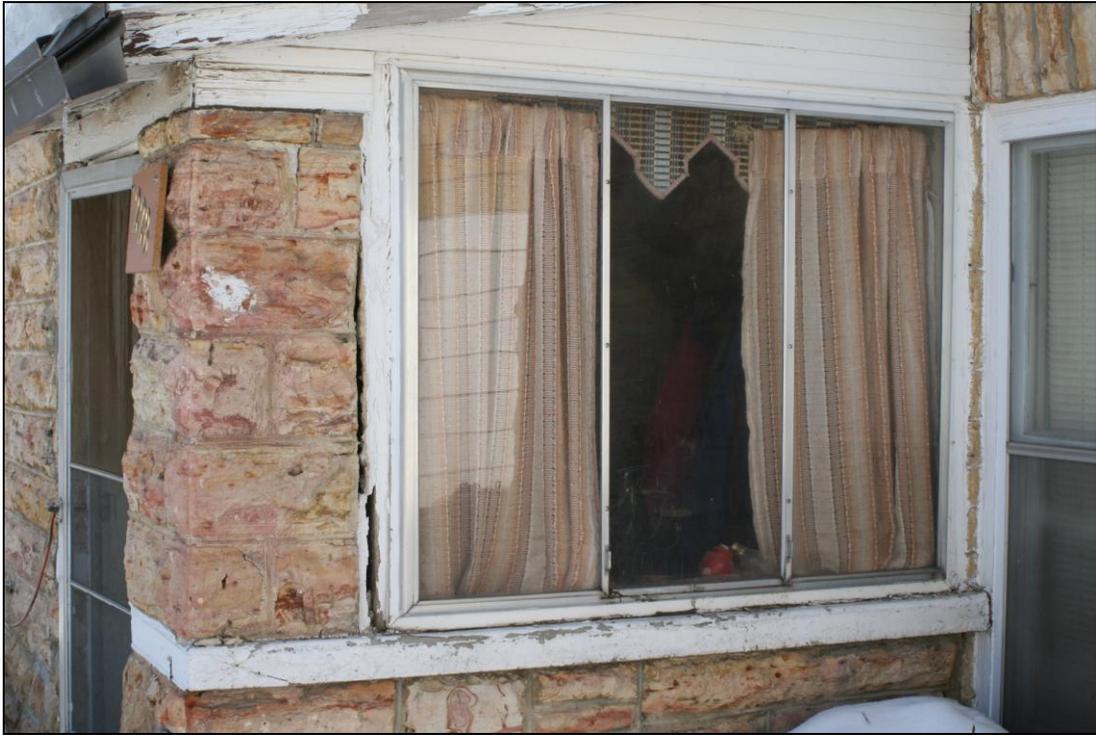
**Figure 4.** Shaking crack formed where the window frame was separated from the rock cladding in the rock-veneered house. Note the window was not broken.

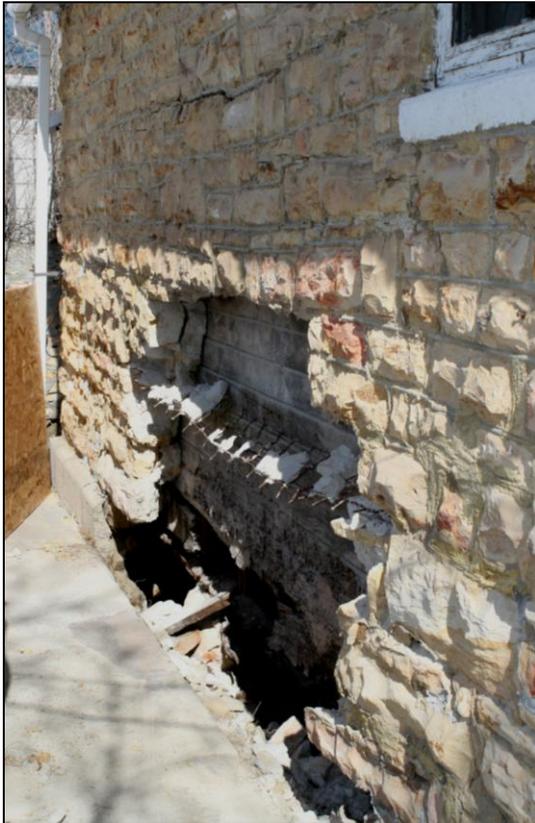
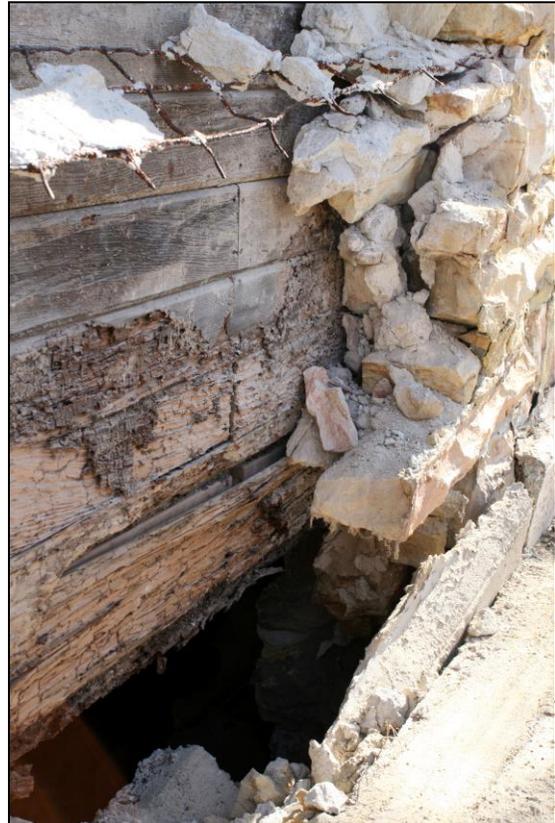
**Figures 5 and 6.** Figure 5 on the left shows an area where the rock house foundation collapsed sending rocks from the veneer into the basement. Figure 6 on the right shows a close-up view of the iron mesh used in the rock walls and some dry rot near the bottom of the wall.

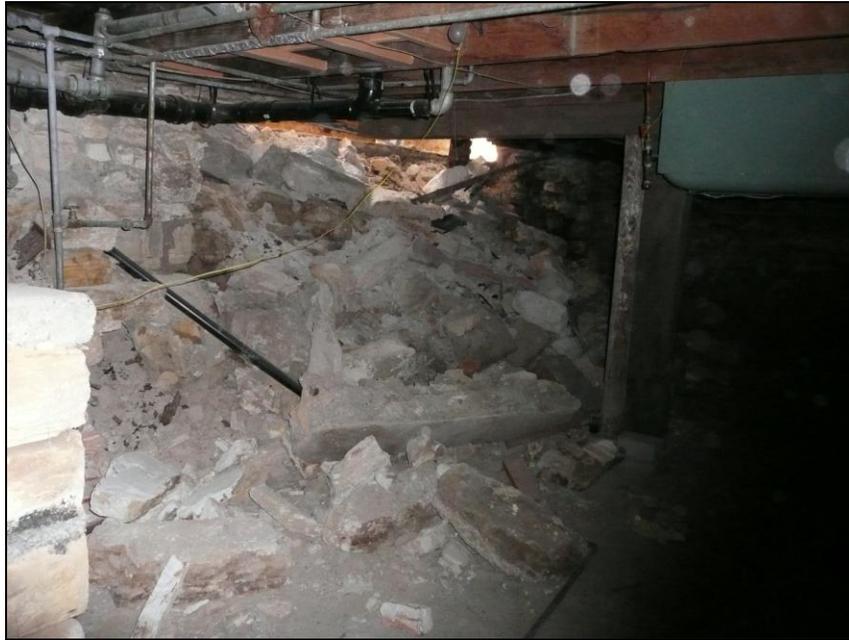
**Figure 7.** Collapse of the rubble-rock foundation and bottom of the rock wall into the basement of the rock house. *Photo by Glen Palmer*

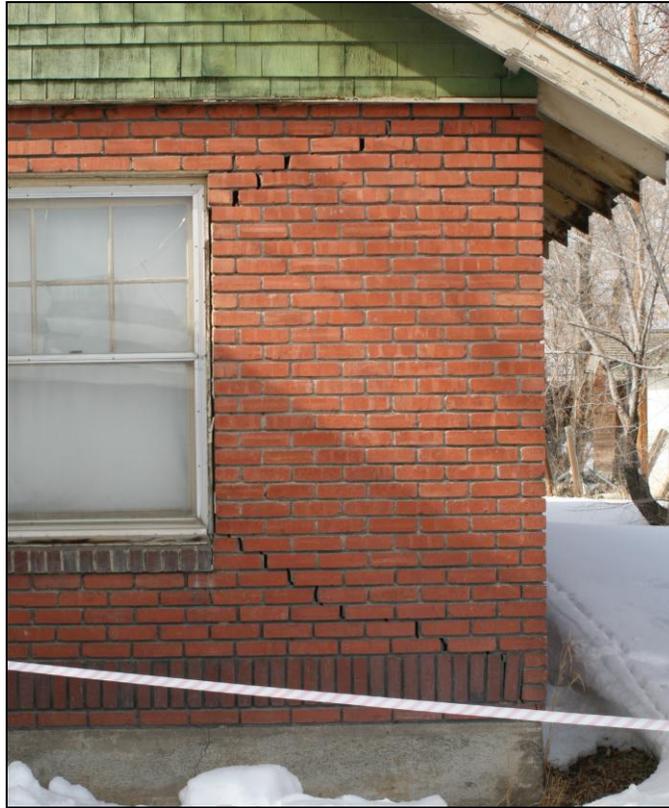
Several brick houses had severe cracking in different locations (e.g., figure 8), but none showed failure beyond the chimneys and their foundations remained intact. Some of these have been repaired by filling and putting epoxy in the cracks in the bricks, and none were considered total losses.

**Figure 8.** Damaged brick house. Large X-shaking fractures emanate from the corners of the window extending to the corners of the house; the window is broken with a partial X-fracture as well. The fate of this house was still unknown, but similar brick houses with cracking damage have been repaired and continue to be occupied.

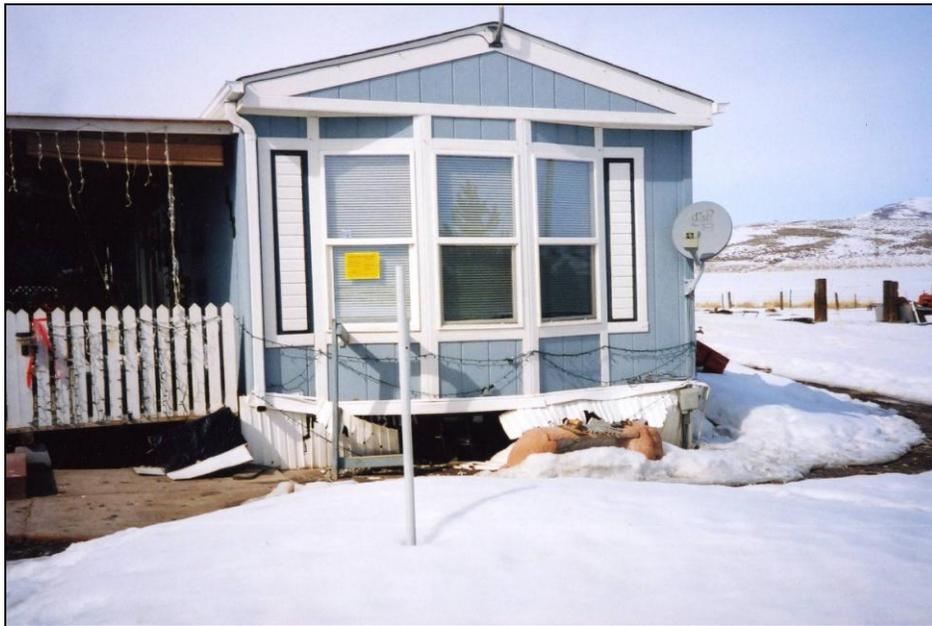
Several manufactured homes were knocked off their jacks or shifted on their support blocks by the shaking, although most manufactured houses in town remained on their supports. One manufactured home was severely damaged when the building shifted and fell off its jacks, twisted the frame, and fell onto the displaced support jacks, some that came up through the floor (figures 9, 10, 11). This home was removed and a new manufactured home on a concrete foundation was put in its place. In other cases, manufactured homes just collapsed on top of the prior support, settled onto the ground, or didn't fall but shifted on their blocks. In most cases, this shift was small or the manufactured home rode out the earthquake without any movement on their blocks.

**Figure 9.** Manufactured home that was knocked off its jacks and destroyed. *Photo by Bonnie Stark*

In the resetting of the earthquake-displaced manufactured homes, and in several other cases, manufactured homes were being strapped in two directions on their supports to resist future shaking displacement and damage. This foundation strapping was not always done in the past, but is now required in the building codes to help avoid the problems discovered during this event.

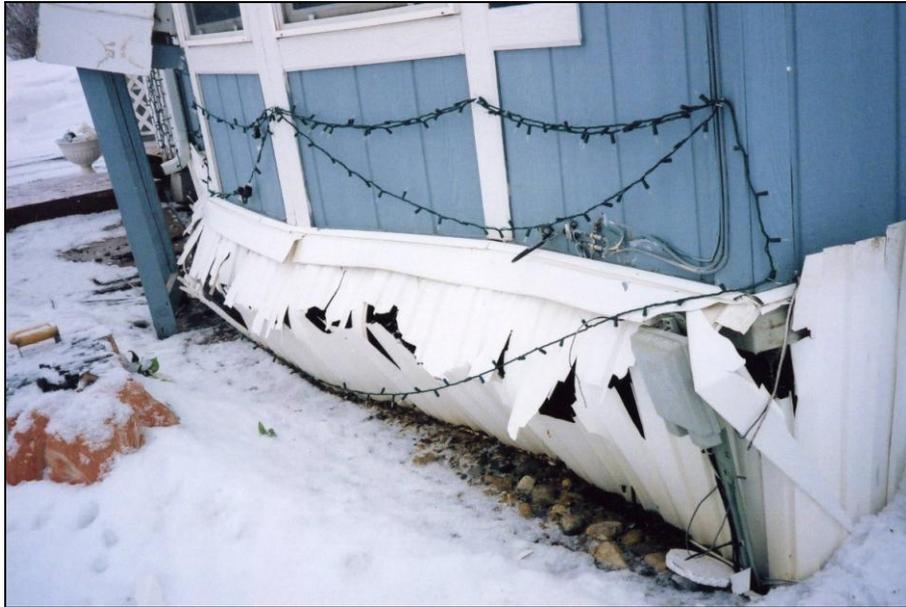
**Figure 10.** View of the rear of the damaged manufactured home. *Photo by Bonnie Stark*

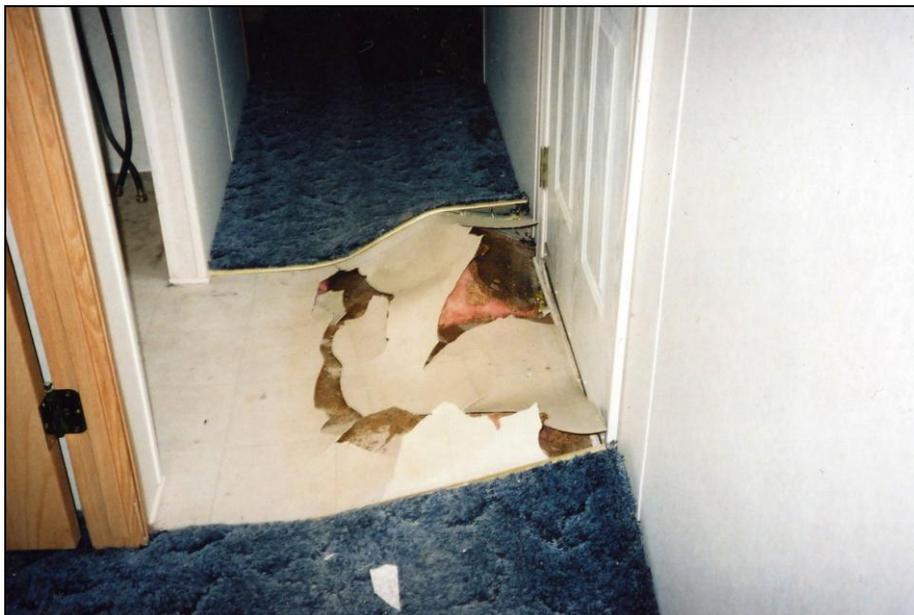
**Figure 11.** Support jack penetrating the floor after the home was knocked off its foundation. *Photo by Bonnie Stark*

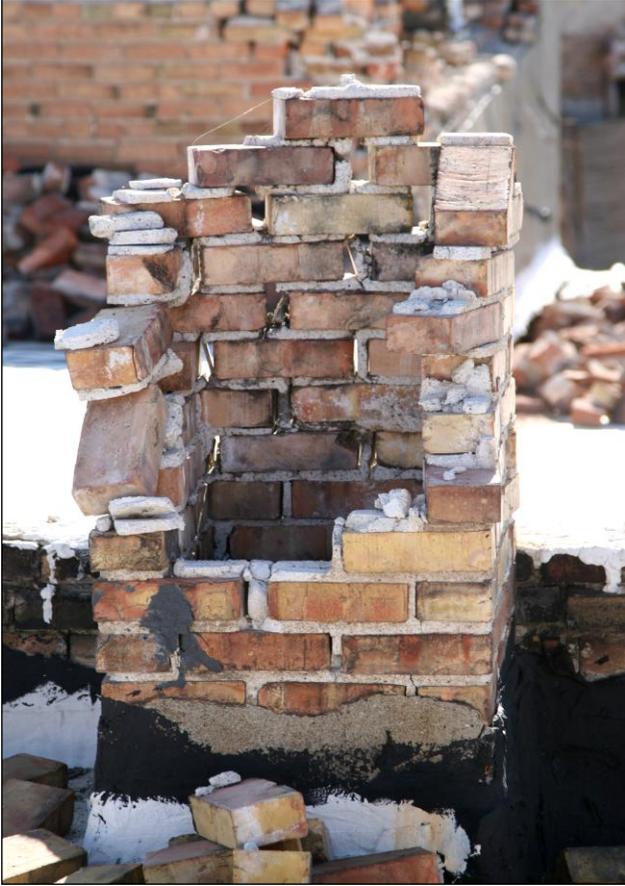
Over 60 chimneys were damaged by the Wells earthquake, which was approximately 10% to 15% of the total number in town. Most of these damaged chimneys were at houses, but there were a few at commercial buildings. Damaged chimneys were broken at the roof line, shattered in place (figure 12), or toppled over onto the roof and/or the ground (figure 13). Falling chimneys and parapets posed some of the most serious safety threats from this earthquake event, but fortunately no one was injured by them. There was some damage to possessions from toppled chimneys however, such as to a car (figure 14). None of the damaged chimneys observed penetrated the adjacent roofs. Where chimneys had pulled away from walls or roofs there were some holes in houses that had to be patched to keep the weather out. In a couple cases, falling bricks from chimneys damaged electrical components requiring that the electric lines be disconnected by the power company.

**Figure 12.** Shattered and fallen chimney from the Bargain Barn roof in old town; the chimney is disintegrating in place.

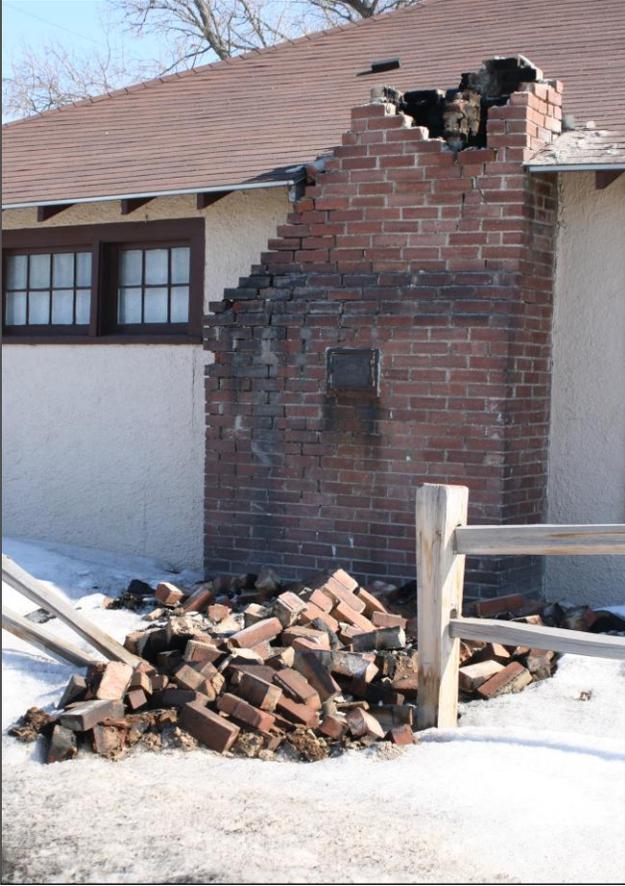
**Figure 13.** The fallen upper part of a chimney that broke near the roof line.

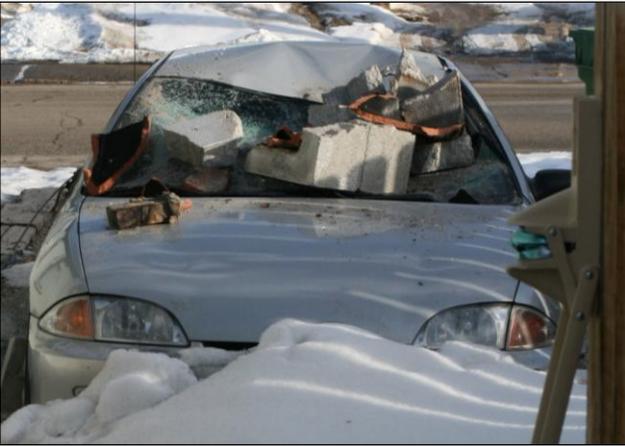
**Figure 14.** Car damaged by a fallen cinder-block chimney.

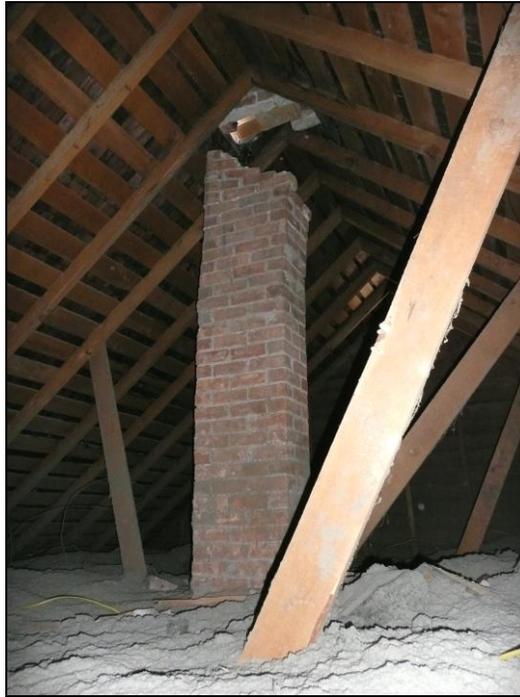
Emergency personnel from nearly all available agencies and companies began immediate recovery work by tearing down damaged chimneys and covering the resultant holes to keep the weather out and the heat in the homes. One engineer noted an unsafe practice of taking a chimney down to an intermediate level in the attics of houses where they were no longer supported by their roof connection creating a potentially even greater toppling hazard (figure 15).

**Figure 15.** The top of this broken chimney was removed but the portion above the ceiling in the attic was left free-standing, creating a possible toppling hazard from further shaking during aftershocks. *Photo by Glen Palmer*

It is recommended that free-standing chimneys be taken down to just above the ceiling line so that the tops of chimneys are supported at the ceiling level, and aren't left free-standing in the attic.

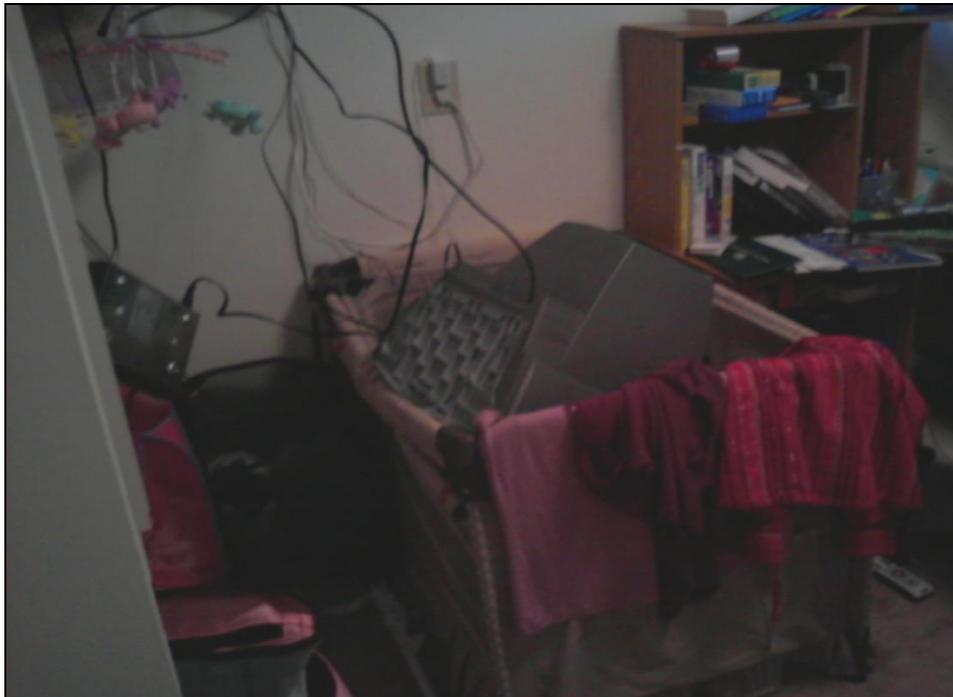
One Wells earthquake incident serves as a pointed example of the importance of relocating heavy objects that might fall on residents during an earthquake. A young mother with a newborn baby had returned to Wells to stay with her parents just before the February 2008 earthquake. The family had set up a temporary makeshift nursery in a small entertainment room, with the crib situated directly beneath a large television set on an overhanging stand. The three-week-old infant had been sleeping in this crib up to two nights before the earthquake, but fortunately the mother and child were temporarily away on a trip when the earthquake occurred. Figure 16 shows how the television was displaced and thrown into the crib during the earthquake. Given the size of the television, the infant would undoubtedly have been crushed if she had been present in the crib in the early morning hours when the earthquake occurred. This incident serves as a lesson that even in an area where earthquakes have a low probability of occurrence, the severe consequences of such an earthquake event must be considered. Cribs, beds, desks, tables, and places where inhabitants spend much time should be placed in areas that do not have large or heavy overhead objects that could fall during an earthquake, or those threats should be relocated.

**Figure 16.** A television fell into a crib in a temporary nursery. A three-week-old girl was in the crib a couple nights before the earthquake, but not at the time of the event. Even though the probability of an earthquake occurring was not high before the event, similar potentially deadly hazards should be addressed everywhere in Nevada. *Photo by resident*

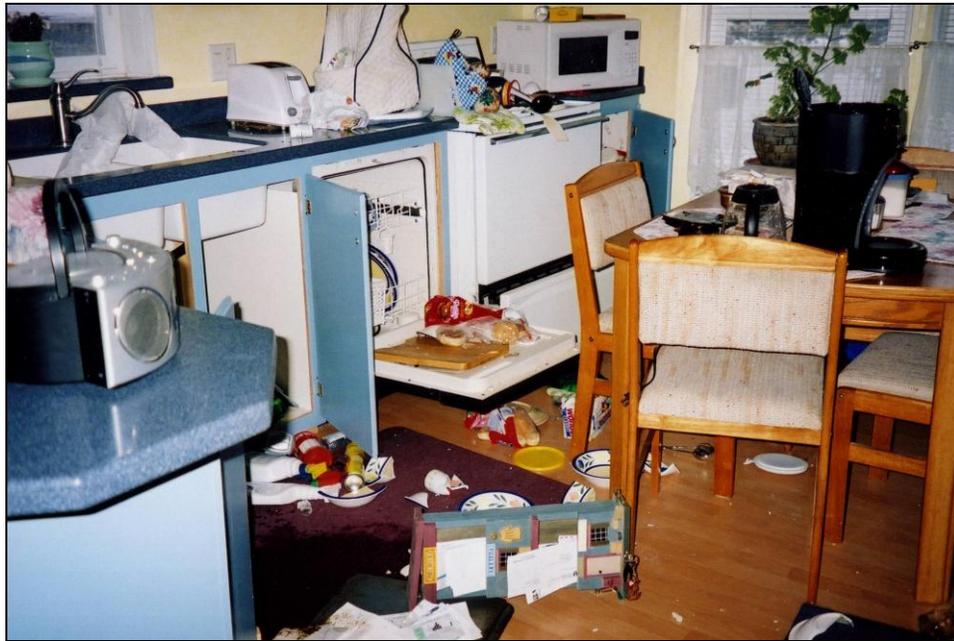
Although nonstructural content damage was widespread in Wells, in most cases it was limited and not extensive throughout the houses or buildings. In Wells, there seemed to be a preferred direction to the shaking that caused dislocation and damage of contents, affecting one set of parallel walls and not the other. In the homes that were directly over the earthquake rupture to the north in Town Creek Flat, nonstructural displacement and damage was more intense, with nearly every cabinet opened and emptied of its contents along all walls. Most nonstructural damage occurred to loose objects or those that were horizontally unstable (figures 17 and 18).

**Figure 17.** Cabinet doors were opened and contents thrown out by the earthquake. *Photo by Bonnie Stark*

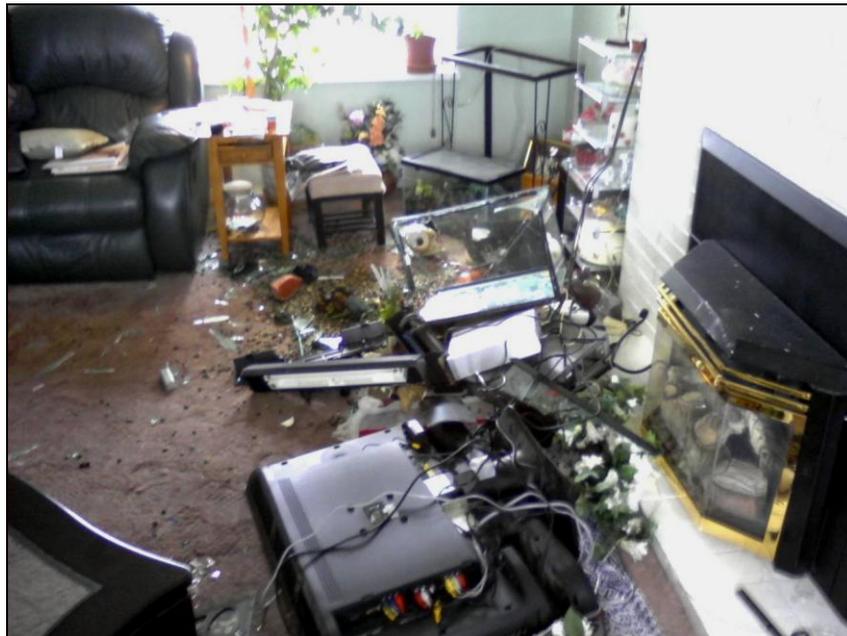
**Figure 18.** Nonstructural damage in a home. *Photo by resident*

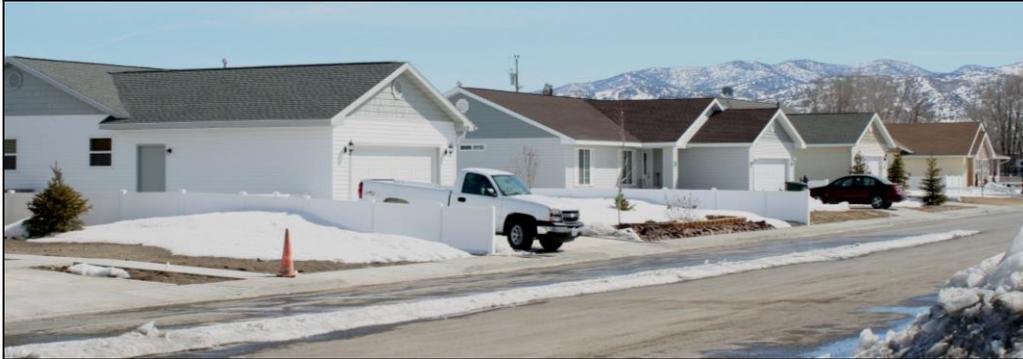
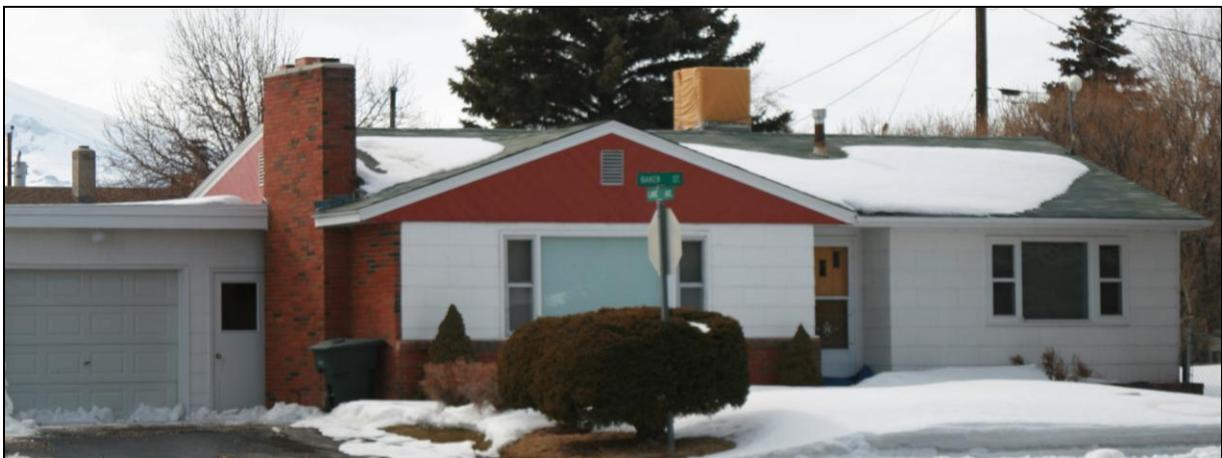
Modern homes appeared to survive the earthquake without any visible structural damage (e.g., figures 19 and 20), although there were some shaking cracks and nonstructural content damage. These are mostly wood-frame houses, some with brick or other veneer finishes. The 1997 Uniform Building Code had been enforced in Wells for several years prior to the earthquake, which added seismic resistance to newer homes and likely contributed to their surviving the event with their structural integrity for the most part intact.

**Figures 19 and 20.** (above and below) Modern homes and chimneys survived the earthquake shaking with no visible structural damage.
