Wells High School Analysis and Reconstruction Following the February 21, 2008 Earthquake

Thomas E. Trabert, M.S., P.E.
Trabert Engineering, Reno, NV

2011

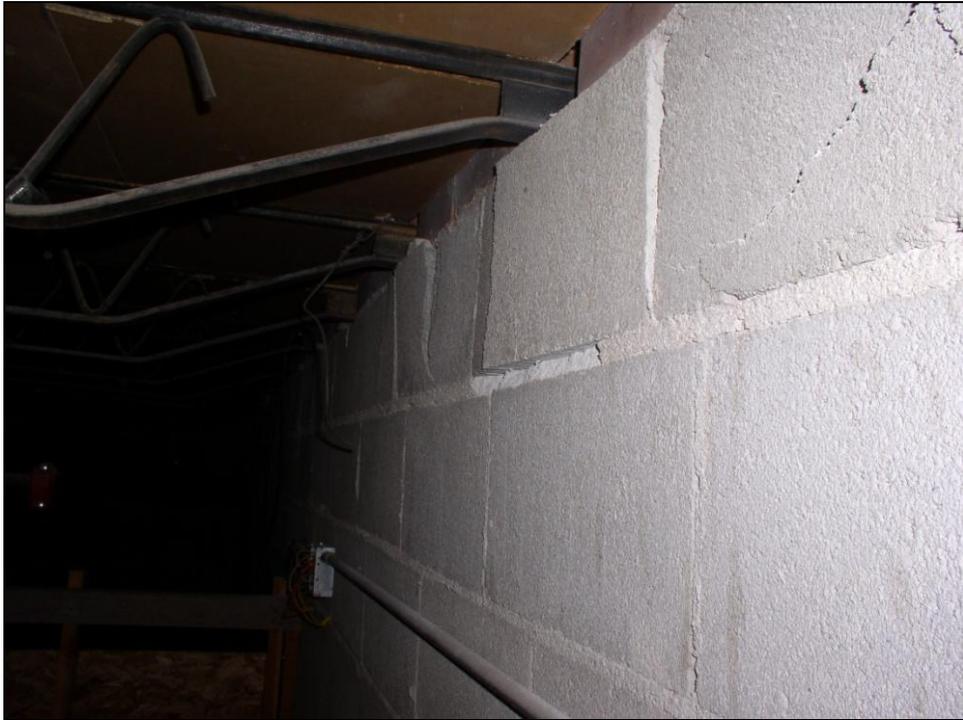
- The south end wall of the auditorium is common with the north wall of the gymnasium. At this wall the auditorium roof bar joists bear on the masonry wall at a location about 24 inches above the top of the concrete tie beam or 24 feet above the floor. Tension in the bar joists created by the lateral movement of the wall had pulled them from their seats in the pockets in the CMU wall. This caused severe shattering of the masonry units below these joists (see figure 3). The photograph shows that a very unstable condition was created in the roof and wall system of the auditorium as well as in the gymnasium because this wall supports a roof on each side. It will be noted later in the section “Repair and Remediation” that this wall, following the earthquake was left in a very unstable condition. A failure of this wall would have allowed a total collapse of at least 20 feet of the gymnasium roof and 15 feet of the auditorium roof.

Figure 3. Common wall between gymnasium and auditorium showing fractured masonry units below auditorium roof bar joists.

Shoring was designed to provide support to the auditorium roof bar joists that had caused the fracturing of the masonry in this wall. This shoring consisted of square tube steel columns and high-strength grout and was designed to provide permanent support and allow the contractor to remove and replace the fractured masonry.

However, during the process of installing these supports it was discovered that the portion of the 13-inch-thick double-wythe masonry wall (figure 8) above the concrete tie beam had delaminated. A vertical fracture line occurred along the vertical collar joint and continued through the masonry units causing the two wythes to act independently. Therefore, as two independent wythes or walls, this upper section of wall no longer met the 20-to-1 height-to-width ratio requirement. Now acting as two walls moving independently away from each other a P- Δ moment was created in each wall. The combination of a significant increase in the height-to-width ratio and the P- Δ moment created an extremely unstable condition for this bearing wall. This is the same wall previously noted and shown in figure 3.

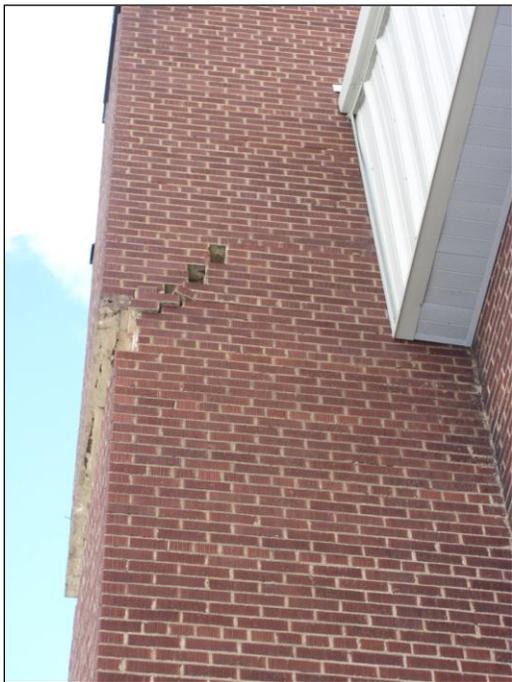
- The chimney is integral with the north wall of the auditorium, which is 64 feet tall, receives lateral support from cast-in-place concrete roof above the stage area of the auditorium. This roof is located approximately 28 feet above the finish floor of the school. The seismic forces caused a shear failure in the chimney just above this auditorium roof line. The failure resulted in a horizontal displacement of the upper portion of the chimney of 4 to 6 inches with the upper portion moving to the north of the lower section (see figures 4 and 5).

Figure 4. West wall of chimney. Note shear fracture and horizontal displacement.

It was learned from the Elko County School District that the chimney was no longer used and approval was given to remove the chimney. Structurally, however, the lower portions of the chimney were believed to provide stability to the 17-inch north wall of the auditorium and total removal could weaken the integrity of that wall. Therefore, the contractor was directed to dismantle the chimney to the level of the auditorium roof or to a level lower as required to eliminate any loose masonry that may exist. Following the removal of the upper portion of the chimney, a steel frame was designed to provide stability to the top courses of brick and a steel-sheathed roof structure was added to provide a storm-proof enclosure for the open end of the chimney.

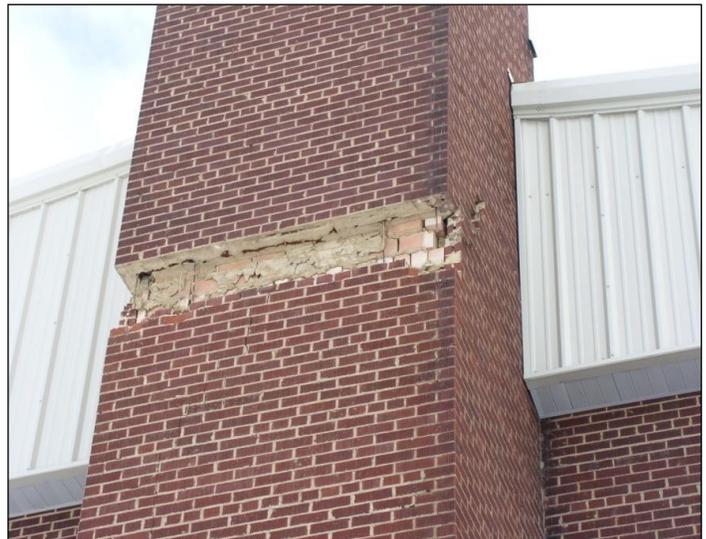
Figure 5. North wall of chimney.

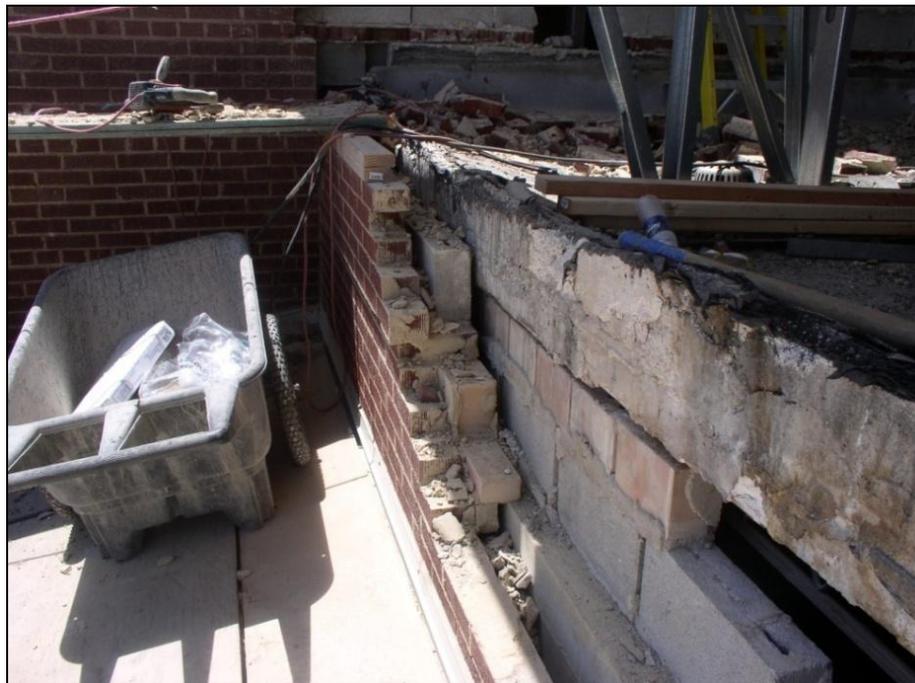
The lower section of the east auditorium wall is common with the west wall of the main school corridor while the upper portion of this wall, above the low classroom level, is an exterior wall. The lower portion was constructed of 4-inch masonry and the upper portion was constructed as a 13-inch wall having wythes of 8-inch CMU and clay brick veneer. As the area experienced several heavy aftershocks, it became apparent that the multiple wythes of the upper portion of this wall had also delaminated or separated (see figure 6).

The process of removing the brick parapet from the perimeter of the auditorium roof allowed a thorough examination of the multi-wythe masonry to verify the extent of the delamination. The 17-inch thick masonry walls on the west and north sides of the auditorium appeared sound and undamaged. The area of delaminated wall was limited to the east wall. This delamination extended from the north wall of the gymnasium to the cast-in-place concrete roof above the stage area. The damaged wall was removed and a new 8-inch-thick reinforced masonry wall was constructed from the floor level to the roof diaphragm along this section of the auditorium.

Figure 6. Delaminated brick and masonry wall at southeast corner of auditorium (roof level).

Along the east and west auditorium walls, the parapet wall had to be removed to the top of the upper beam of the concrete frame. The top of this beam is lower than the roof slab by about 16 inches. This created a gap or opening in the top of the wall (see figure 6). This opening could not remain or be covered with a light-weight siding as it violated the fire-resisting envelope of the auditorium. The gap was filled with 8-inch-thick reinforced concrete masonry that was grouted solid. The construction of this wall provided a means to improve the connection between the concrete roof diaphragm and the concrete frames.
