Wells High School Analysis and Reconstruction Following the February 21, 2008 Earthquake

Thomas E. Trabert, M.S., P.E.
Trabert Engineering, Reno, NV

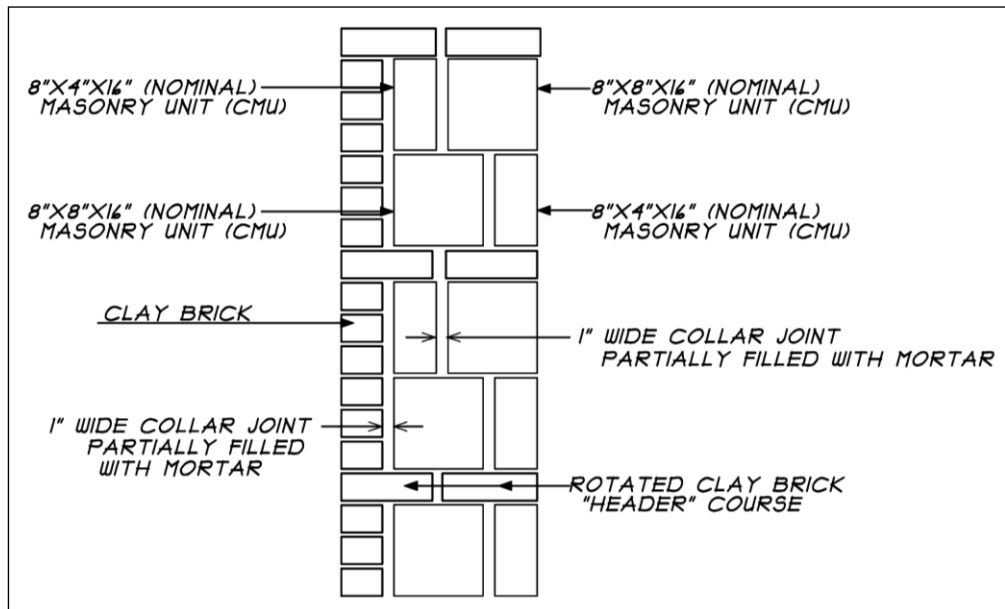
Figure 9. Seventeen-inch-wide brick/CMU wall (not to scale).

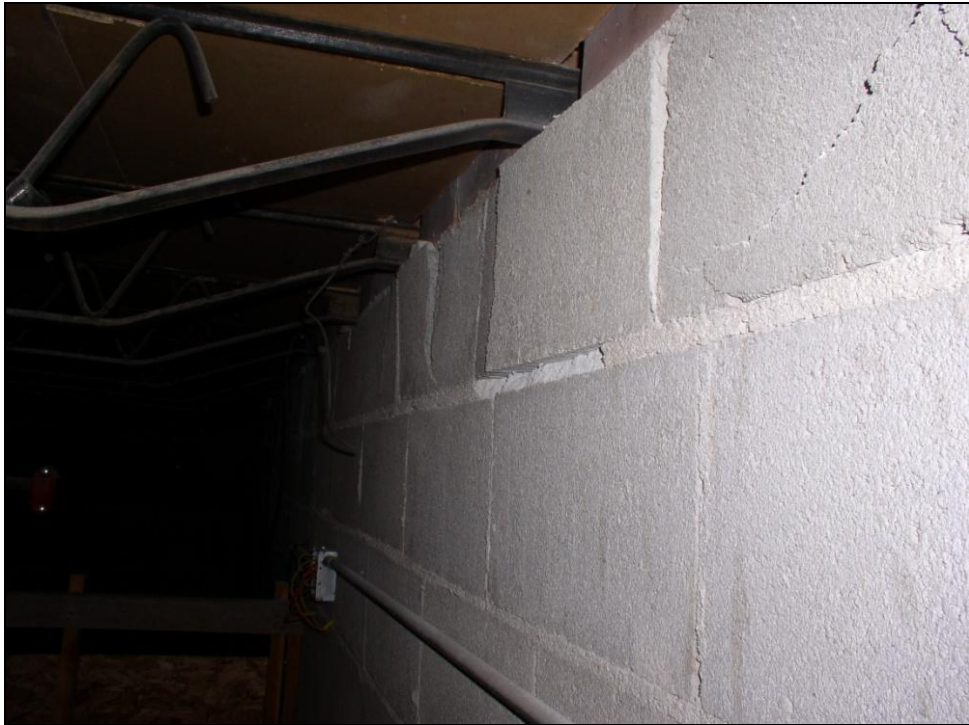
Figure 3. Common wall between gymnasium and auditorium showing fractured masonry units below auditorium roof bar joists.

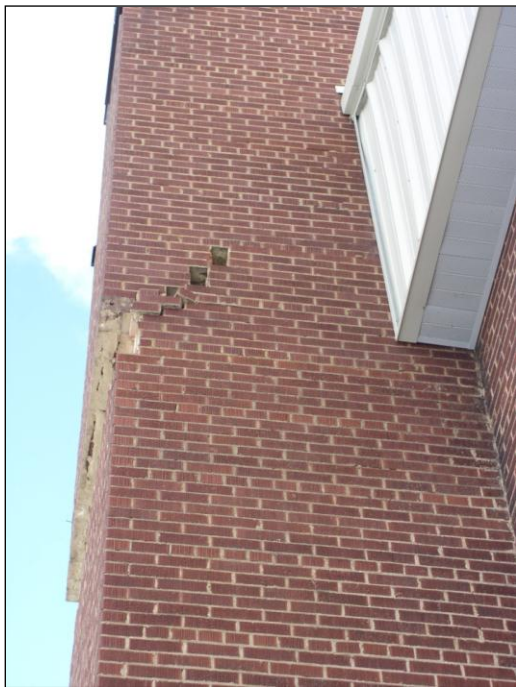
Figure 4. West wall of chimney. Note shear fracture and horizontal displacement.

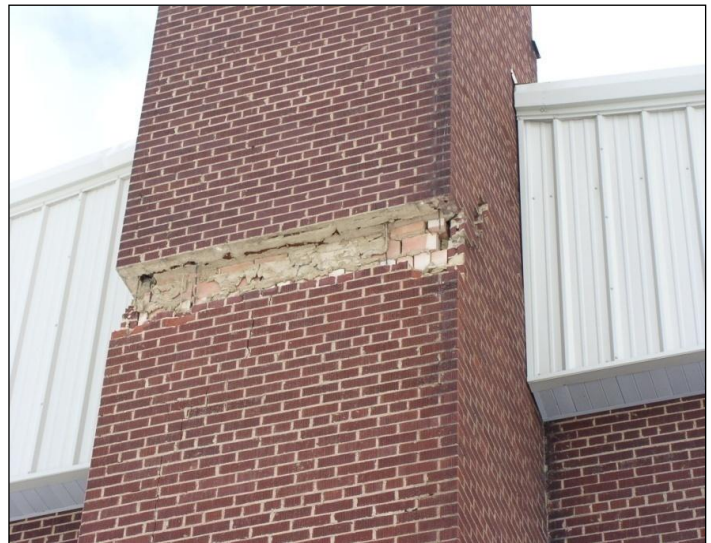
Figure 5. North wall of chimney.

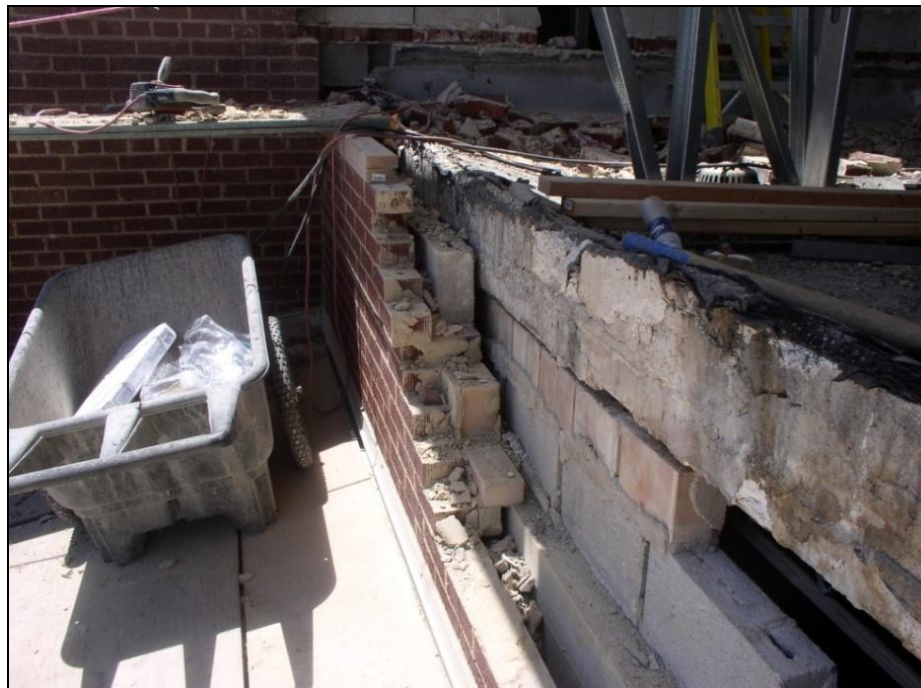
Figure 6. Delaminated brick and masonry wall at southeast corner of auditorium (roof level).

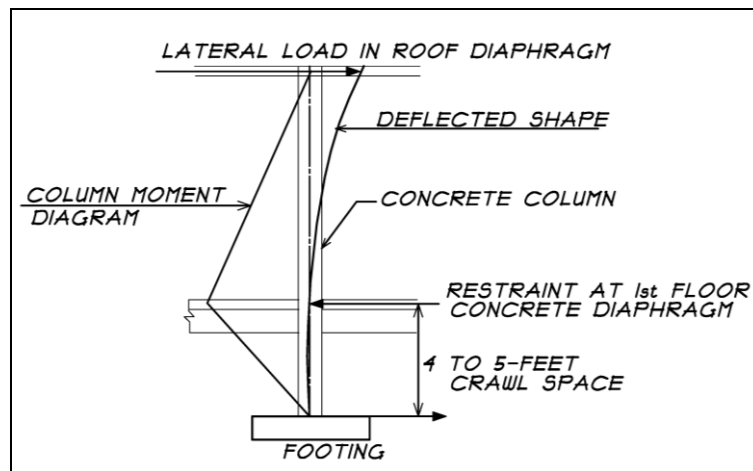
Figure 10. Low roof column restraint (not to scale).
