APPENDIX D

Objects that were Thrown, Toppled, or Slid by the 2008 Wells, Nevada Earthquake

Craig M. dePolo
Nevada Bureau of Mines and Geology,
University of Nevada, Reno

2011

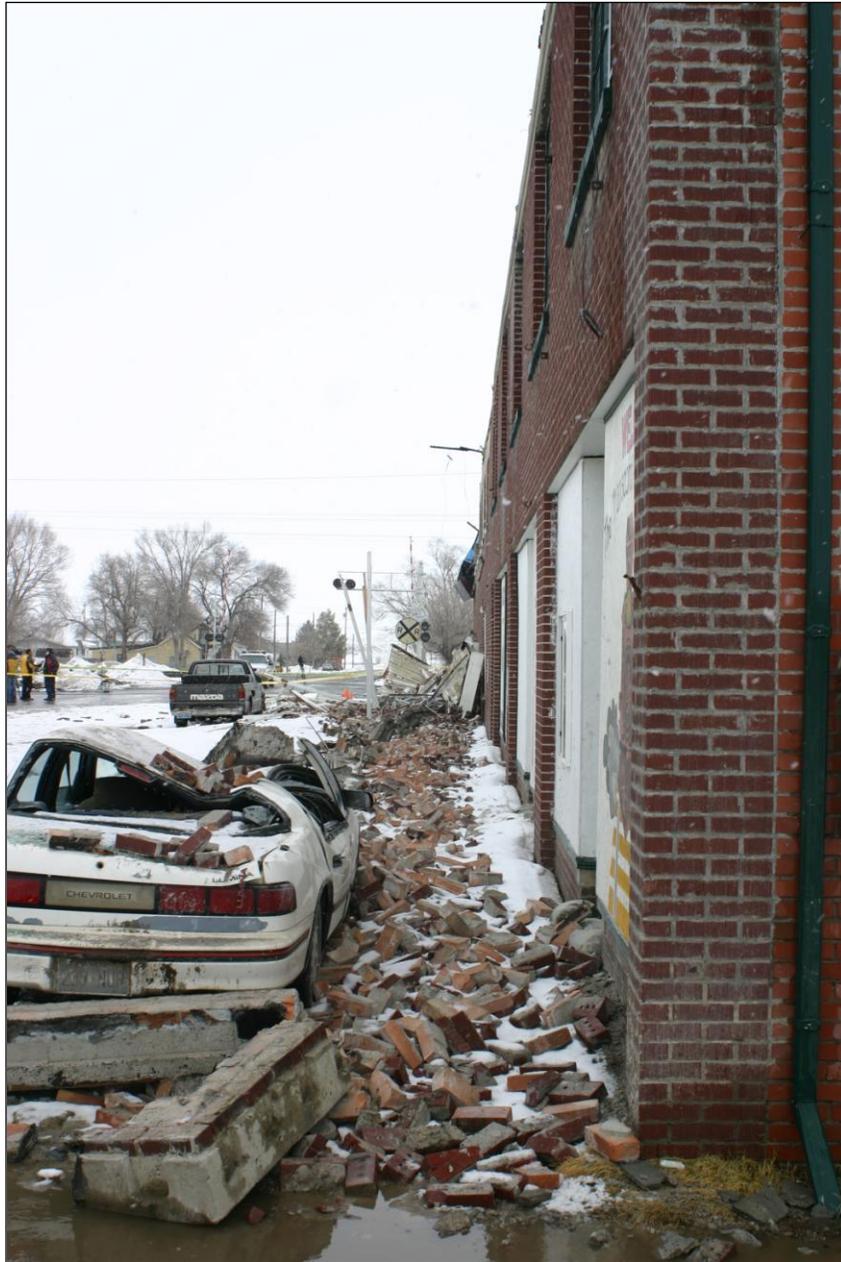
The entire concrete crowning bond beam was thrown to the northwest off the western side of the Bullshead Bar and the Wells Chalet, and appears to have hit a balcony, a car, and the ground in large pieces (figures 3, 5, 6, 7, and 8); fractures that were seen in the bond beam midway down the block between the two buildings were sub-evenly spaced transverse cracks that may have been caused as the beam hit the ground unevenly (figure 7). The western side of the Wells Chalet is shown in figure 3. Note also the crowning bond beam corner on the ground lying northwest (left of photo) of the corner of the building it was on top of. The remnant of a short top wall the beam was on is shown in figure 4. The beam fell in a 315° direction away from the building. The building likely influenced the throwing of the bond beam, especially the amount of throw, but the direction was likely strongly influenced by ground motion and the direction is comparable to the direction a chimney was toppled about two-and-a-half blocks to the south (300° at Location 2 in figure 2).

Figure 3. View to the northeast along the sidewalk along the northwestern side of the Wells Chalet (near) and the Bullshead Bar (down the block where the collapsed balcony is). The corner of the crowning concrete bond beam can be seen as can the corner of the building it was on top of. The corner is only a couple to few decimeters to the southwest of the building corner whereas the estimated horizontal distance between where the bond beam was at the two-story roof level and where it impacted the car as indicated by the divot in its roof is 1.8 m, +/- 0.5 m. *Photograph by Utah Division of Homeland Security.*

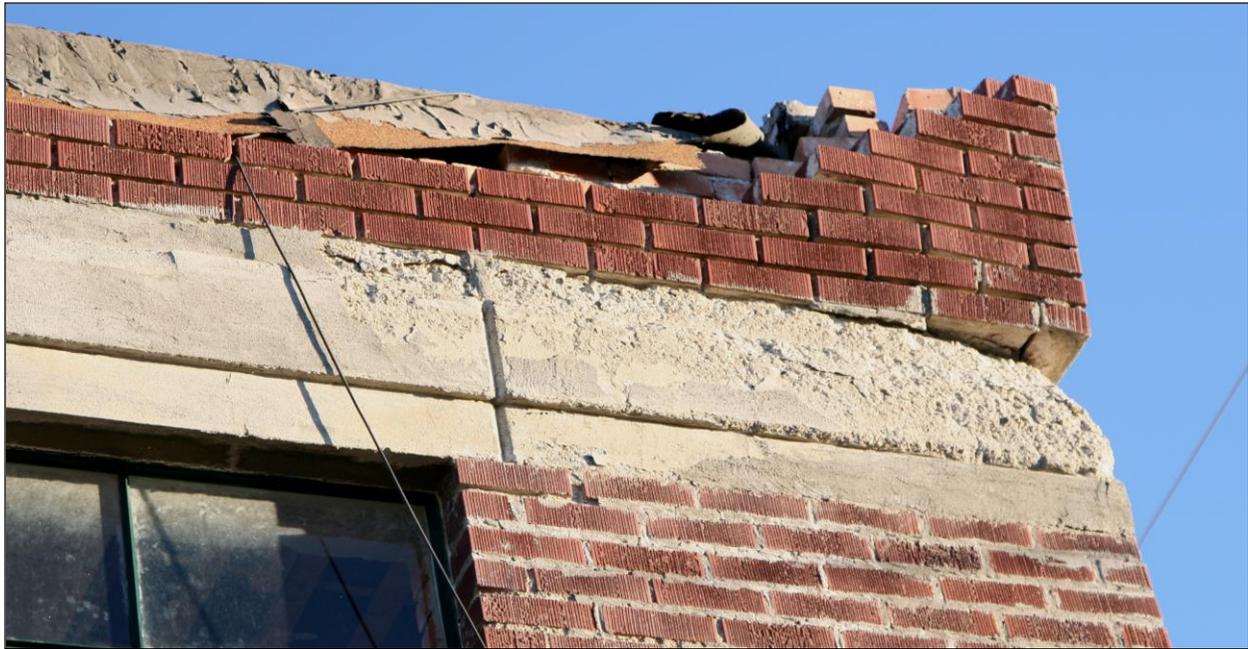
Figure 4. Remaining upper part of the southwest corner of the Wells Chalet. The crowning bond beam sat on top of at least 10 and as many as 14 courses of bricks, and fell off with at least seven or eight courses, but limited perhaps by the strength of the underlying bond beam. Note the spalled off parts of the upper part of the concrete beam; this damage may have been inflicted by the rocking back-and-forth of the upper part of this wall/parapet.

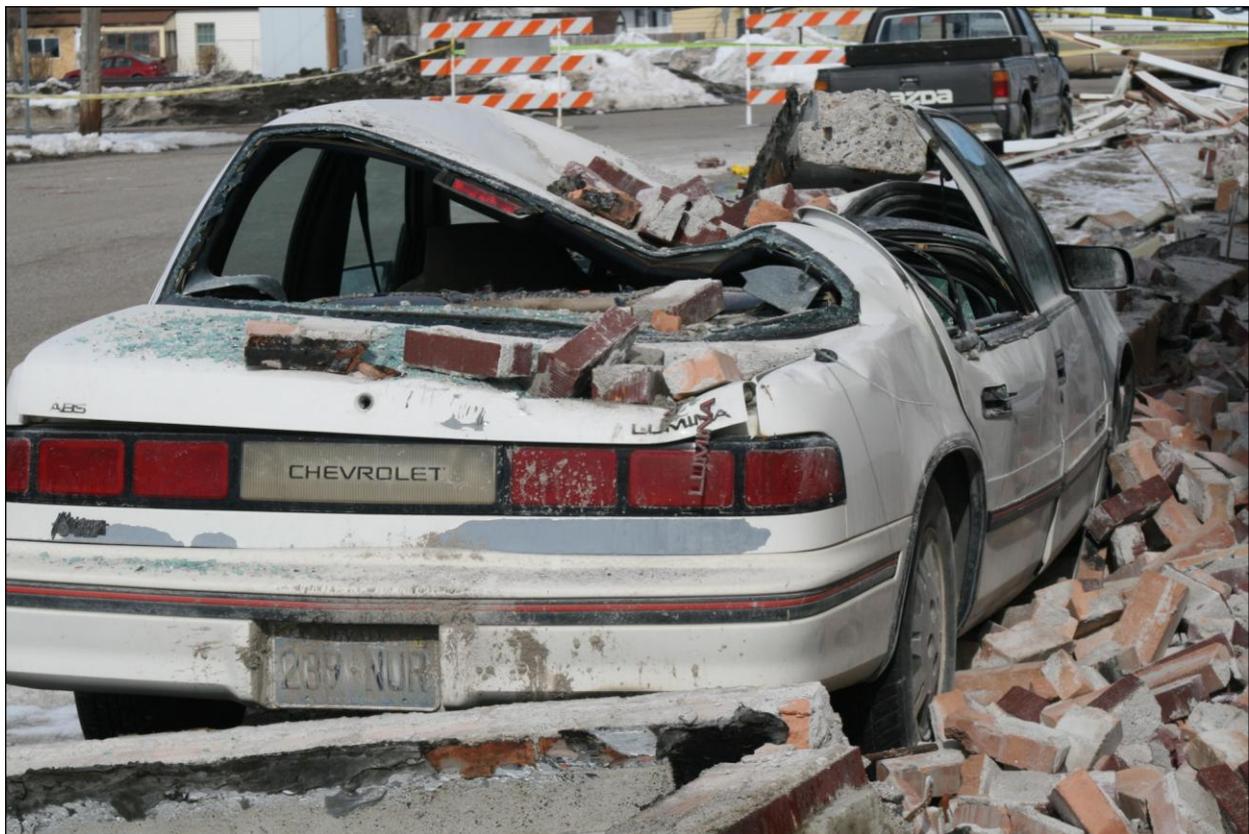
Figure 5. Car hit by the falling bond beam and bricks. The divot in the roof shows where the impact was.

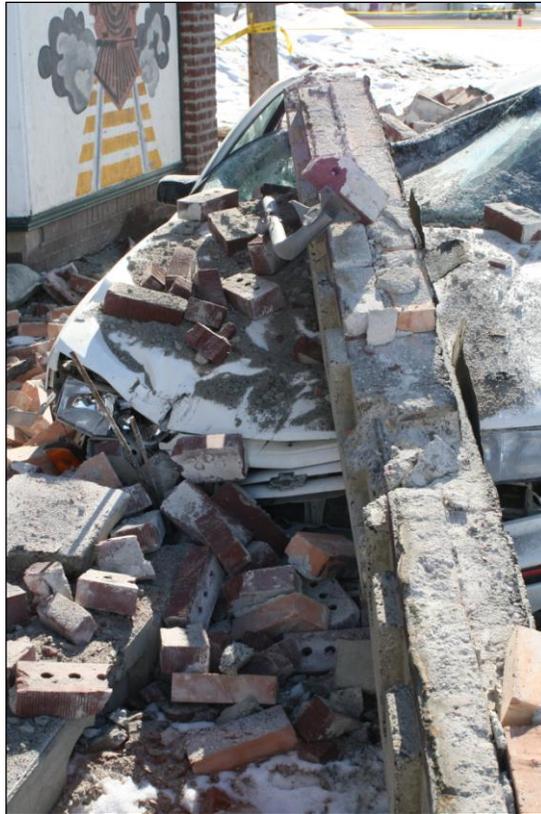
Figure 6. Front end of the car hit by the bond beam in figures 4 and 5. The actual point of impact appears to be just to the right of the headlight, not where the bond beam finally came to rest. This point is in line with the impact on the roof. The car is partly on the sidewalk and it is unknown if this was its original position or whether it was shifted there.

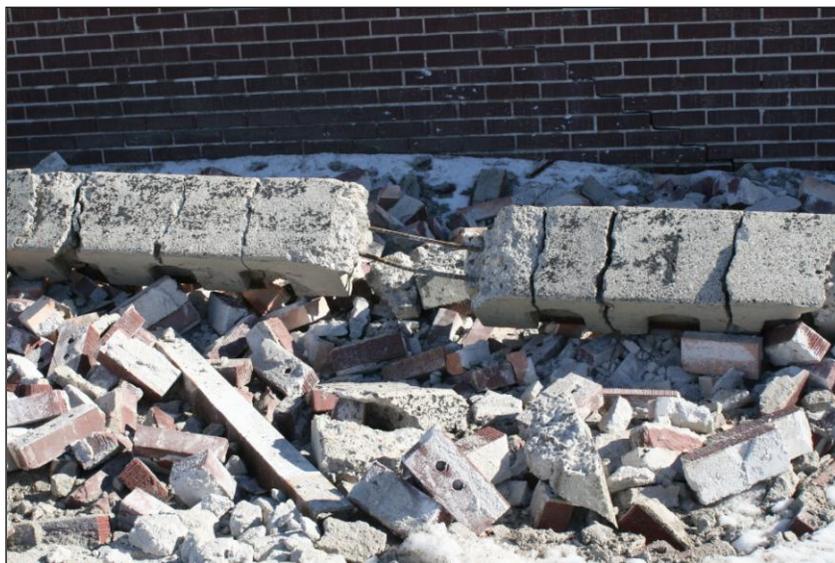
Figure 7. Section of sub-evenly spaced transverse cracks that may have been formed from the uneven impact of the bond beam on the ground; this is the same bond beam that crushed the car that is shown in figures 3, 5, and 6. Here, about midway down the block, the bond beam is close to the building. This pattern is mostly present in this area, which is the area between the two buildings; the bond beam may have fallen off at slightly different times or may have been delayed by the impact on the balcony causing a differential impact with the ground.

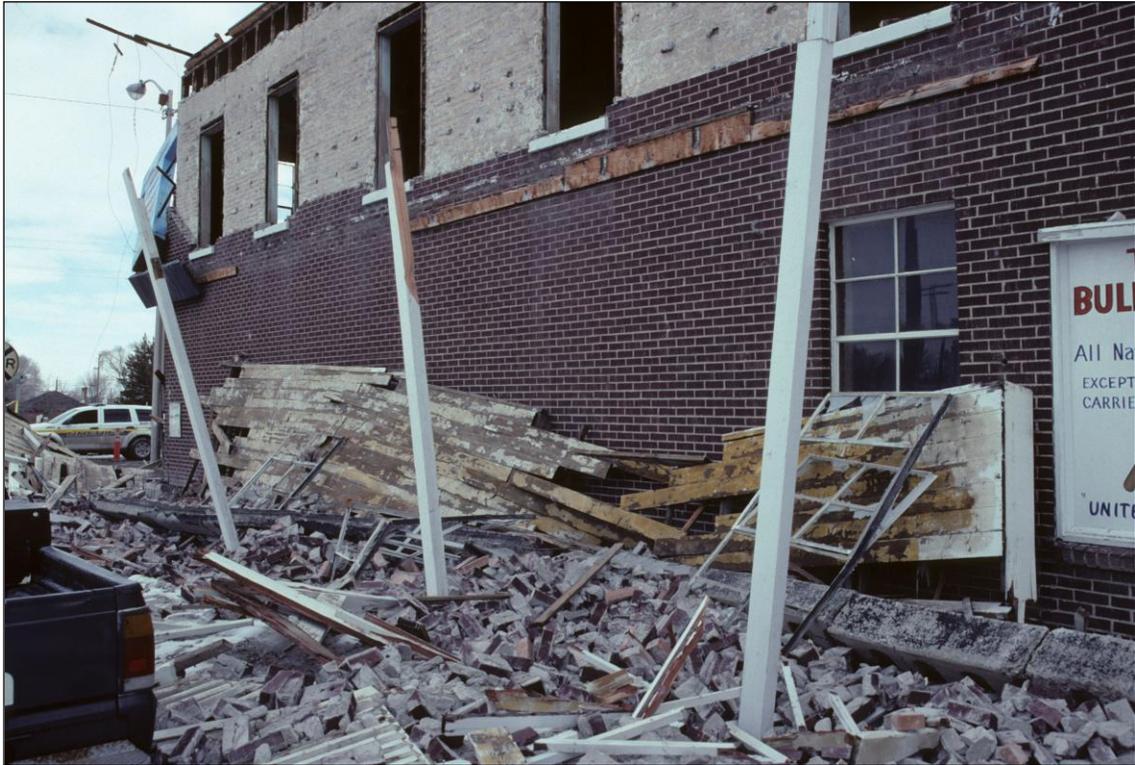
Figure 8. Northern part of the fallen crowning bond beam in front of the Bullshead Bar. The bond beam is currently about 0.5 to 1 m from the building.

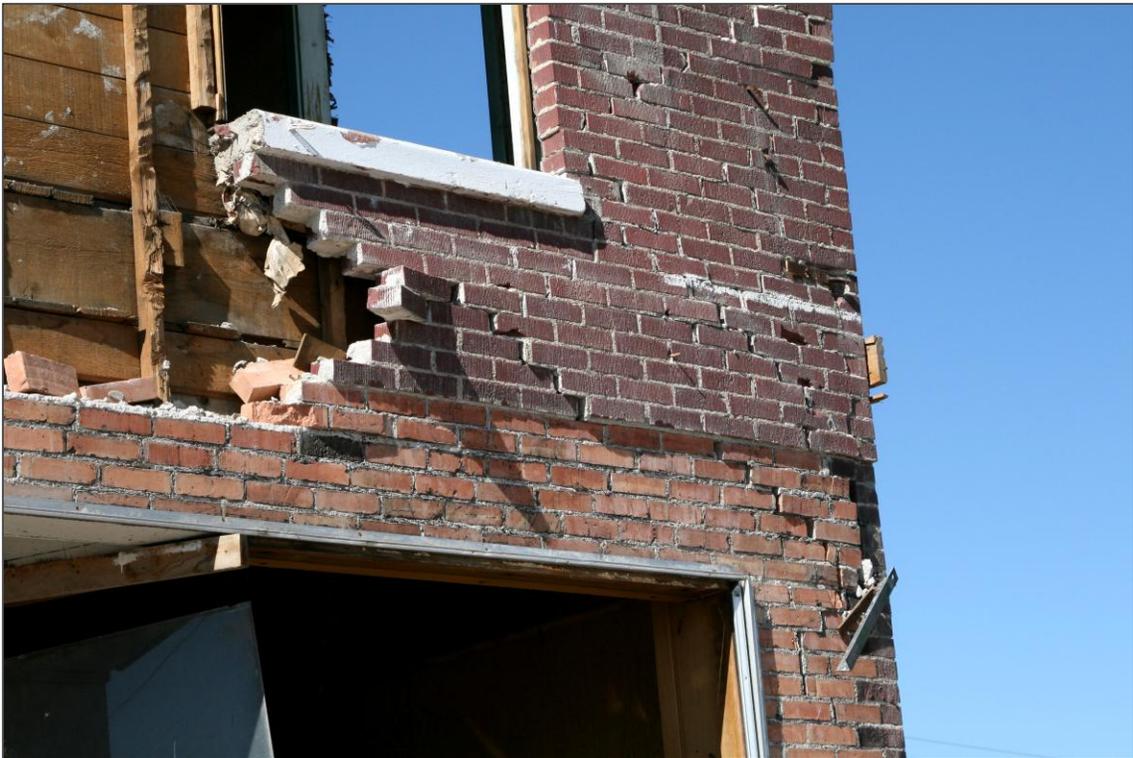
Figure 9. "X" fracture patterns in the remaining brick veneer in this northeast-facing wall of the Bullshead Bar indicates the building rocked parallel to the wall. The eastern part of the crowning bond beam on this wall fell on the roof, whereas the rest fell off the side.

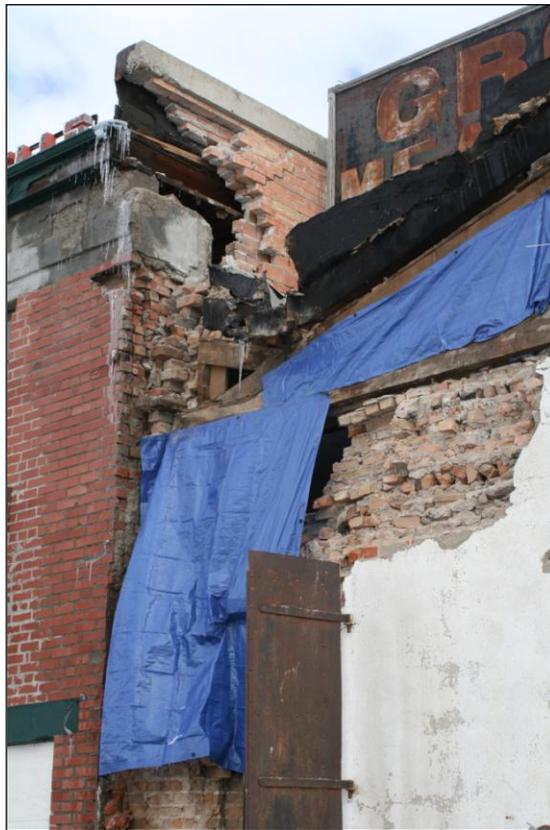
Figure 10. Large concrete beam on the southwestern side of the Wells Chalet where it has punched a hole in the southeast wall. This supports a major rocking of the Wells Chalet in a northwest-southeast direction of excitation, or ground motion.

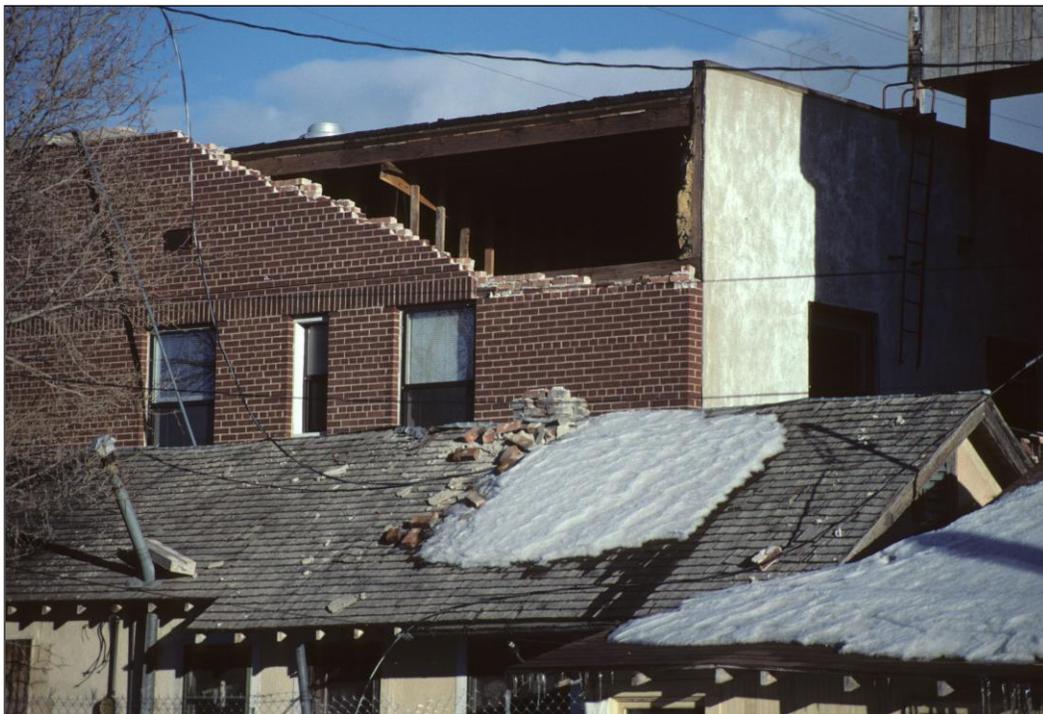
Figure 11. Northwestern side of the El Rancho Hotel and the small one-story house to the northwest of the building. A piece of the bond beam from the El Rancho can be seen caught up against the metal stove pipe that fell far enough west to clear the crest of the roof of the house and the bricks from the damaged house chimney are strewn to the northwest on the house roof, indicating strong ground motion in a northwest-southeast direction.

The El Rancho Hotel was diagonally across the street to the northwest from the Wells Chalet and had crowning bond beams fall off three sides, but it particularly was thrown or cantilevered out on the western side; this is the second arrow on the left at location 1 on figure 2. In figure 11, a portion of the bond beam that cleared the crest of the roof of the adjacent building can be seen caught against a metal smoke stack. The bricks from the destroyed chimney on the house are also strewn down the house in a northwest direction, and this is a one-story building with the short dimension in the northwest direction, limiting the response of the building.

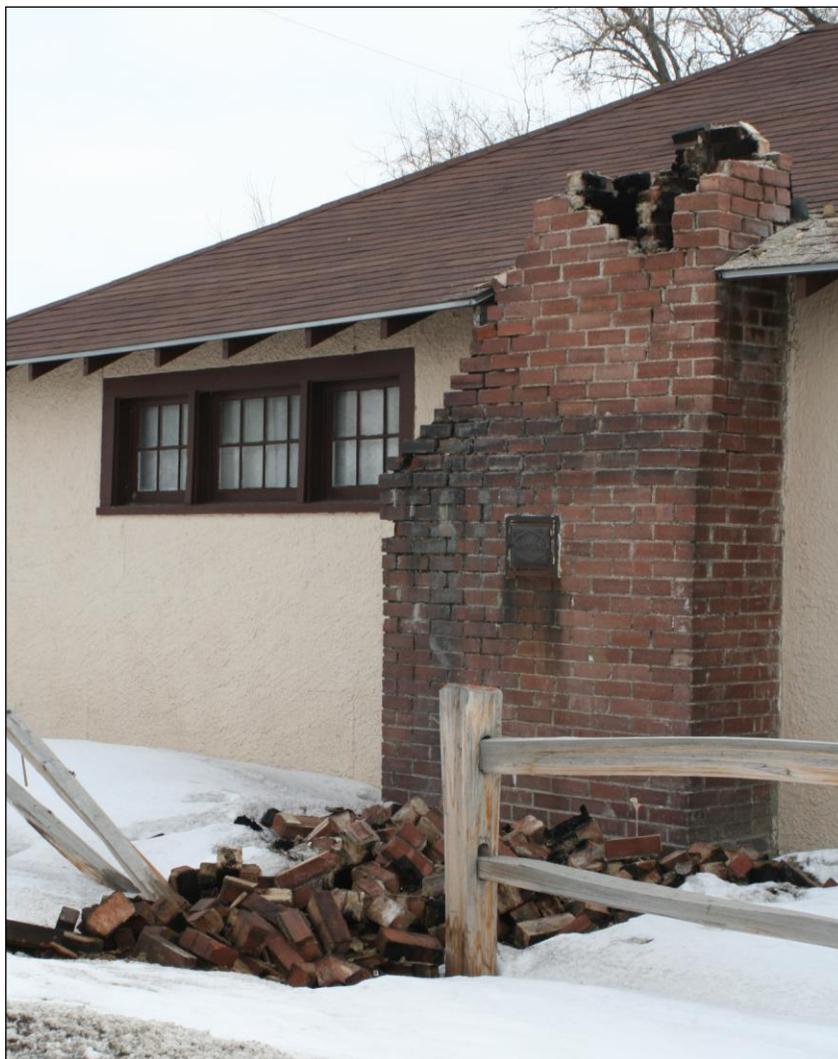
Figure 12. Chimney that was toppled and lies in a rough order with the bricks from the bottom of the chimney near its base and the bricks from near the top of the chimney near where the fence was crushed.

An example of an exterior house chimney that toppled is shown in figure 12, near the corner of Ruby Avenue and 6th Street. The direction of the toppled chimney was measured, and it was consistent with the break-off pattern left at the top of the chimney (divot where it fell and high side where it broke clean when it lifted off of that side). The break at the top is clean and all the bricks that fell from the chimney are on the northwestern side of the chimney. The chimney fell in the direction of 300°.

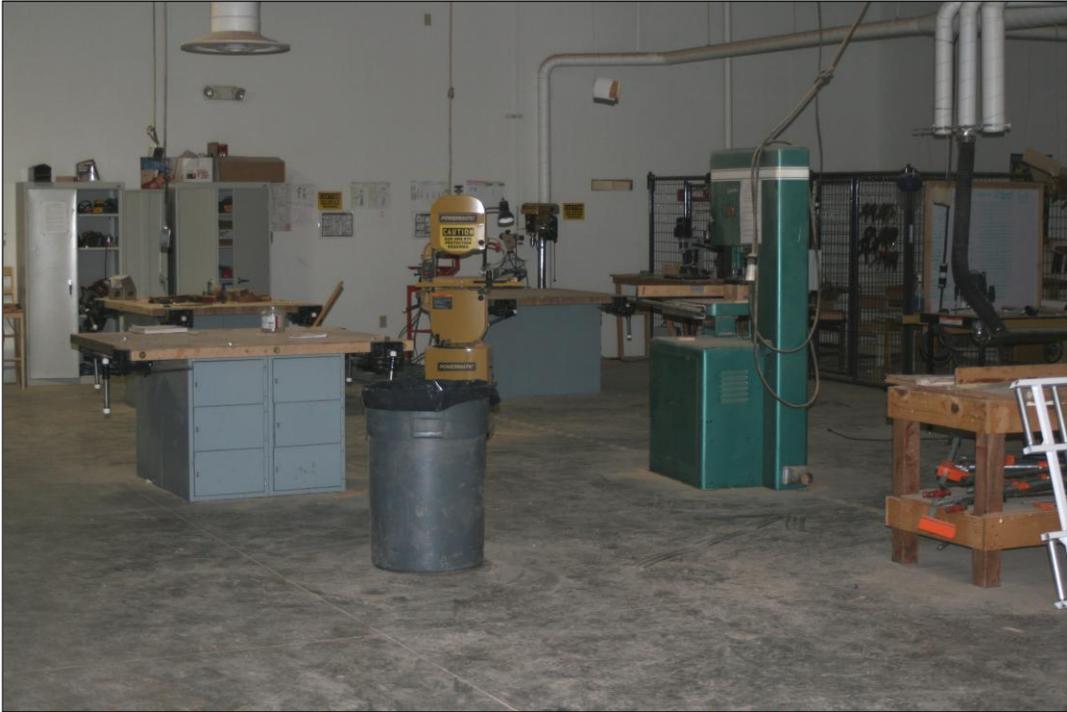
Figure 12. Southwestern part of the high school wood shop. The shop had been swept but a halo of sawdust was left around the equipment so the tracks could be measured.

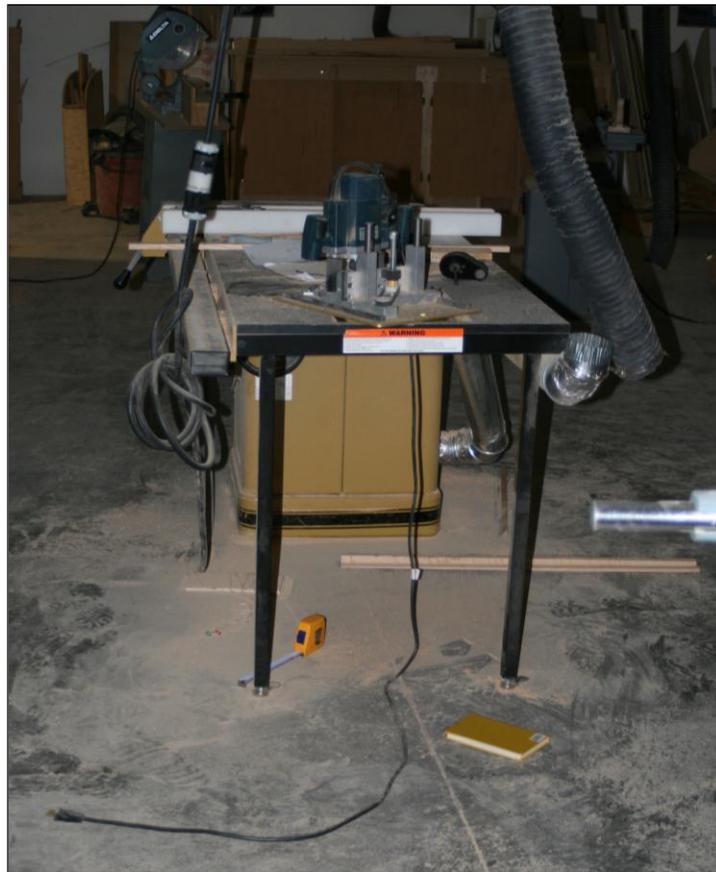
Figure 13. Router table which has slid towards the lower left side of the photograph as the ground moved in one or more pulses in the opposite direction.

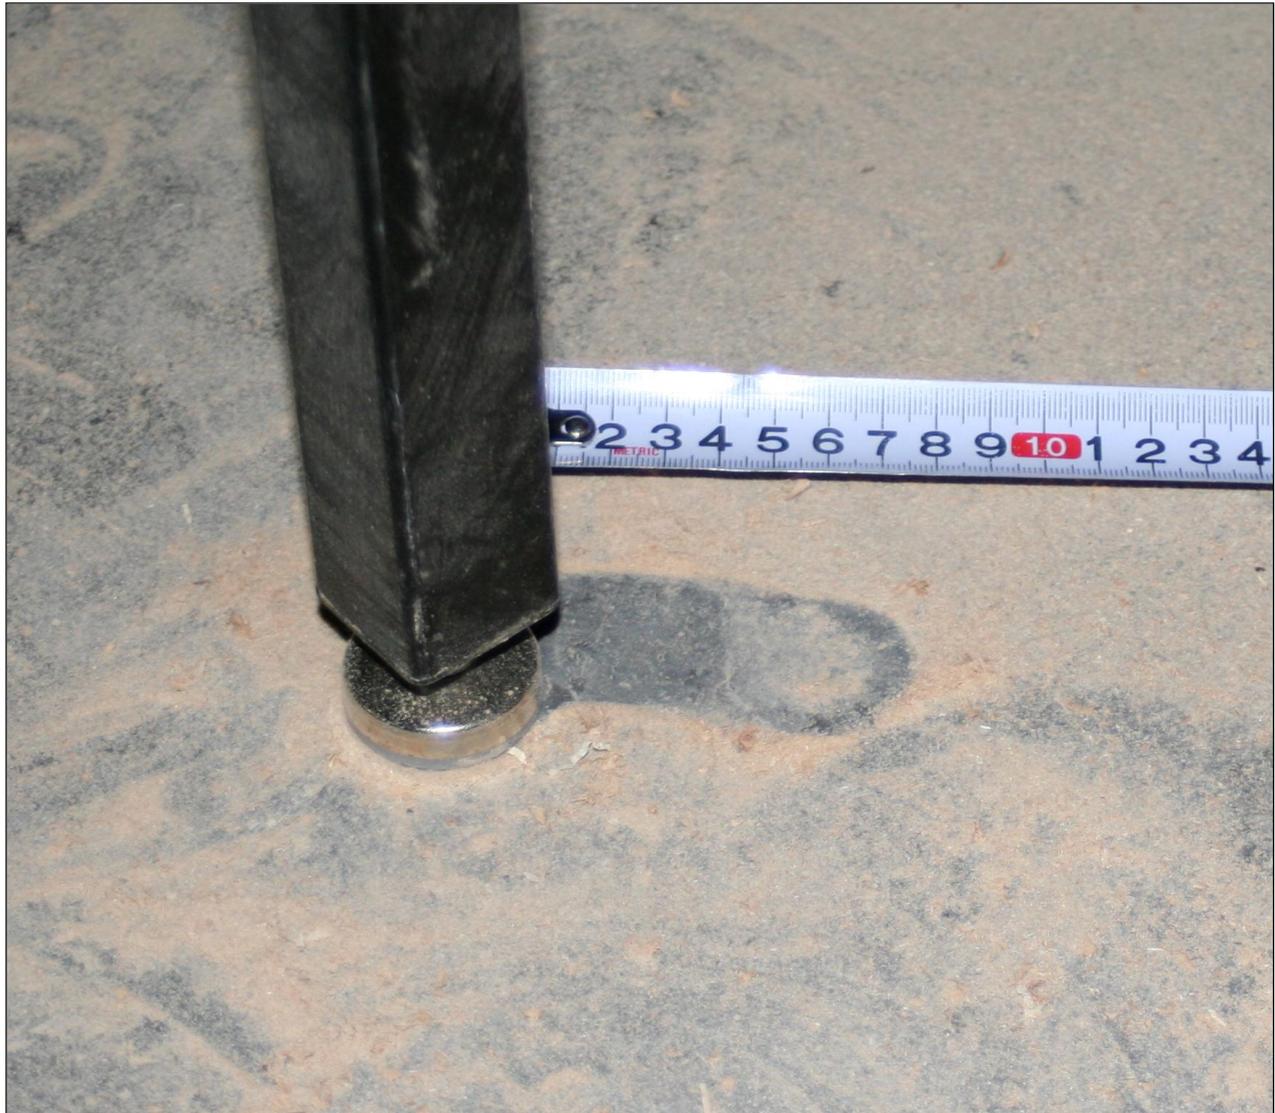
Figure 14. Jumping and sliding track of a router leg; the ruler is in the same position as in figure 13. Note the initial location of the right side of the round silver foot at approximately 8 cm on the ruler. There is a rough circle of where the contact was initially on the floor and an area of sawdust inside this circle. The left side of this circle has some dust on. This leg of the machine appears to have jumped at the start to have left this track; the jump is about the width of the foot, or about 2 cm. At 4+ cm on the ruler the area of cleared dust in the track has an abrupt, concave to the left shape indicating the foot was back in contact with the floor at that point and was sliding to the left at that point. The foot slides 3 to 4 cm to the left, and then changes direction almost 80° and slides 1.5 to 2 cm towards the lower left corner. The total offset of the main displacement to the left was about 6.5 cm in a direction of 271°. Not all the tracks from the legs of the router are the same indicating there is some modulation of these tracks from the response of the router to the shaking.

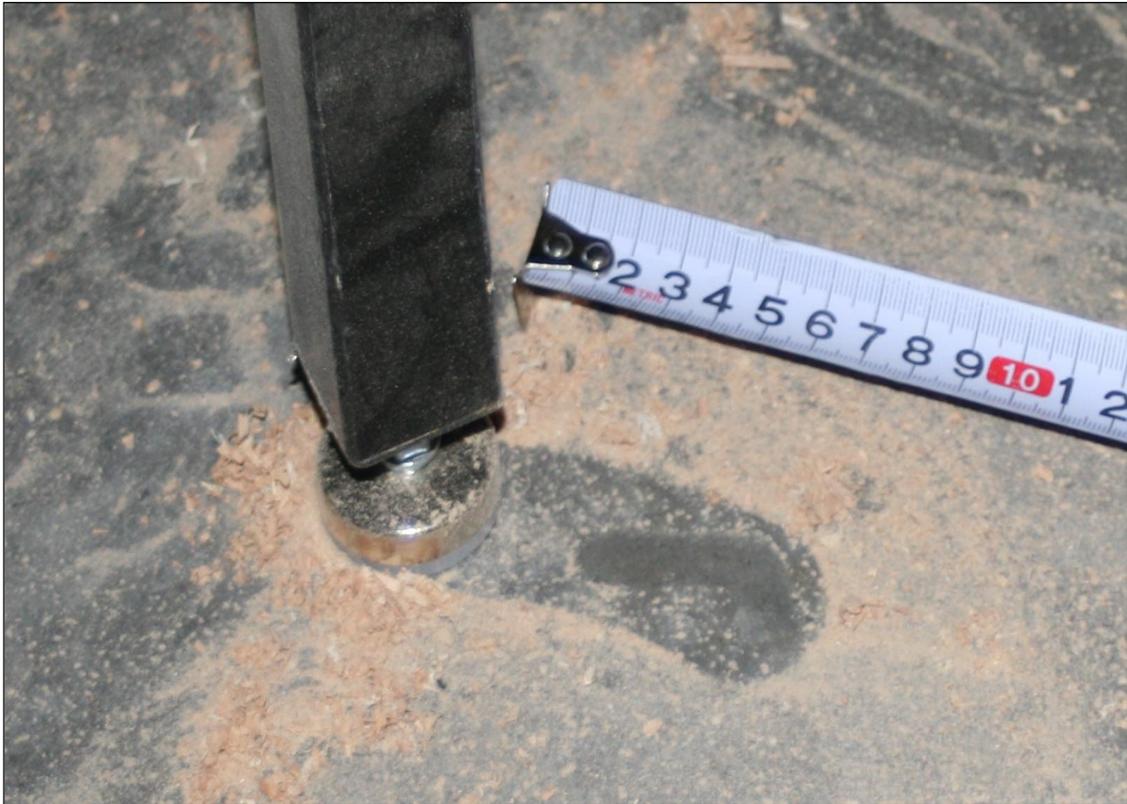
Figure 15. Router leg track from the front right leg in figure 13. This leg slid in a very gentle arc, starting in a 291° direction and within ~ 1 cm changing to an approximate direction of 277° . This track is about 7 cm long. The finger scrape was an observation of the roughness of the floor, which had a very smooth concrete finish.

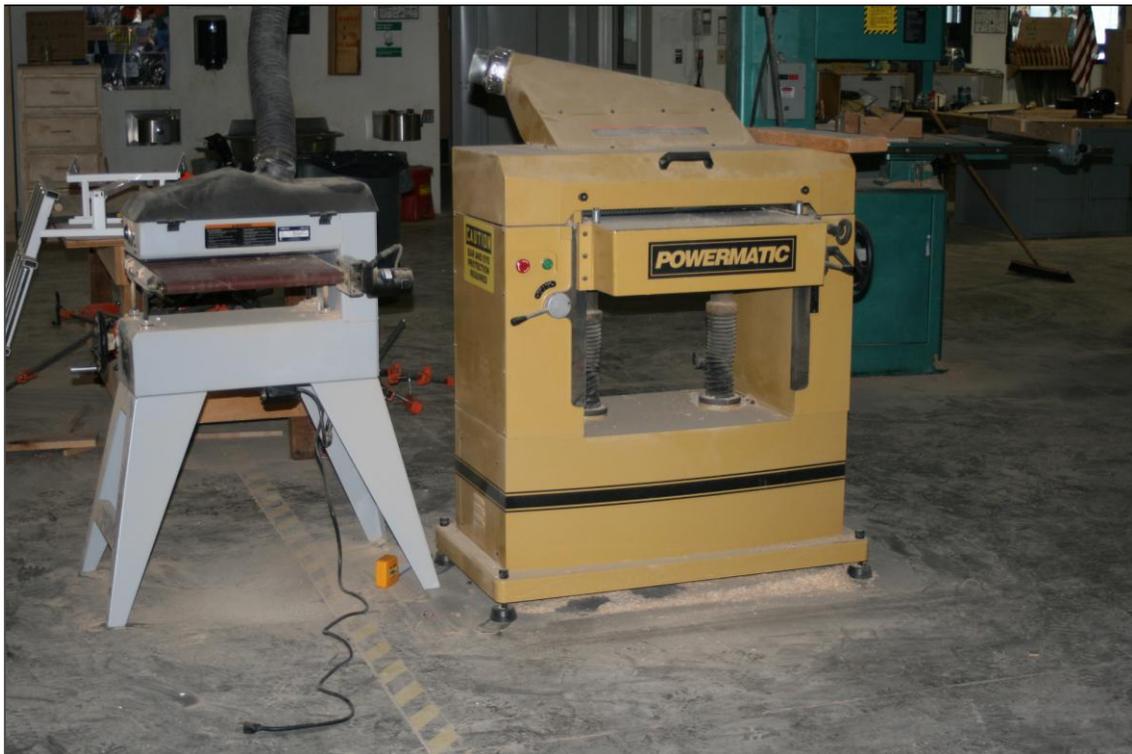
Figure 16. Massive free-standing metal press.

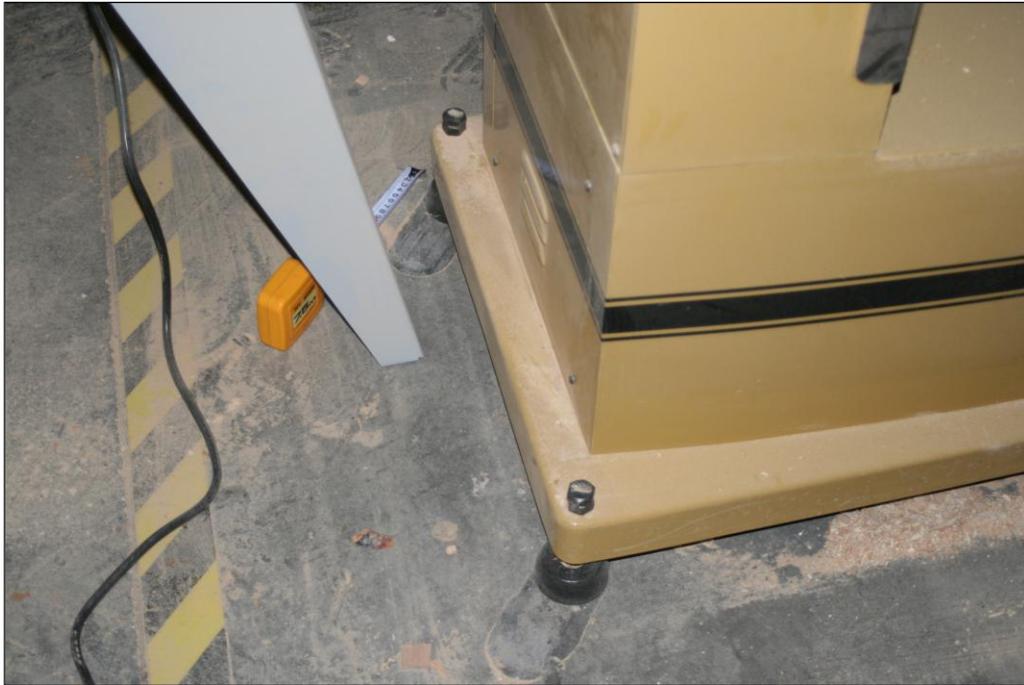
Figure 17. Tracks of the feet of the massive metal press shown in figure 16.

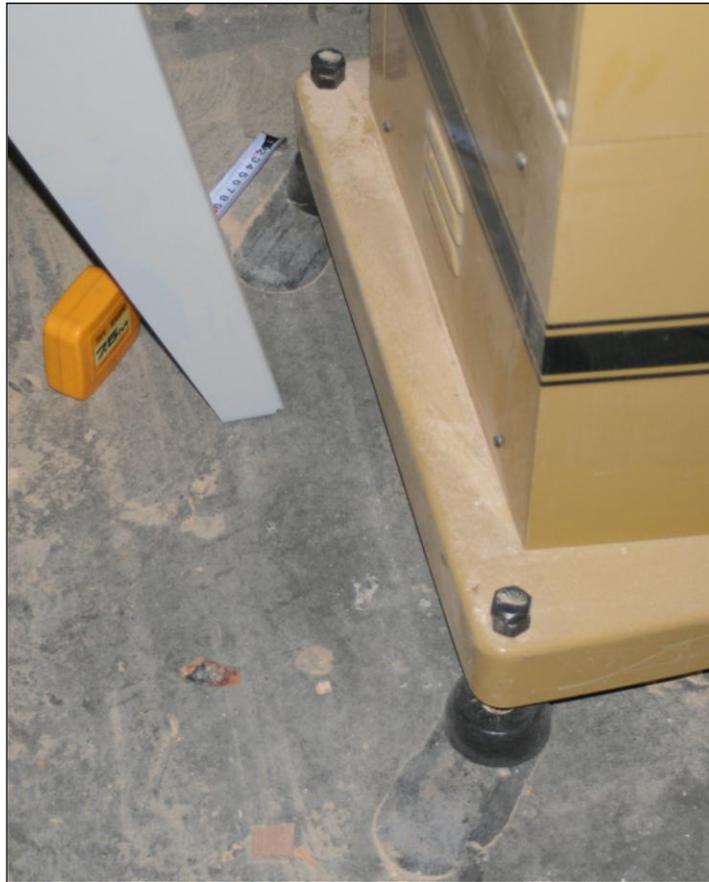
Figure 18. Fairly straight tracks in constant contact with the floor from these hard rubber feet, with possible rubber scrape marks in the upper track. These two legs slid in the same direction, 281° and about the same distance, 9.5 cm.

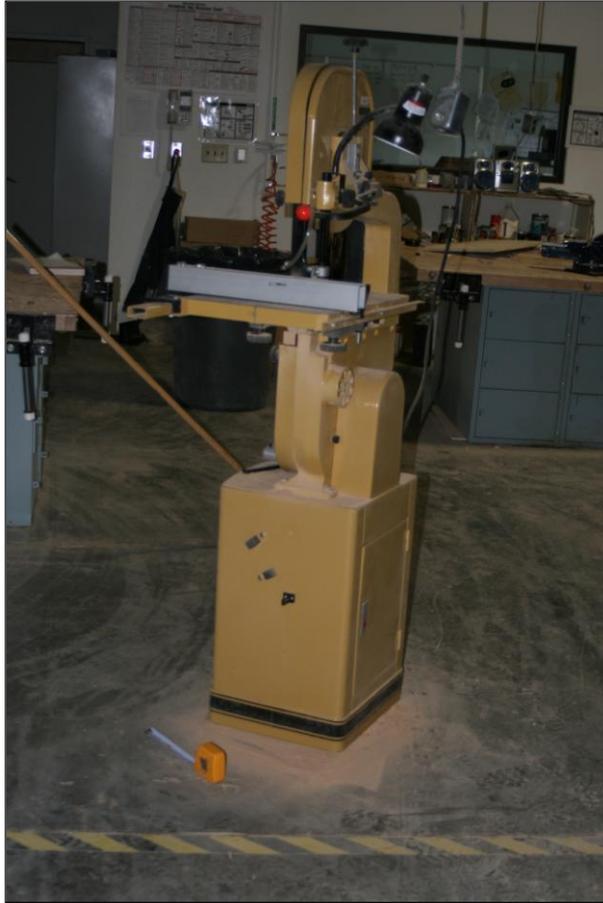
Figure 19. Band saw that walked in response to the earthquake, probably because of its vertical eccentricity and heavy base.

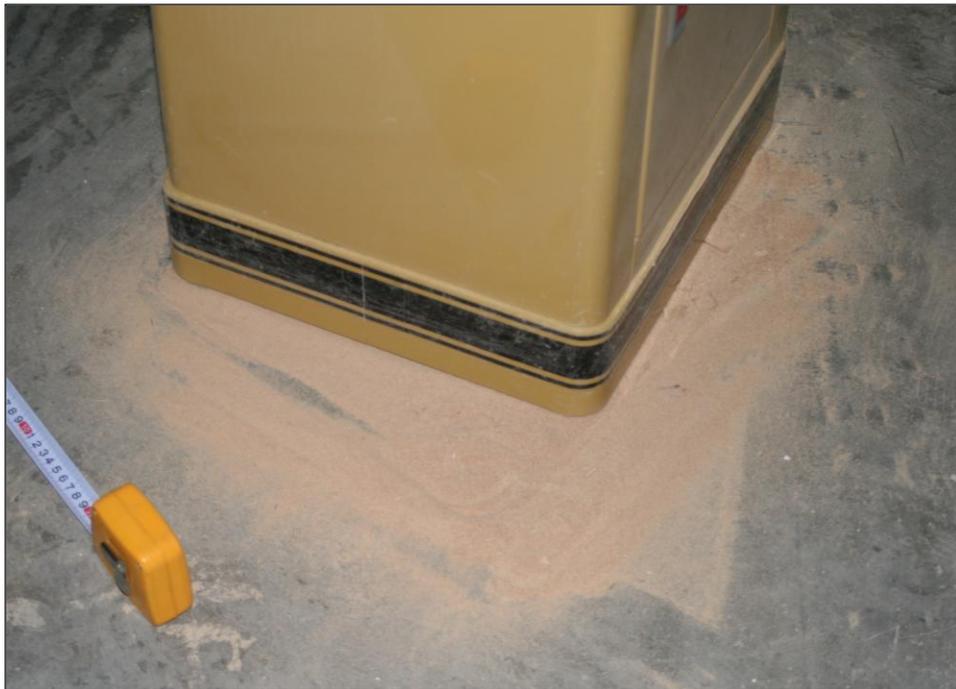
Figure 20. Rocking and twisting of bandsaw shown in figure 19. left footprints made from the sawdust within the base of the machine. The largest step is the first, then there are ghost prints indicating the saw rocked back and forth with some rotation in between steps an addition four times to get to its final position. The final position showed counterclockwise rotation of about 30° from the initial position.

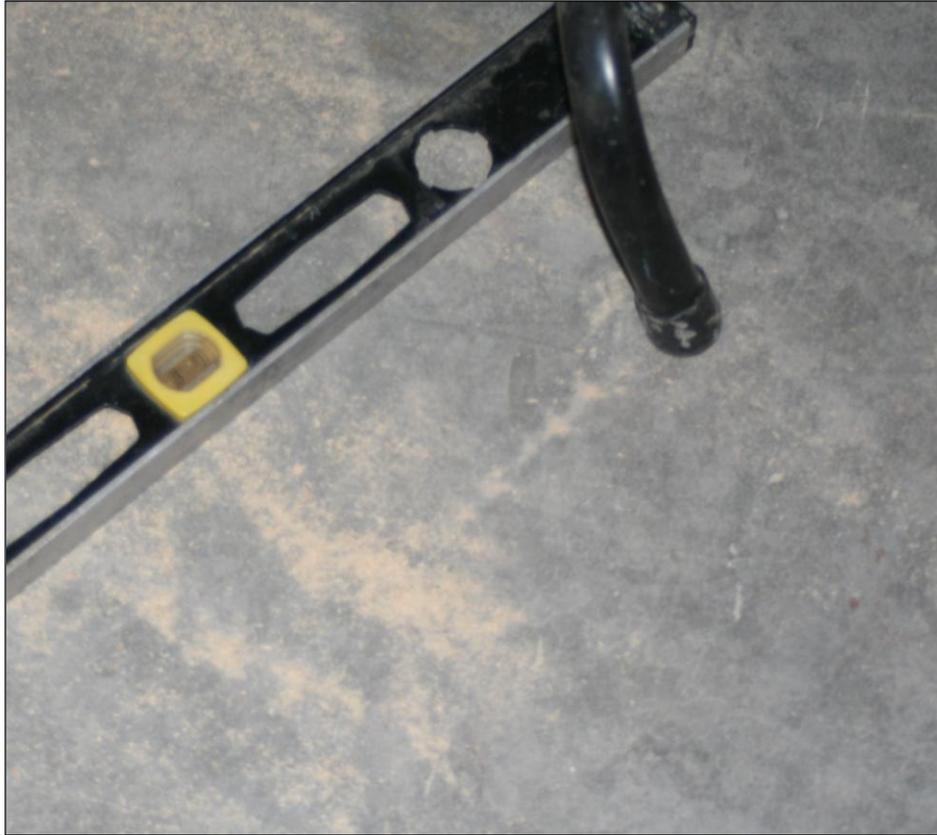
Figure 21. A relatively light radial arm saw table with four legs and rubber feet shows several (seven?) steps it made during the earthquake as it shuddered across the floor, perhaps with each oscillation of strong shaking. The tracks from the western legs were 14 and 15 cm in a direction of 261°.

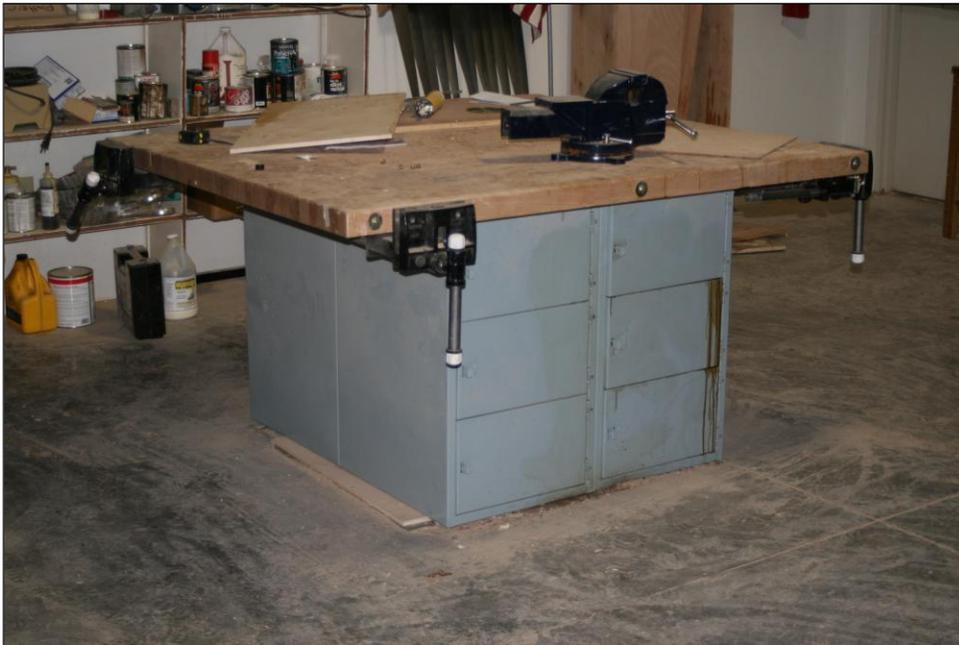
Figure 22. These table tops with a locker base were the most equidimensional objects in the shop with a relatively even distribution of mass slid the general direction of all the objects, suggesting they were the most precise measurements that could be made (had the least modulation from the object itself). There were two tables like this and both were moved uniformly 4.5 cm in a direction of 271°.

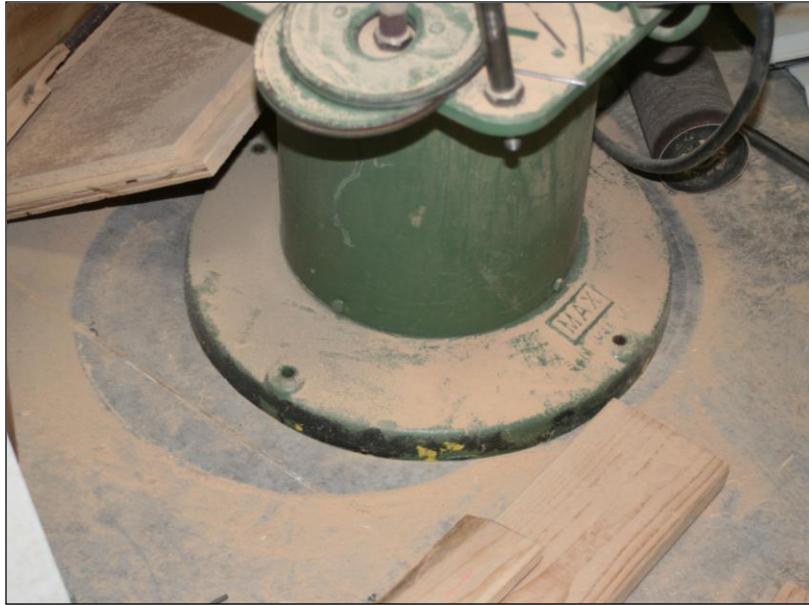
Figure 23. Wobbling pattern back-and-forth of a round metal object in the shop; the direction generally matched the other tracks but it was not measured.

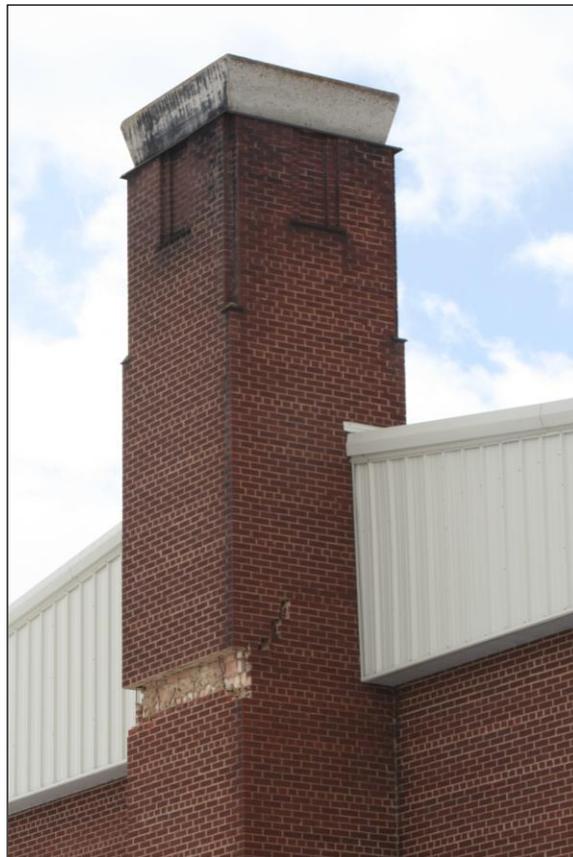
Figure 24. Large chimney on the northeastern side of the Wells High School auditorium. The top of the chimney was cocked back towards the building, as indicated by the tension cracks on the opposite side and the bricks that were thrown out of the unreinforced brick chimney. The tension cracks on the side of the chimney indicate a hinge point near the contact of the chimney and the top of the roof. The direction of ground motion indicated by the chimney is about 45° of the ground movement direction indicated in the woodshop, which is immediately to the west of the chimney; this is an example of how different the direction of strongest shaking from a building and that from free-standing equipment can be.

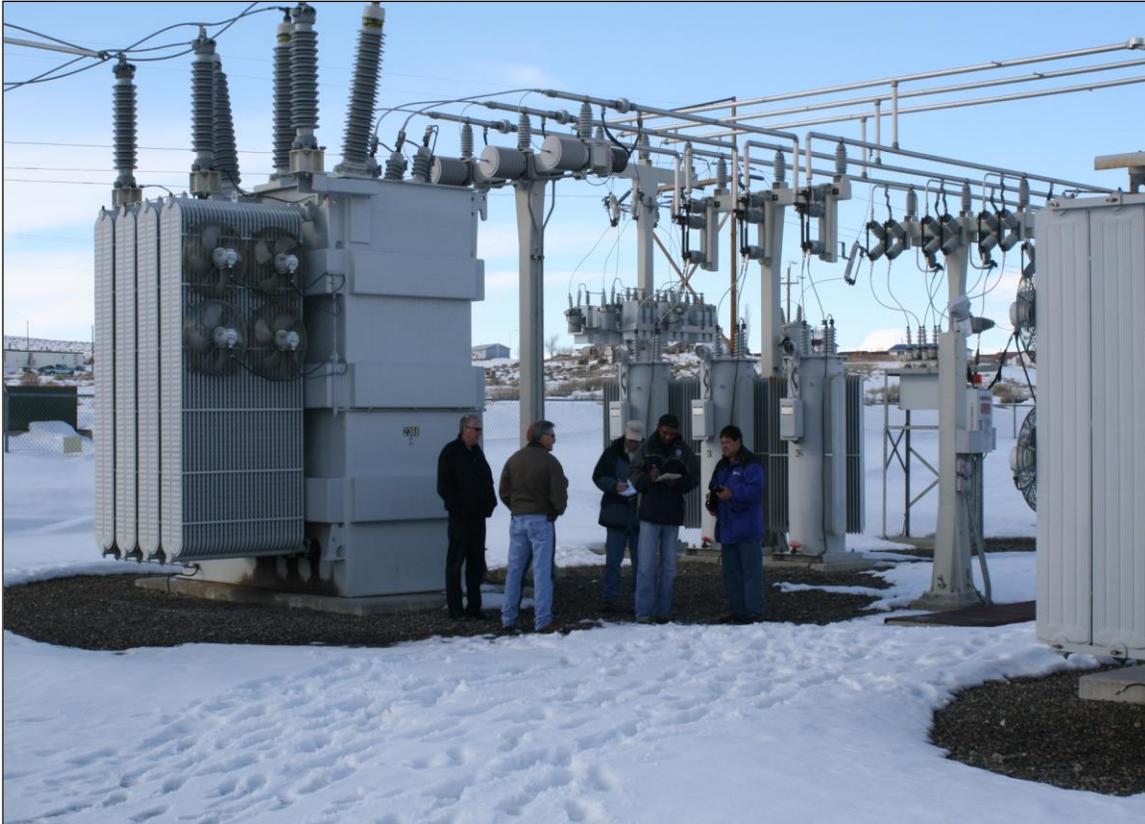
A transformer weighing 102,000 pounds (46,200 kg) located just west of the map area shown in figure 2 slid and rotated on its concrete base. The movement made a connecting electric cable on top tighten up and a ground wire cable on bottom taut. The transformer rotated clockwise a little on its pad (figures 26 and 27). The southeast corner moved 14 cm in a direction of 260° and the northeast corner moved 11 cm in a direction of 245°. These two adjacent corners are a distance of 171 cm apart. The transformer is on an even-surfaced concrete pad. These measurements are +/-10°.

Figure 25. The transformer on the left is the one that was shifted by the earthquake ground motion.

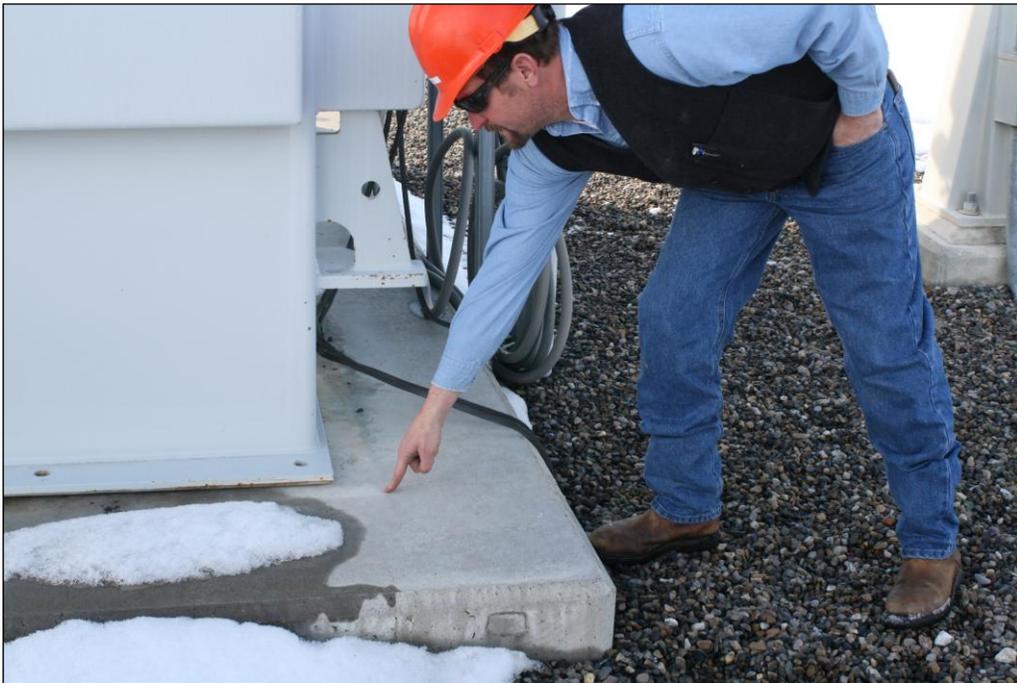
Figure 26. Wells Rural Electric worker indicates where the corner of the transformer was before the earthquake shifted it into the position now shown in the photograph. The transformer has since been reset to its original position.

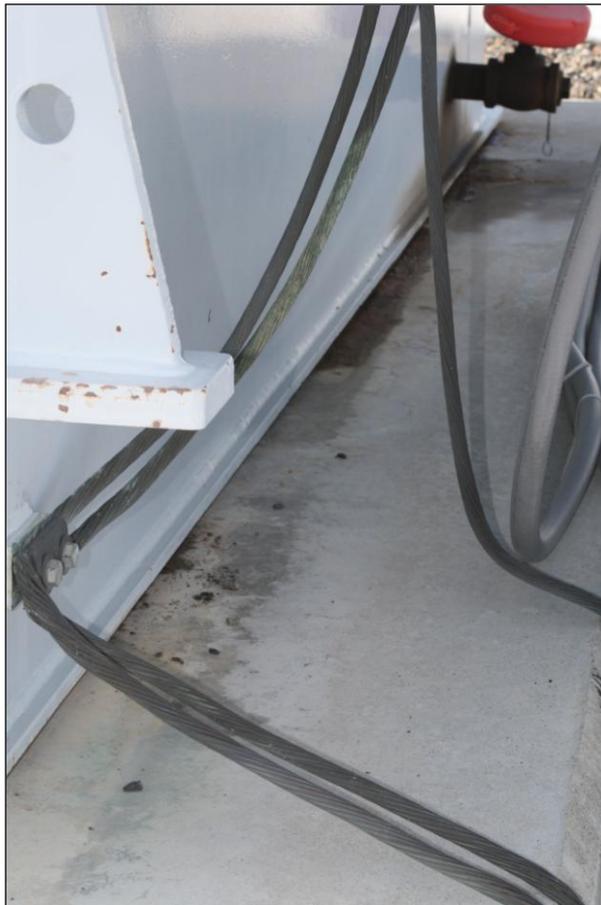
Figure 27. Northeastern side of the transformer base showing the prior mark of where it was before the earthquake.
