APPENDIX D

Objects that were Thrown, Toppled, or Slid by the 2008 Wells, Nevada Earthquake

Craig M. dePolo
Nevada Bureau of Mines and Geology,
University of Nevada, Reno

2011

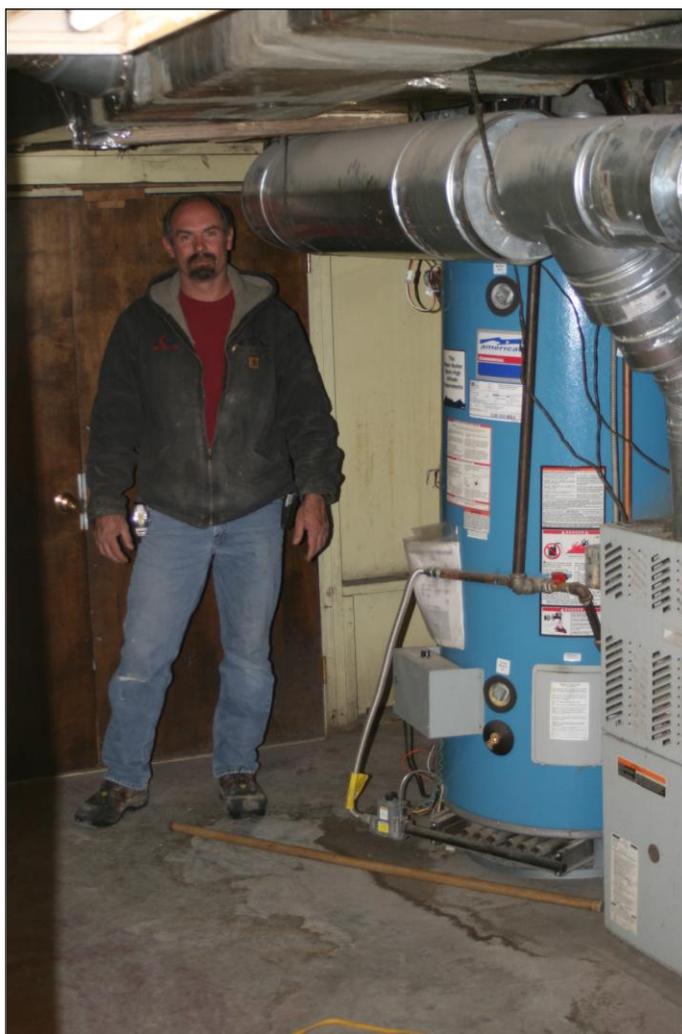
The full 100-gallon water heater (figure 28) slid in a direction of 175° +/-10° about 9.5 to 10 cm (figure 29). It was restricted at the top by rigid piping that pulled along with the tank. The floor was an even, semi-smooth concrete with some rust.

Figure 28. The blue industrial water heater that slid in the basement of the 4-Way Casino.

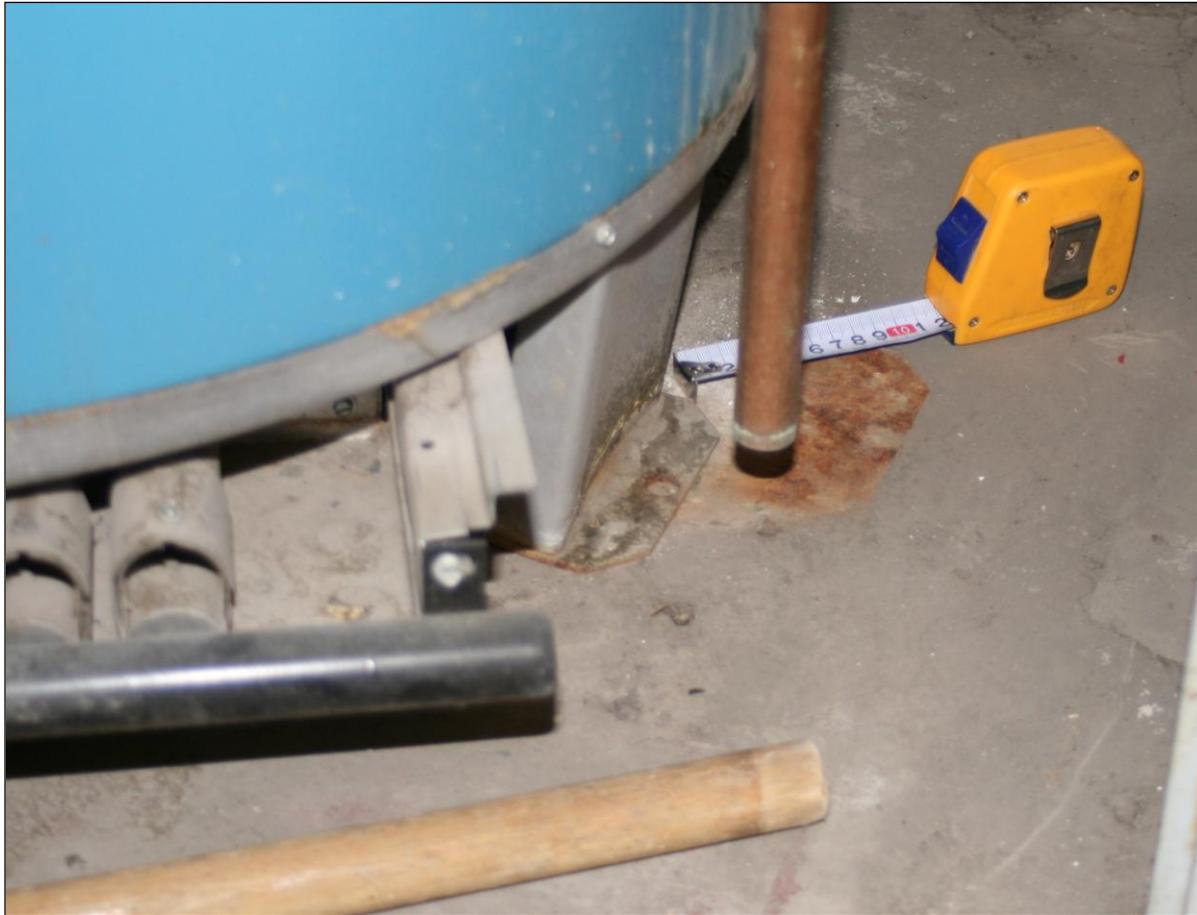
Figure 29. The foot of the water heater and the rusted footprint of its pre-earthquake location.

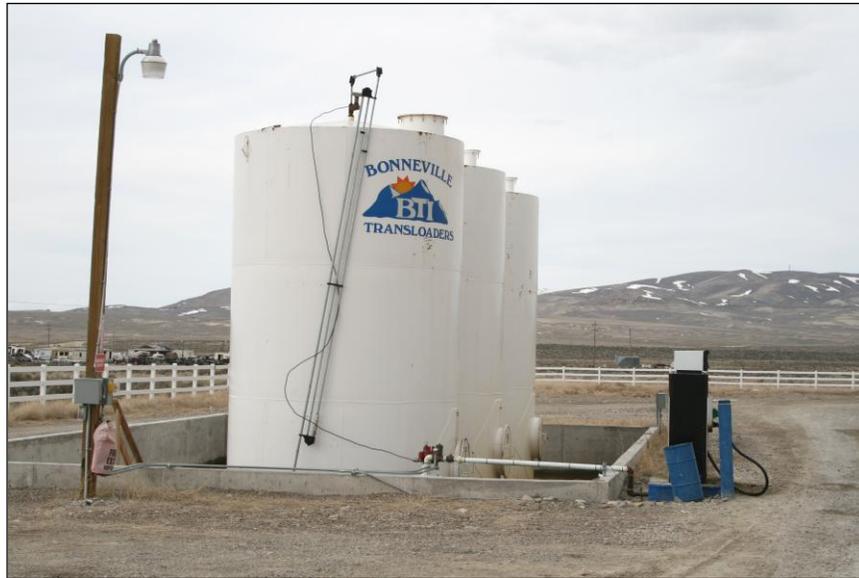
Three 15,000-gallon fuel tanks that were connected by a pipe near their base were slid on a concrete pad by the shaking, just north of where U.S. Highway 93 crosses over the railroad tracks that go through Wells. The tanks were about half full at the time of the earthquake and were slid 10 to 15 cm in a direction of 240° +/-5°. The tank had been reset when visited, but the direction could be reconstructed in the field as shown in the photo in figure 31.

Figure 30. Fuel tanks that were shifted by the earthquake.

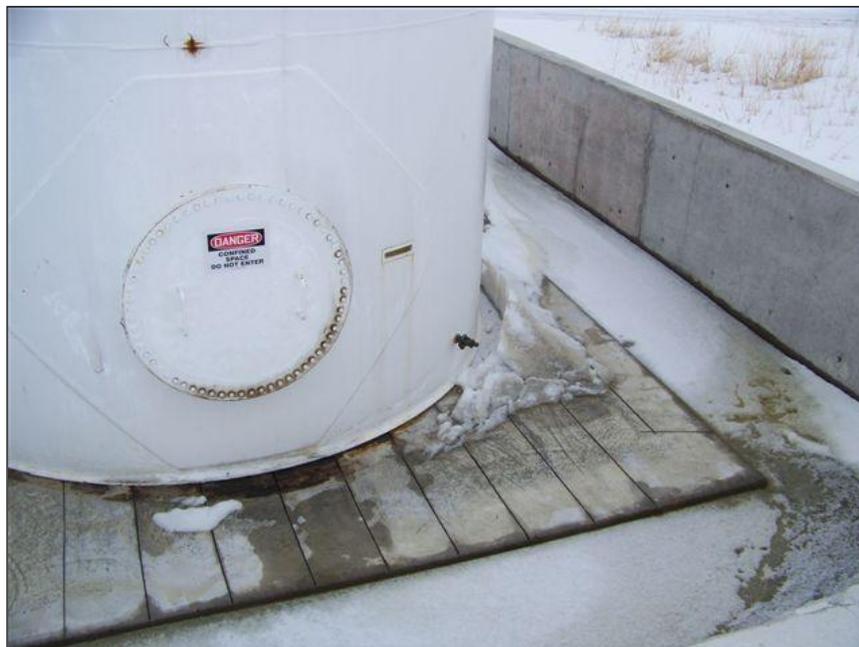
Figure 31. The fuel tank was shifted as indicated by the cast of its edge that was left in the snow. This is the farthest tank shown in figure 30. *Photograph by BTI employee.*
