Building Damage from the 2008 Wells, Nevada Earthquake

Craig M. dePolo
Nevada Bureau of Mines and Geology
University of Nevada, Reno

2011

ABSTRACT

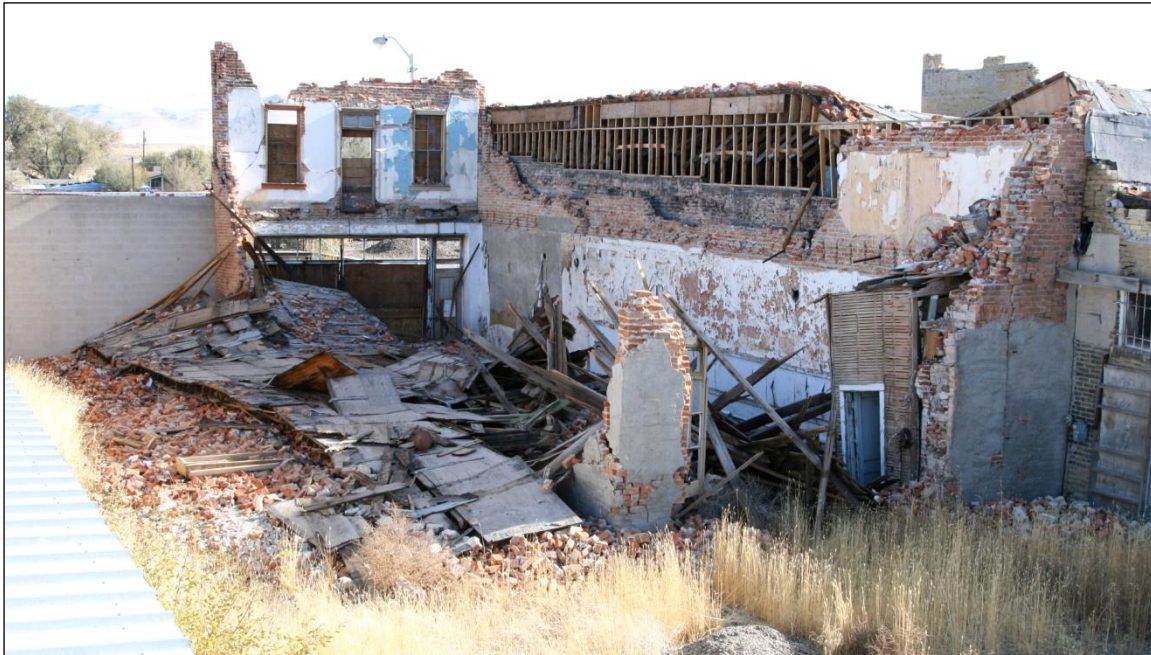
Only one building, the San Marin Hotel, collapsed in its entirety from the earthquake (figure 5). This vacant building, originally built in 1899, was in poor condition and part of the back wall had reportedly collapsed in prior years. The building was stabilized following this back wall collapse using steel rods to prevent the building from falling on adjacent properties. Even though the building was in poor shape, the collapse from the earthquake was impressive and catastrophic.

The western wall of this two-story building toppled to the northwest, bringing the entire roof and second story down onto a brick-covered bottom floor and on top of the collapsed wall. The western wall totally disintegrated to a brick and broken-brick level. Window frames from the wall lay in the rubble field as isolated members. There may have been a dramatic contrast in the drift of this wall between the front and the back of the building because the front of the building was braced between the concrete block “flag wall” on the west and the Eagle Club on the east, and had a concrete beam/header at the first story ceiling level giving it support. The only small part of the western wall that remains is the lower front part. In contrast to the front, the back wall was free-standing on its western side.

Figure 5. Collapsed San Marin Hotel, viewed from the back. The western wall (left side) has collapsed bringing down the second story floor and the roof. Only the lower corners remain of the western wall. Displacement may have been limited in the more rigid front of the building which buttressed by a concrete block wall and has a solid concrete header beam over the open window front. The opposite remaining corner is badly cracked and rear of the building is reported to have partially collapsed before the earthquake.

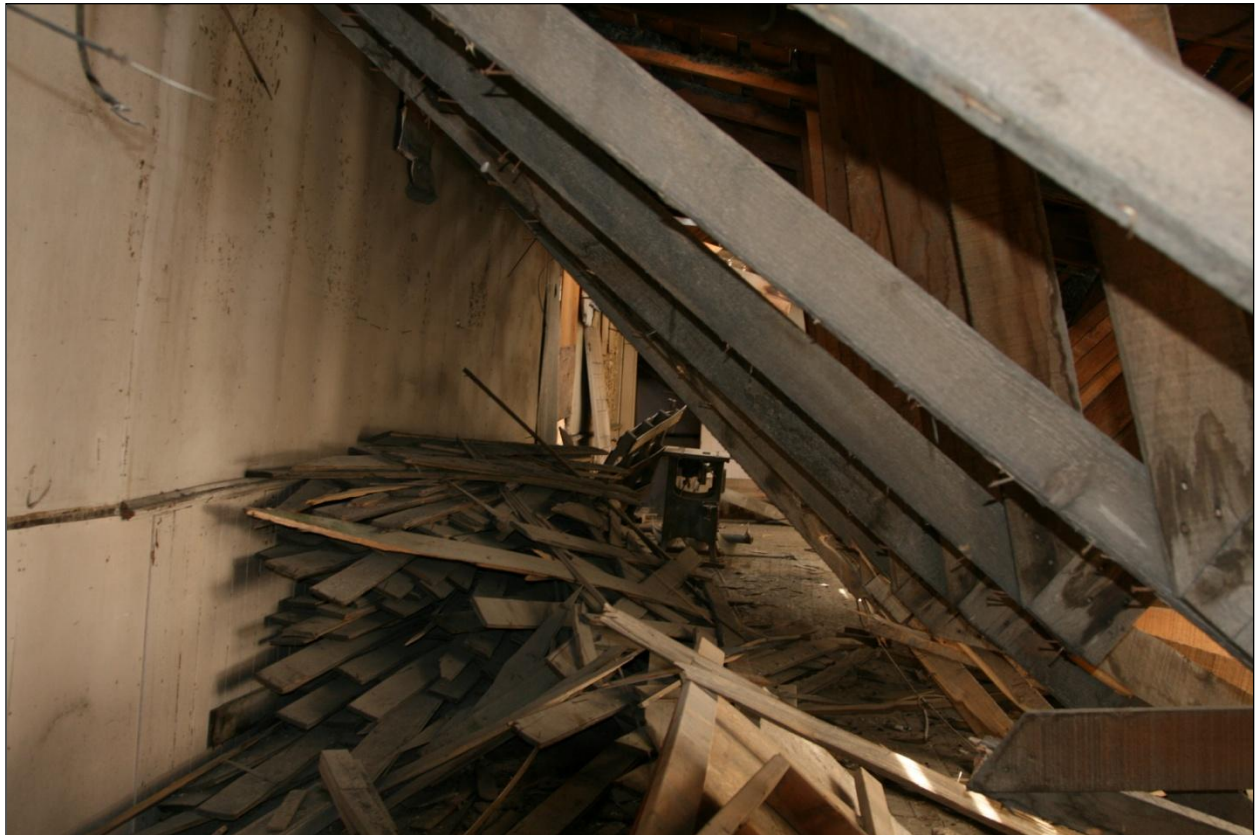
Figure 10. Inside the Mint Saloon with the collapsed roof system still hinged on the eastern wall.

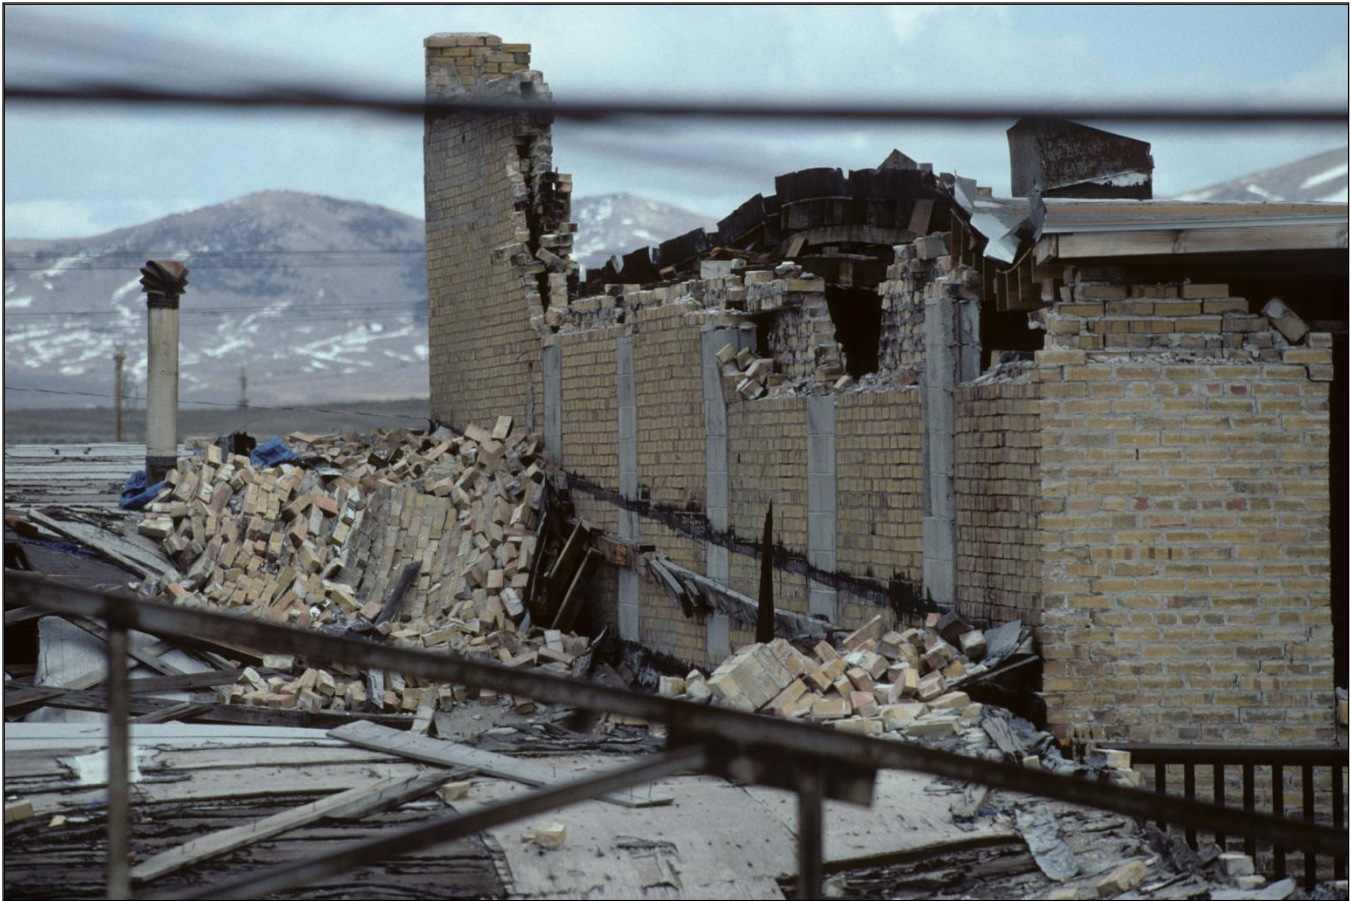
Figure 15. Failure of the parapet and upper wall of the eastern side of the Nevada Hotel. The roof failure of Murphy's Bar was pre-existing from snow damage. The wall is laid down on the roof as if it fell out en masse. Even though over 25 courses of bricks fell on Murphy's Bar, where the roof was in place, it stayed up. The bricks fell a distance of about half a story. The Nevada Hotel and Murphy's Bar share a common wall.

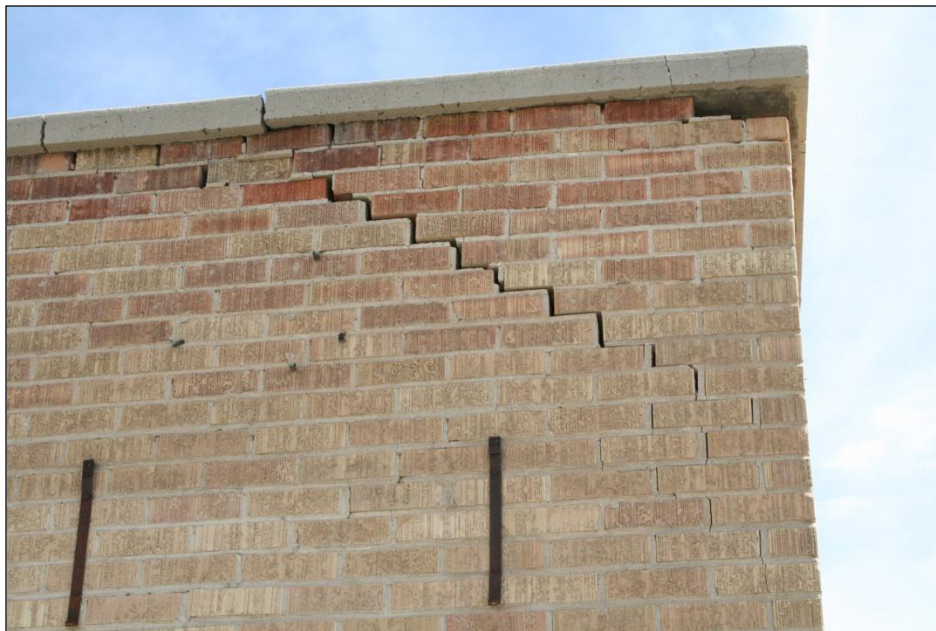
Figure 16. Concrete bond beam on the top of an unreinforced masonry wall at the back of the Eagle Club. The beam was used to stabilize the top of the wall. The bond beam is usually attached to the wall with only mortar at its base.

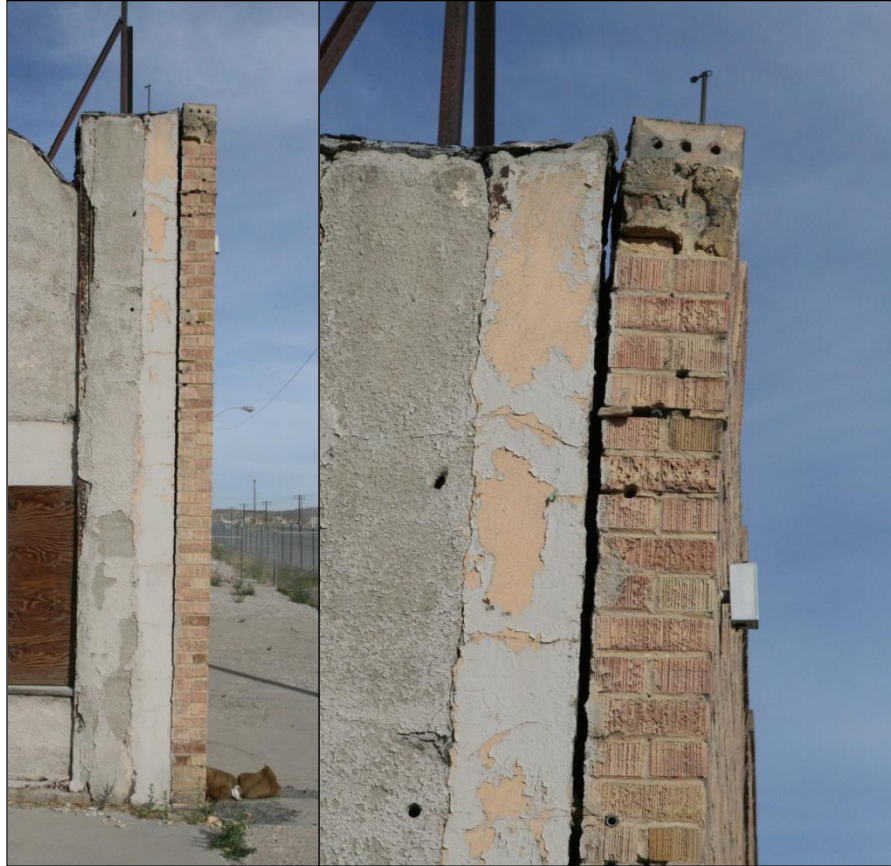
Figure 20. Separation and outward tilt of front wall of the Progress Building. This building has since been demolished.

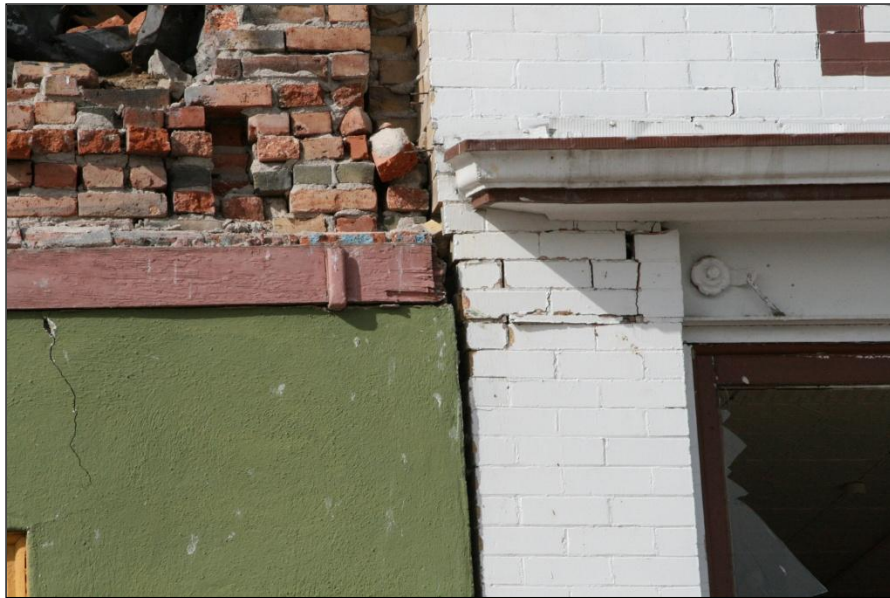
Figure 24. Building pounding damage between the Goble Market and the Bargain Barn. The white column of the Bargain Barn is displaced about 4 cm over four courses of bricks.

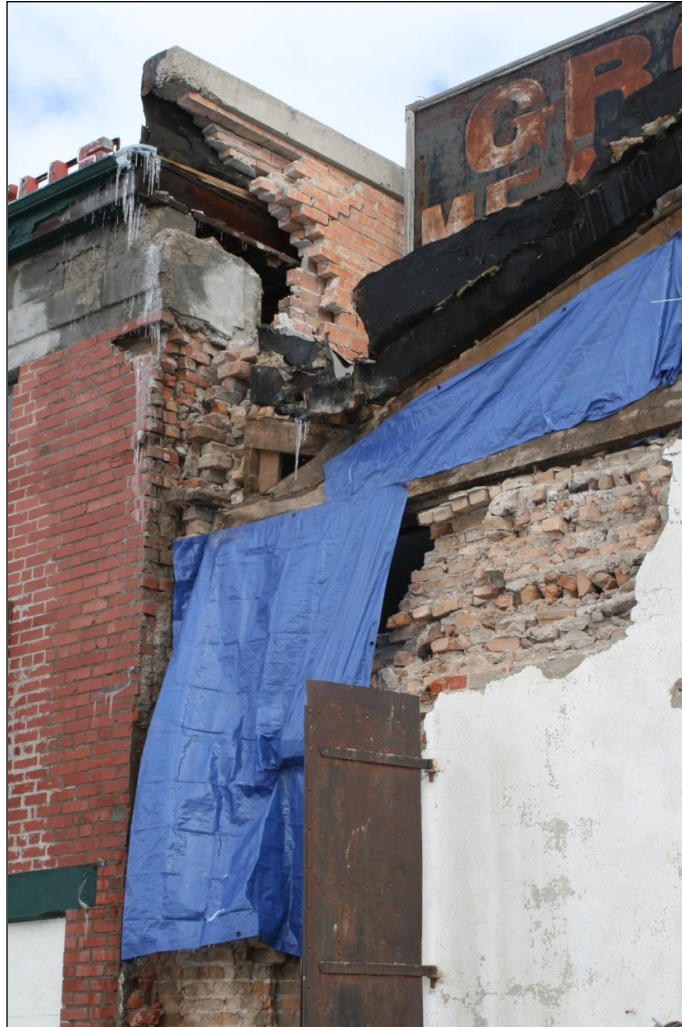
Figure 25. A hole has been pounded out of the eastern wall of the Wells Chalet. The upper part of this wall is two wythes wide. Note how the crowning concrete bond beam on top of the eastern wall and some bricks overhang the concrete beam on the southern wall, giving a hole-like appearance to the damage; this failure does not appear to have peeled down from the top as many of the other wall failures did. The concrete beam appears to have pounded this hole into the wall. This pounding and the resulting falling bricks may have contributed to damage in the upper corner of the back of the Quilici Market. The blue tarps were put up the day of the earthquake to cover holes to protect the interior from weather.

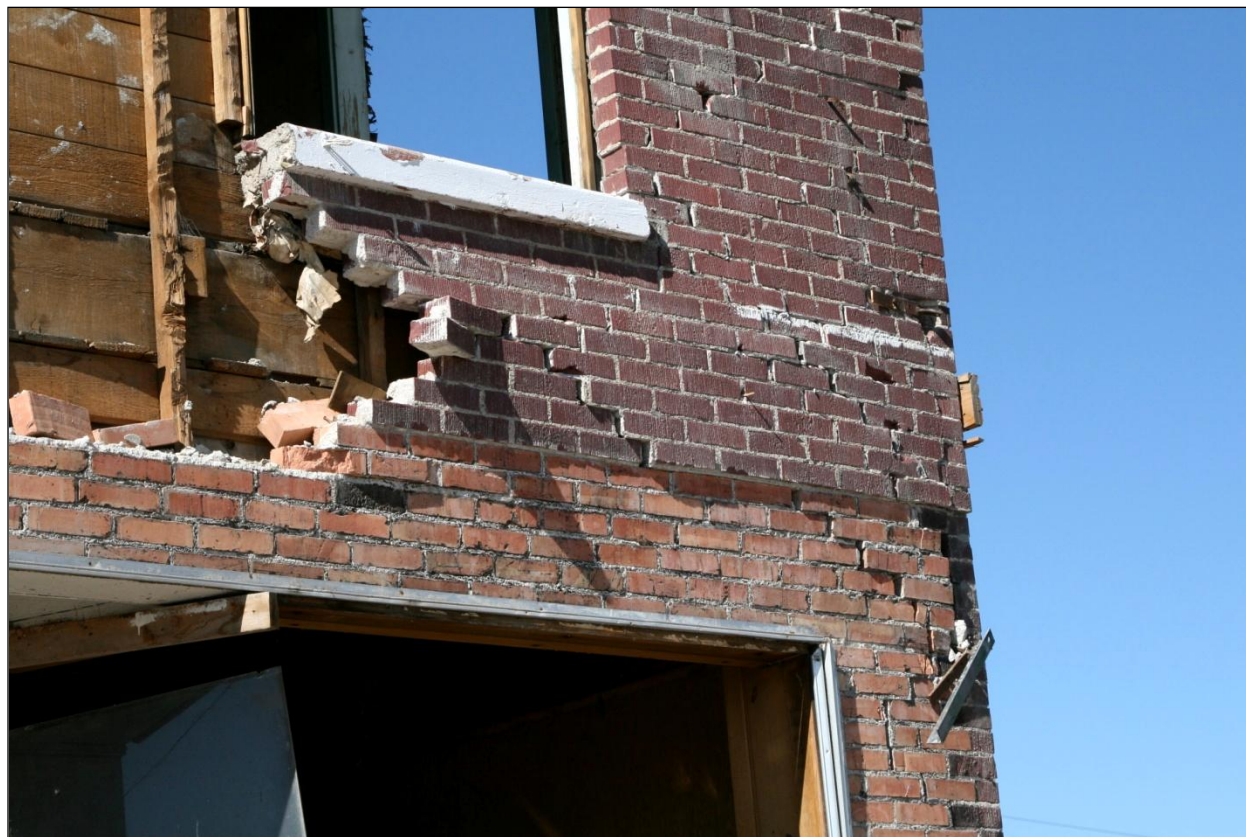
Figure 27. Large "X-fractures" in the remaining brick façade on the front of the Bullshead Bar show the break-up of the façade due to the rocking back-and-forth of the building. The lower, redder bricks are solid, older bricks. The darker bricks above have small holes in them (figure 28). The ledger for the balcony can be seen poking out on the right side of the building, just above the color change in the bricks.

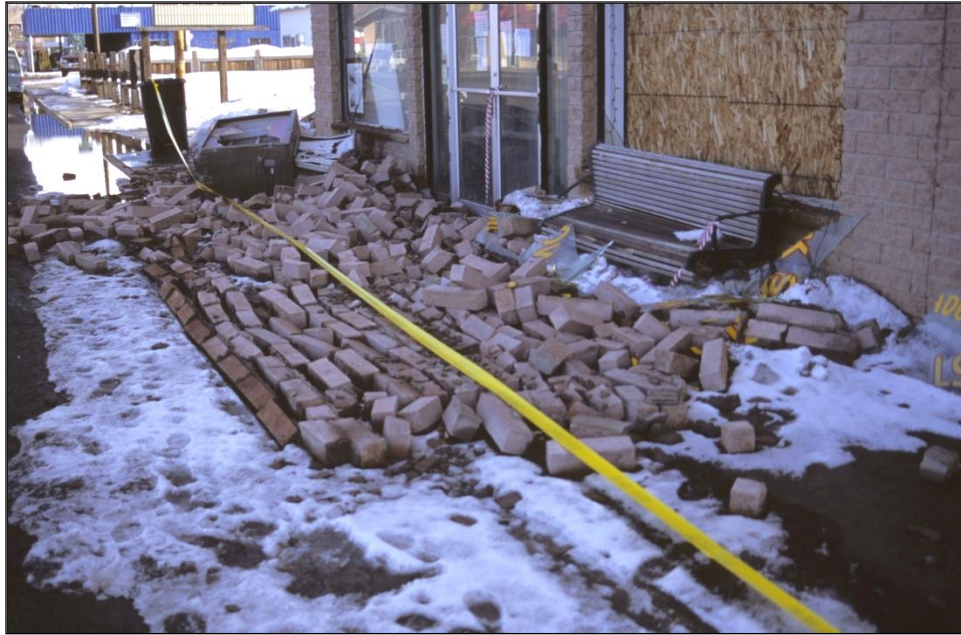
Figure 31. Failure of an unreinforced brick veneer on the Overland Hotel. The ordered nature of the bricks indicates much of the veneer fell out *en masse*.

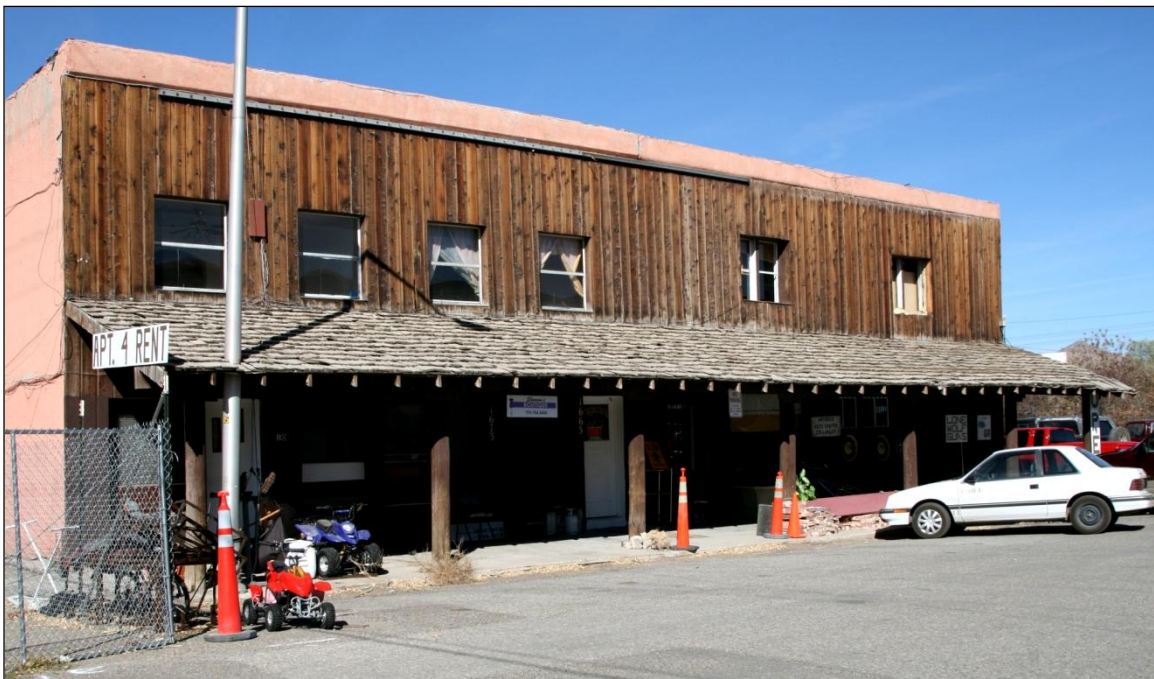
Figure 34. The Frontier Apartments are in a composite wood/railroad tie/concrete building in old town that survived the earthquake fairly well, although it had some nonstructural damage.

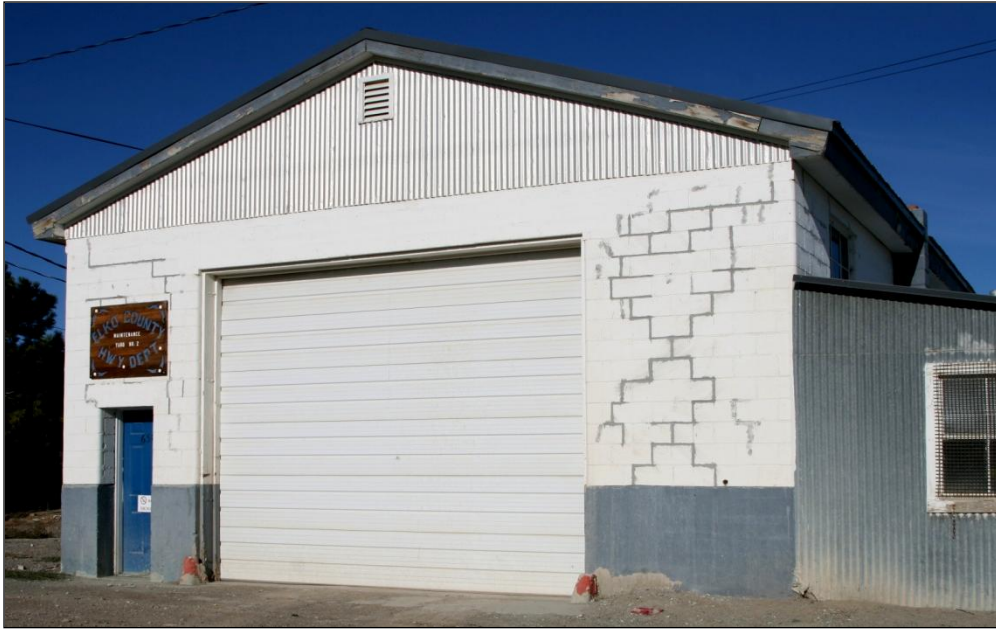
Figure 39. Patched cracks in the eastern wall of the Elko County Highway Department building. Cracks are between the blocks and show some crude "X" patterns.

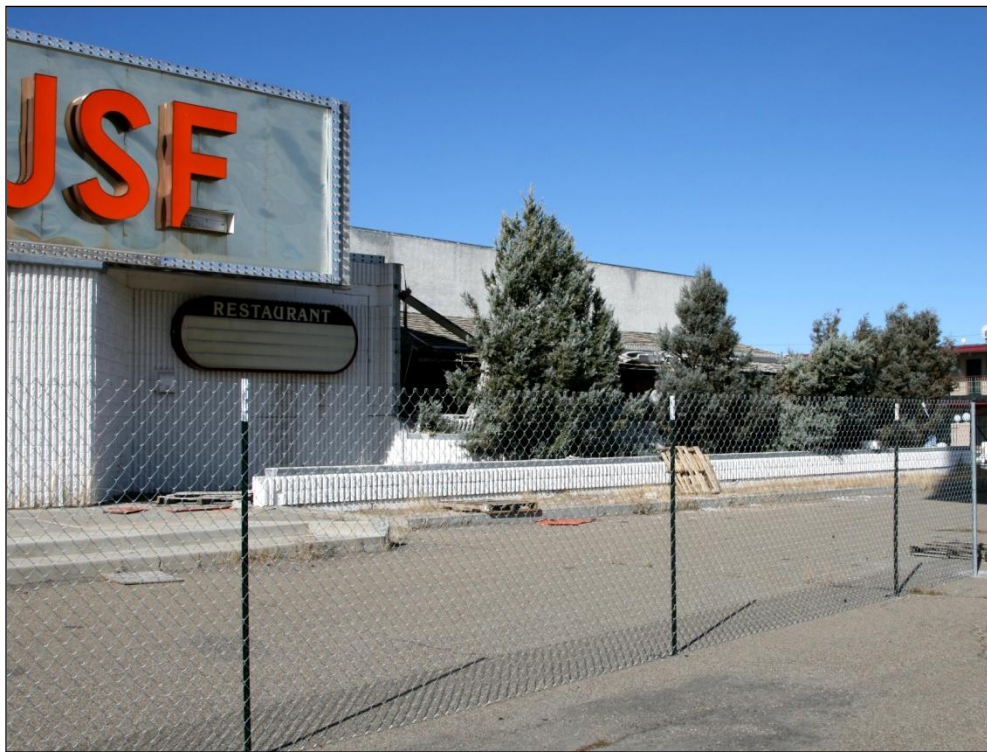
Figure 42. Damage to the concrete block front of the Ranch House. The wall behind the trees has fallen away; the wall is shown in figure 43.

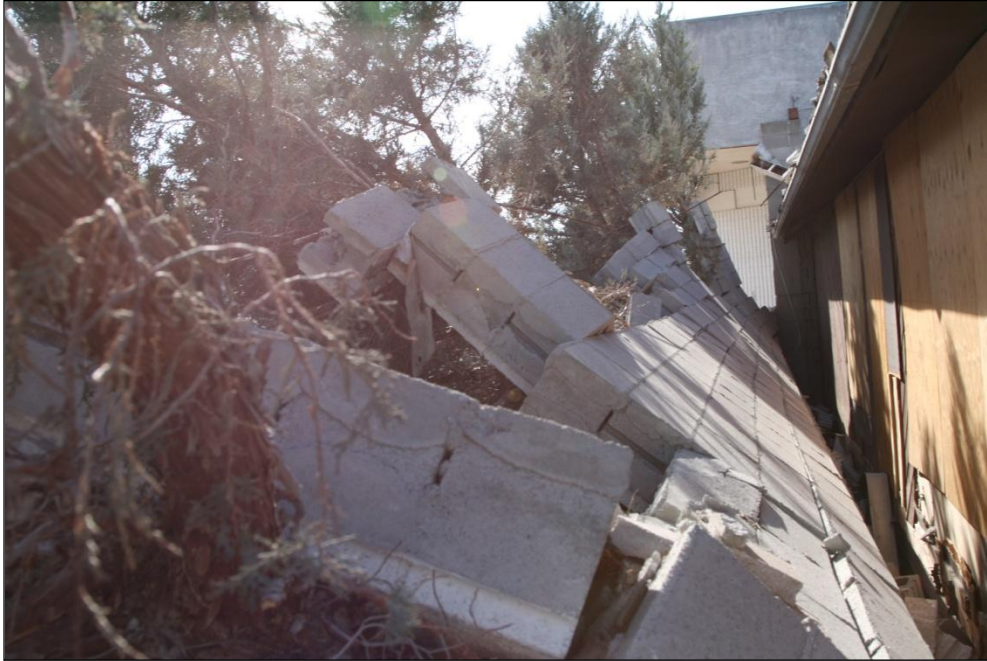
Figure 43. Failure of a concrete block wall away from the structure at the Ranch House Casino. There were a few vertical reinforcing pieces of rebar in the wall.

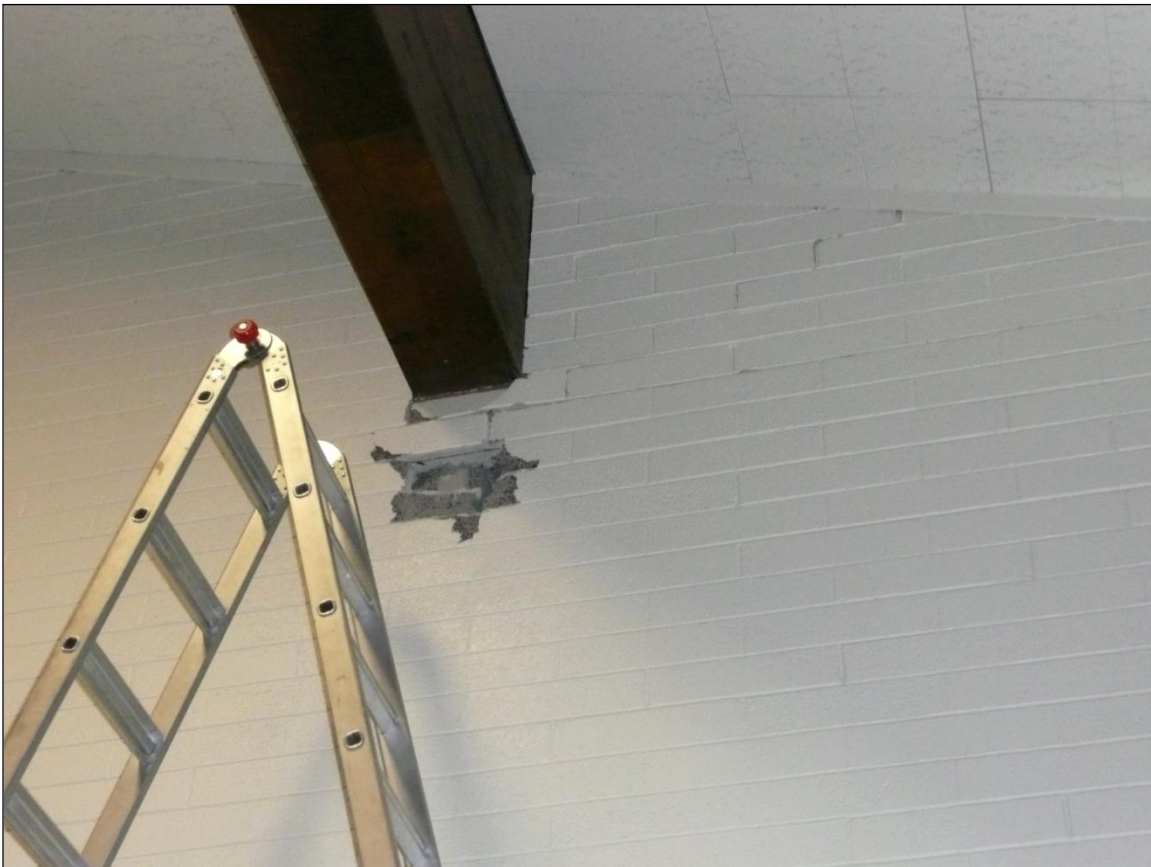
Figure 44. Damage to concrete blocks under a large glulam support beam in the Wells Ward LDS church. A column of concrete should have been poured under the beam, but the blocks were only partially filled with concrete. *Photograph by Glen Palmer.*

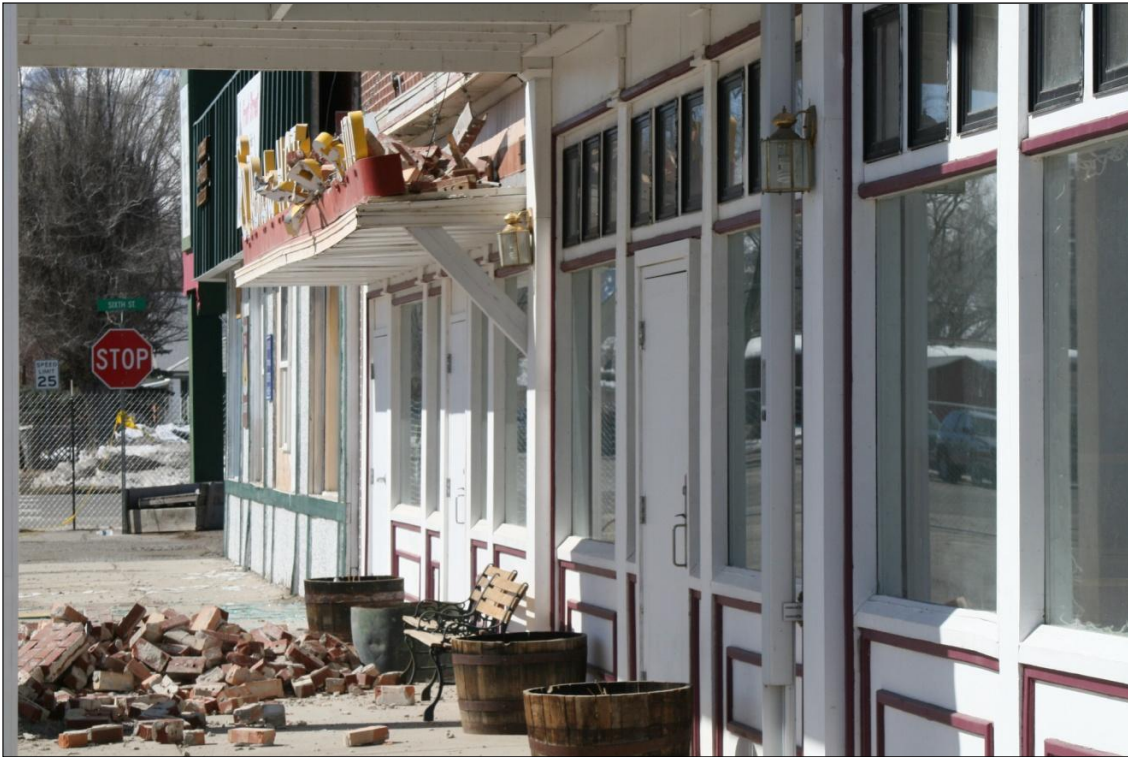
Figure 47. An El Rancho Hotel awning protected two benches from falling bricks, despite its rather meager support.

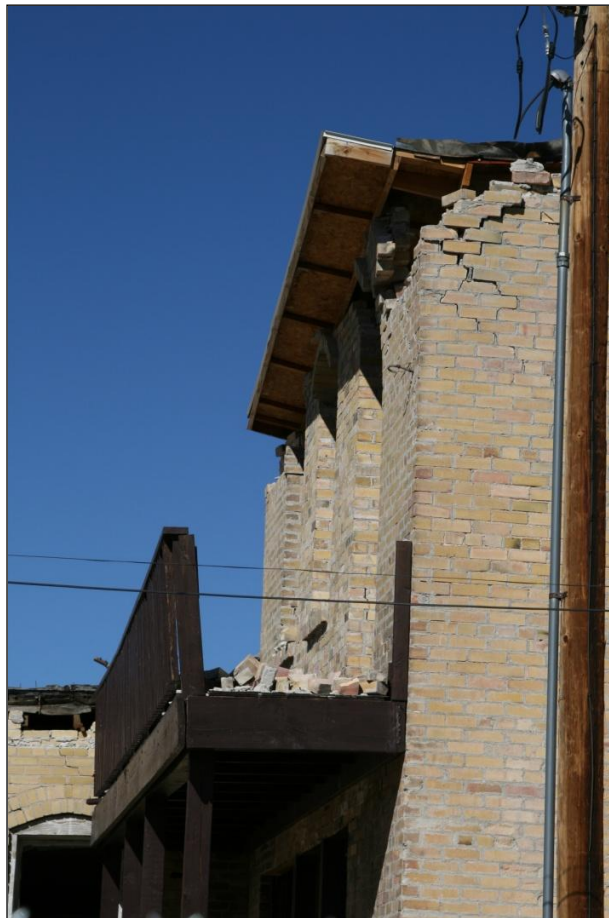
Figure 48. The rear Nevada Hotel balcony caught every brick falling from the back of this severely damaged building.

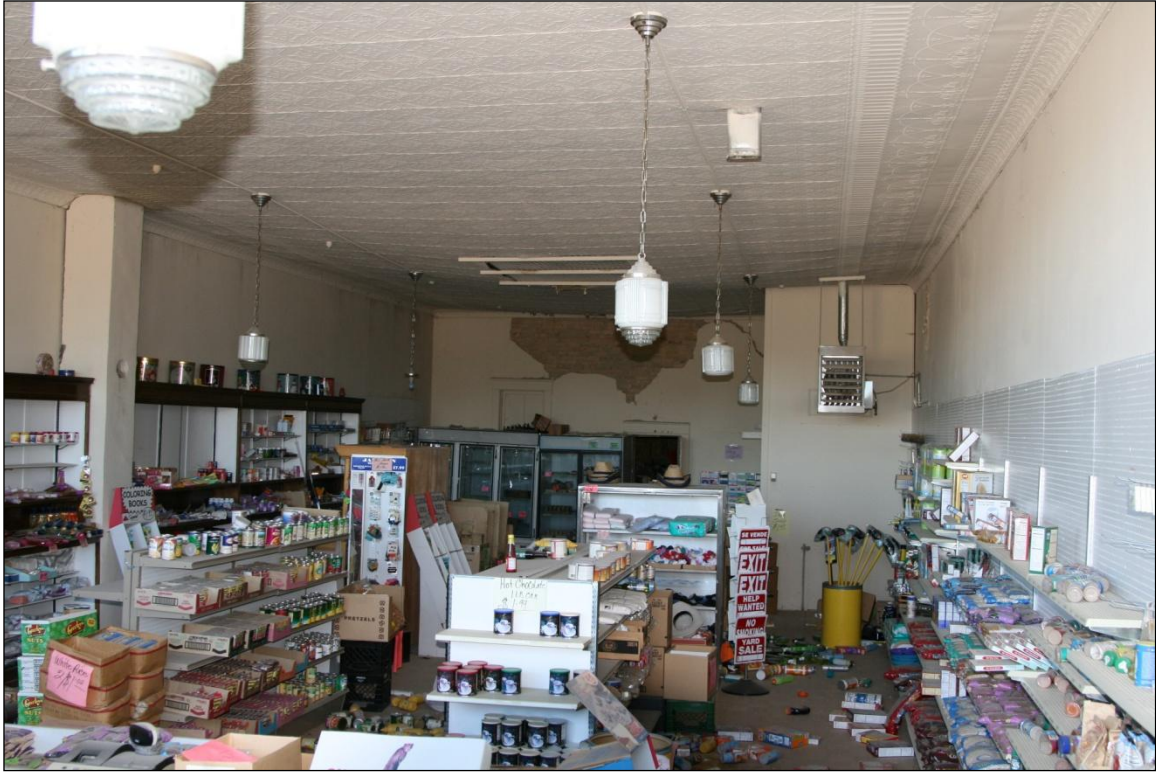
Figures 55. Interior nonstructural damage in the Bargain Barn. Although several items fell to the floor, most remained on the shelves. Ceiling tiles remain in place, hanging lamps and the suspended metal heating unit all are still in place.

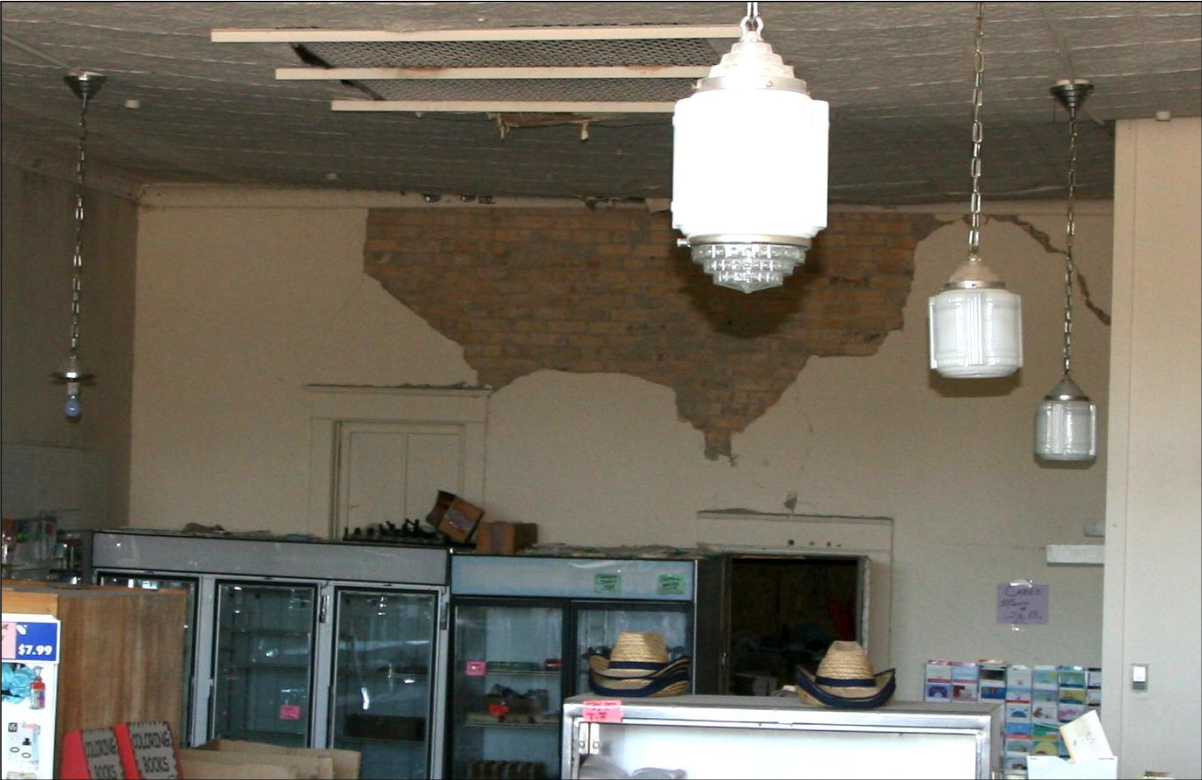
Figure 56. The back wall of the Bargain Barn shows broken Plaster, which reveals an unreinforced brick wall, probably an old back wall.

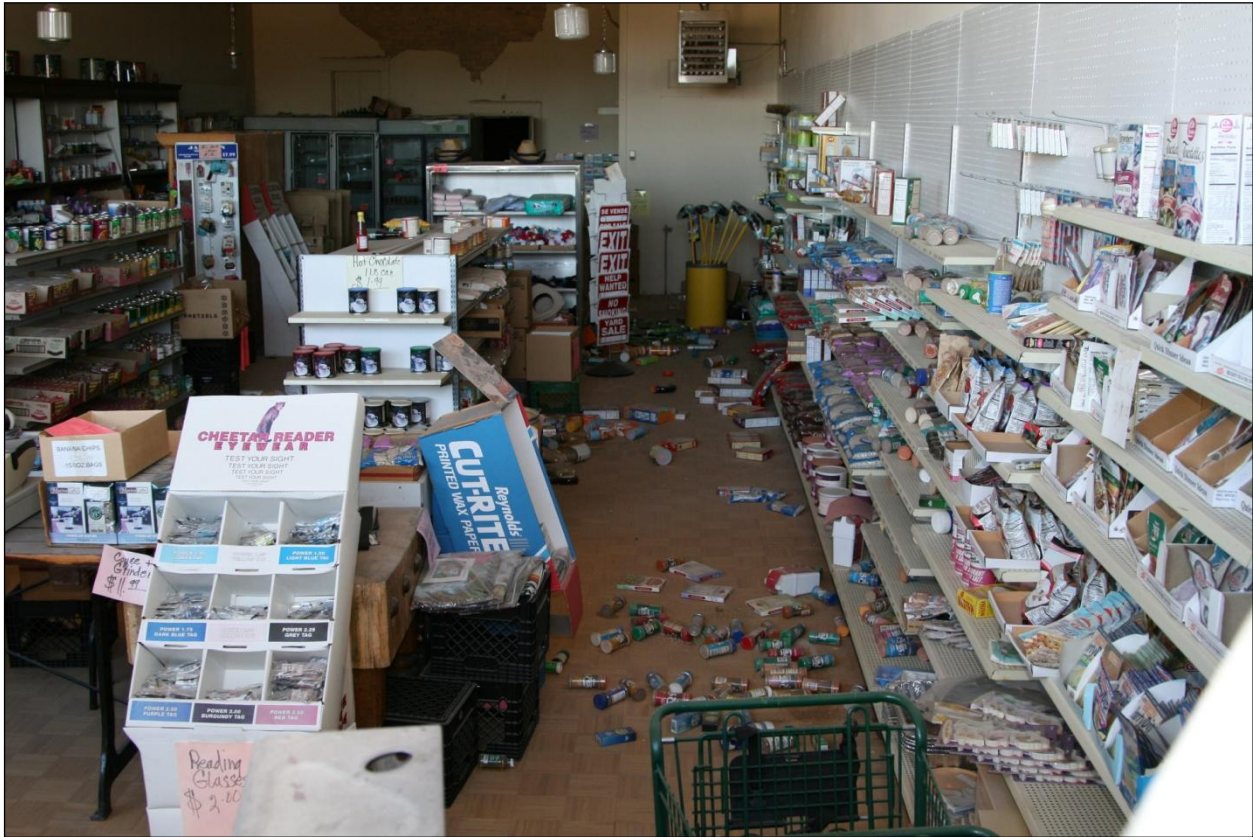
Figure 57. Close-up views of the shelves and stock in the Bargain Barn. Most merchandise remained on the shelves in this single-story building. The floor is only partly covered.

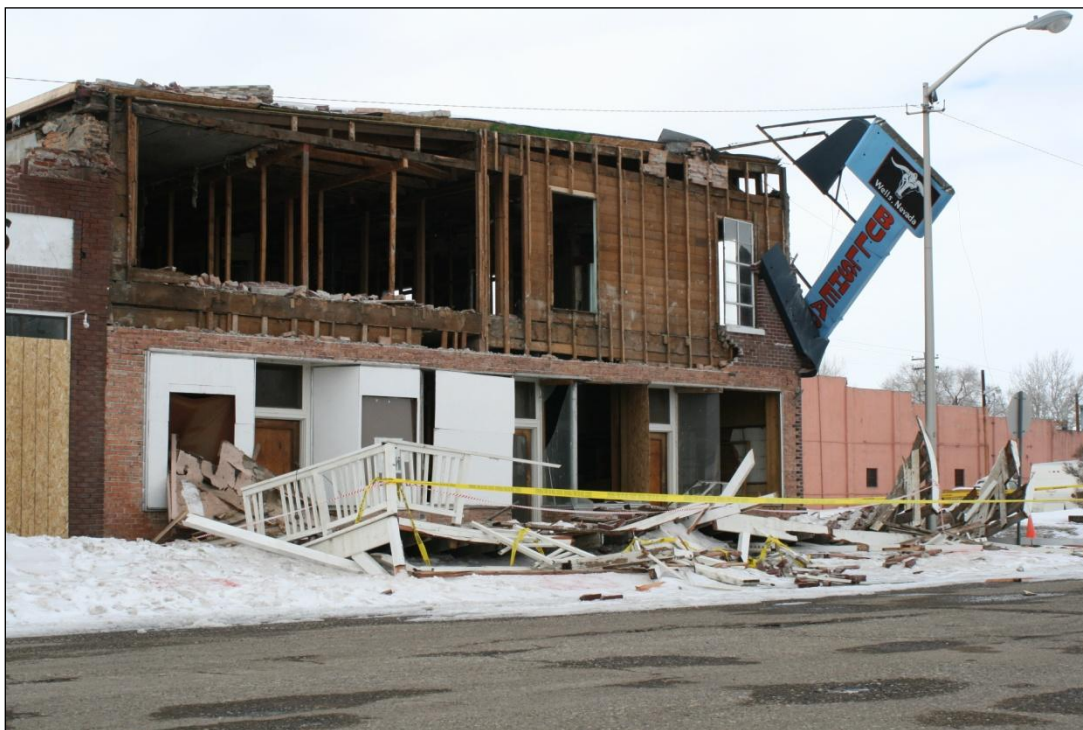
Figure 60. Front of the Bullshead Saloon. The collapsed white balcony extended the entire length of the building before the earthquake (figure 61) and had been attached with hangers near the top of the brick facing (where the second story begins). During the earthquake, the brick façade and some parts of the crowning bond beam fell onto the front balcony, collapsing it. The balcony did not appear to disintegrate – rather it fell as a series of masses. In the front of the Bullshead, the balcony pulled away from the building and collapsed towards the northwest. The Bullshead has a western half of the second story that has a wooden wall (right half in photograph) and an eastern half that is an open area, previously covered with a brick wall. The thin, brick wall covering the open area was relatively unsupported.

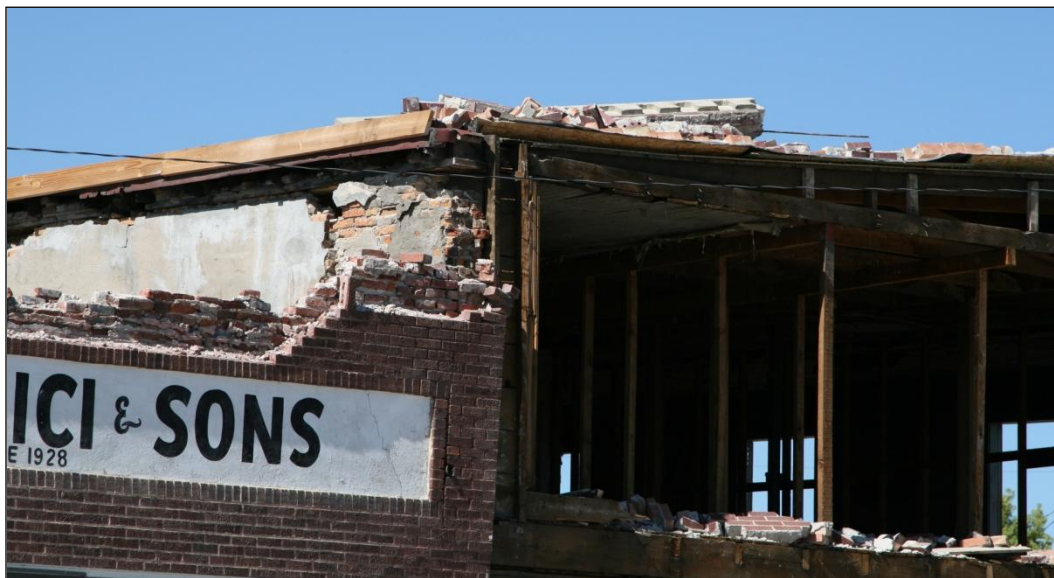
Figure 62. Upper eastern corner area of the front of the Bullshead Saloon. The open area of the second story can be seen, along with part of the eastern unreinforced brick wall, badly cracked near the corner. A section of the bond beam can be seen on the roof.

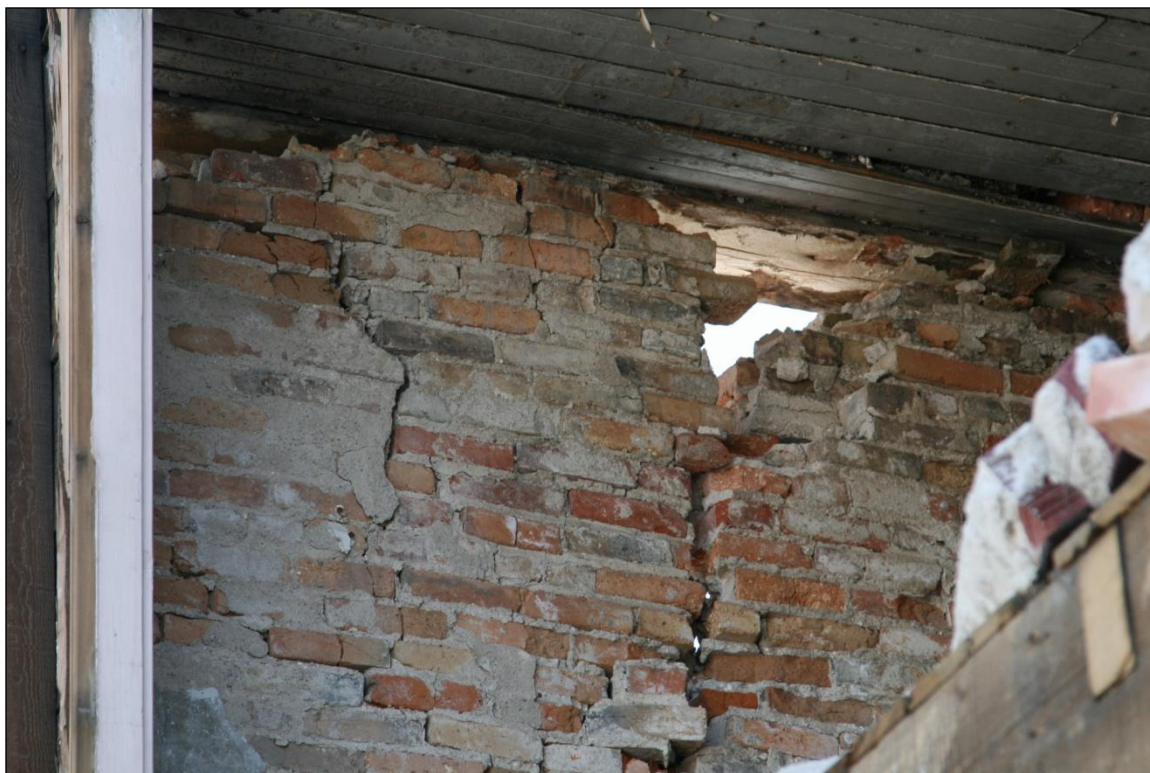
Figure 63. Close-up picture of damage to the eastern wall near the front corner. The wall is cracked, including a large crack that flowers into a hole near the top. The roof is detached from the wall and appears to have moved back-and-forth over it.

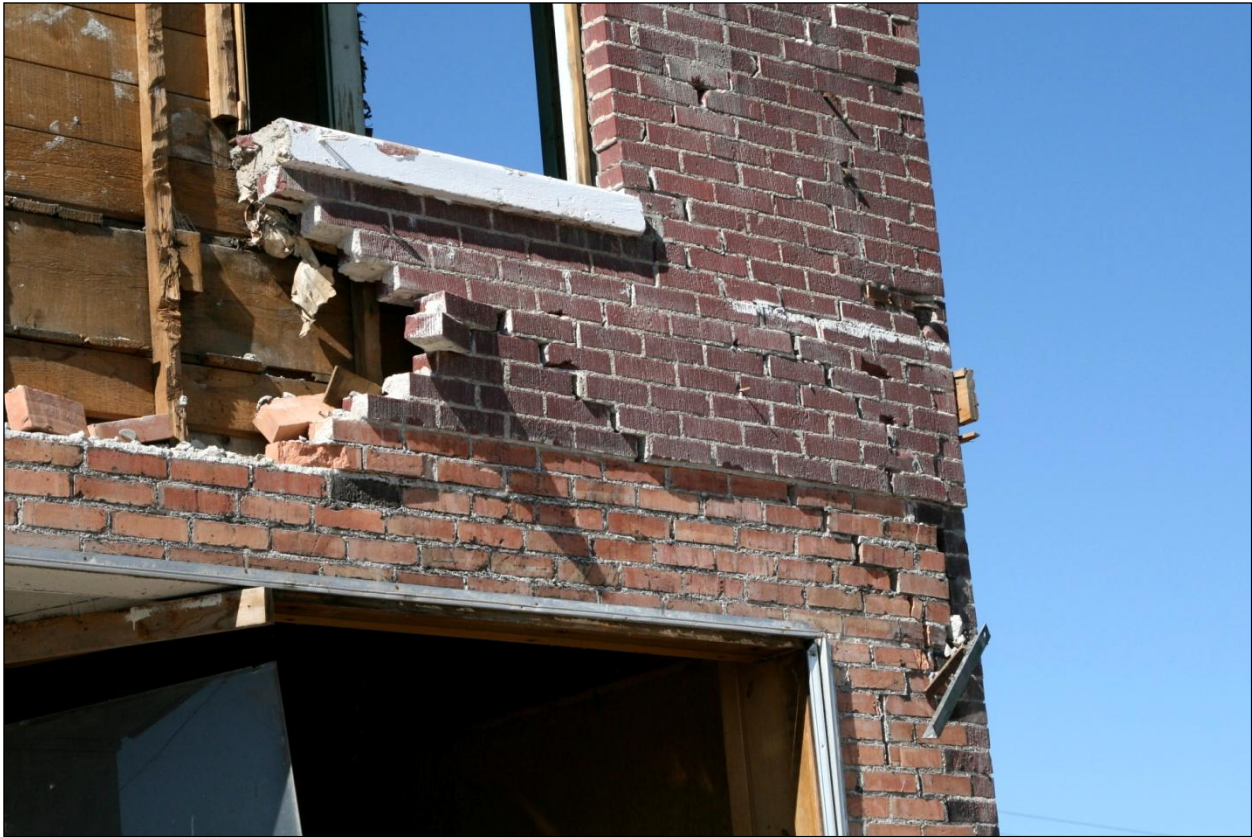
Figure 65. Large X-fractures in the remaining brick veneer on the front of the Bullshead Saloon show the break-up of the façade due to the back-and-forth rocking of the building. The lower, redder bricks are older and are solid, whereas the darker bricks above have small holes in them (figure 66). Both types of bricks fractured similarly.

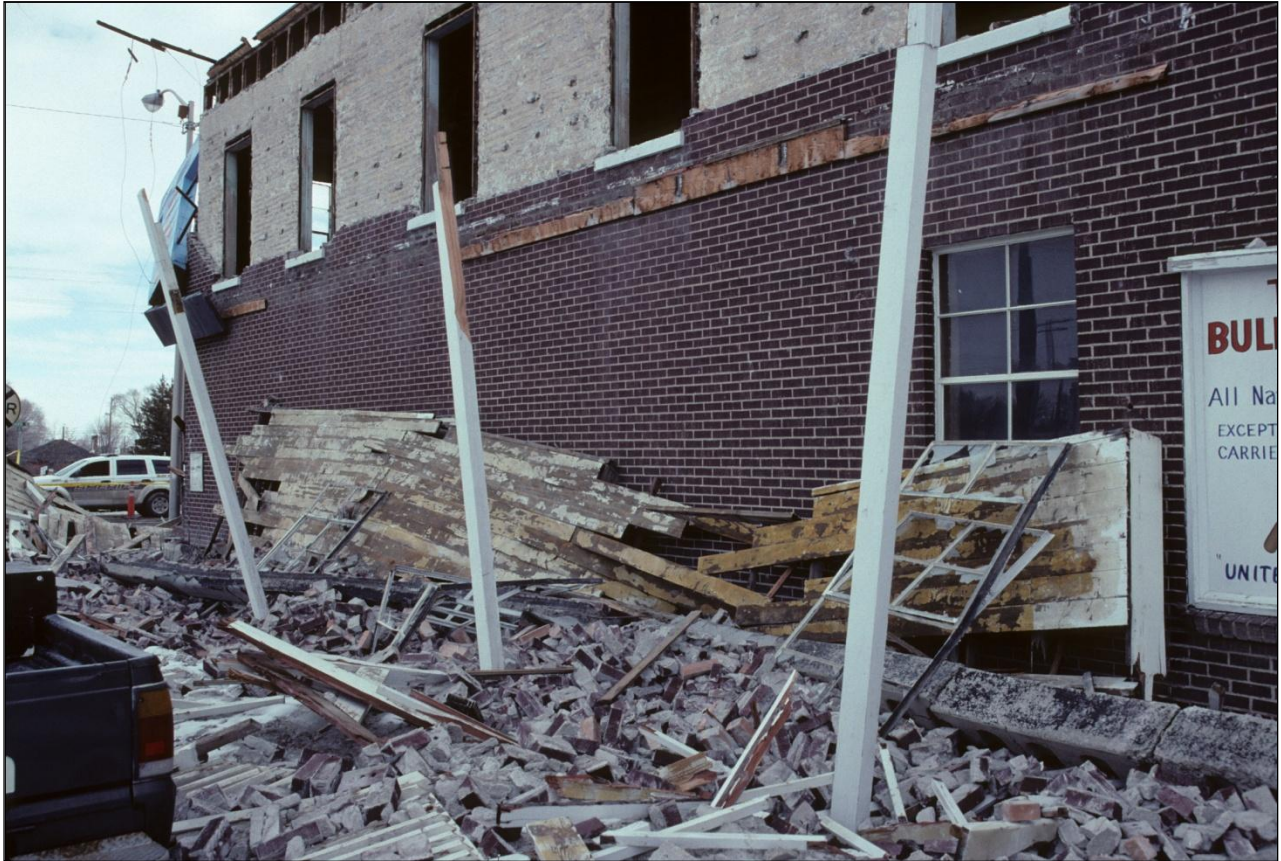
Figure 67. Western side of the Bullshead Saloon. The balcony was smashed to the ground abruptly by the crowning bond beam, breaking the column connections and leaving the columns standing. The large, nearly intact, bond beam can be seen in the central part of the photo and the lower right. This is the same beam that crushed a car to the right of the area shown in this photo.

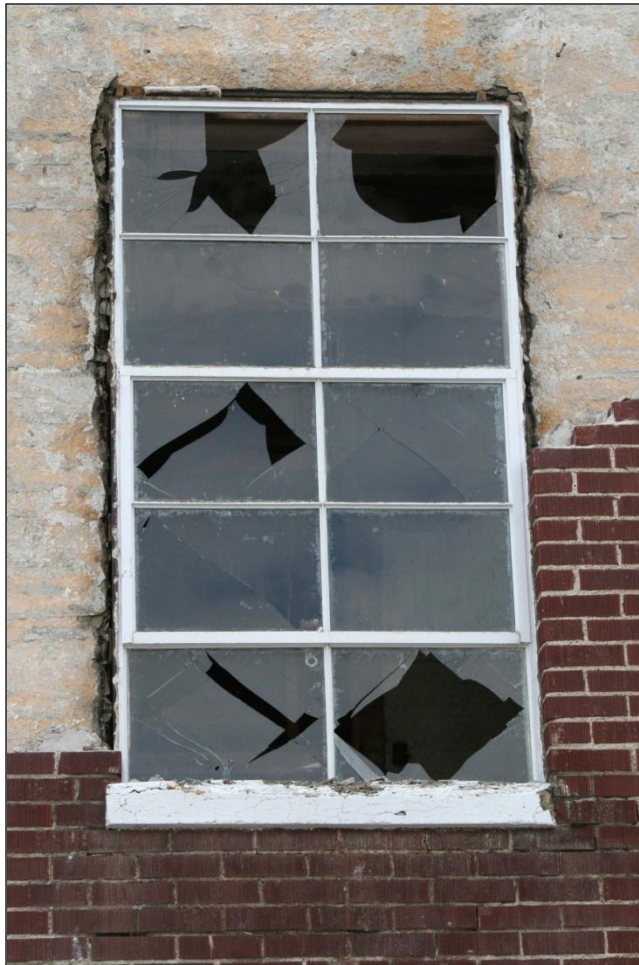
Figure 69. Broken window on the second story of the western wall that shows X-fractures from the back-and-forth distortion of the window.
