Building Damage from the 2008 Wells, Nevada Earthquake

Craig M. dePolo
Nevada Bureau of Mines and Geology
University of Nevada, Reno

2011

ABSTRACT

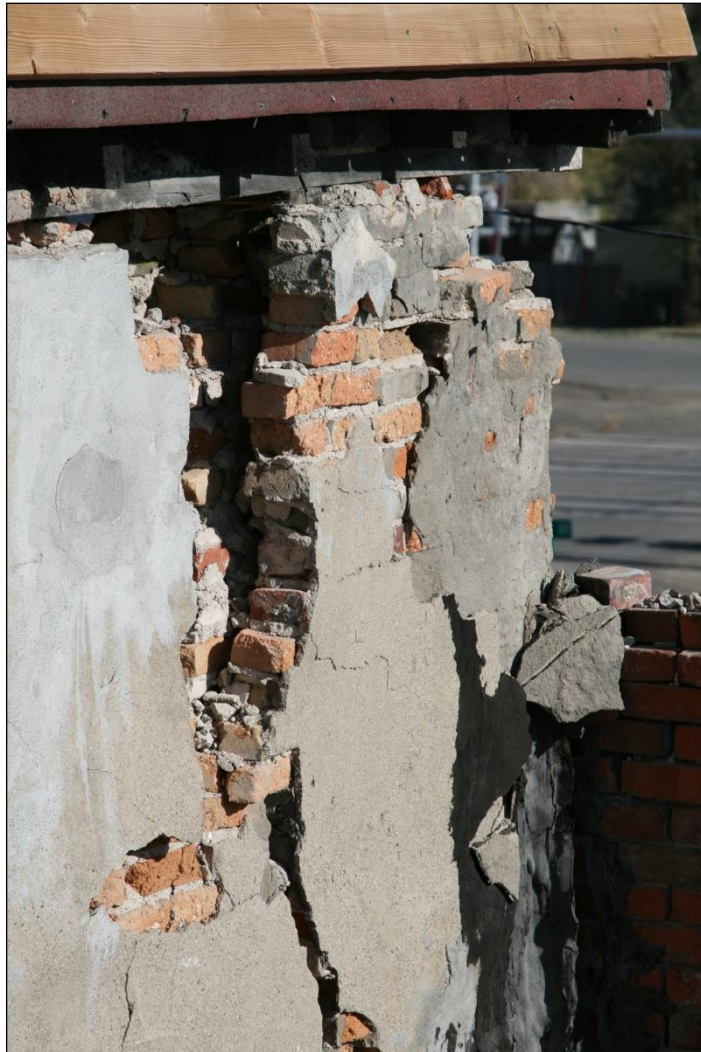
Figure 72. Detail of the broken northeast corner of the wall shown in figure 71.

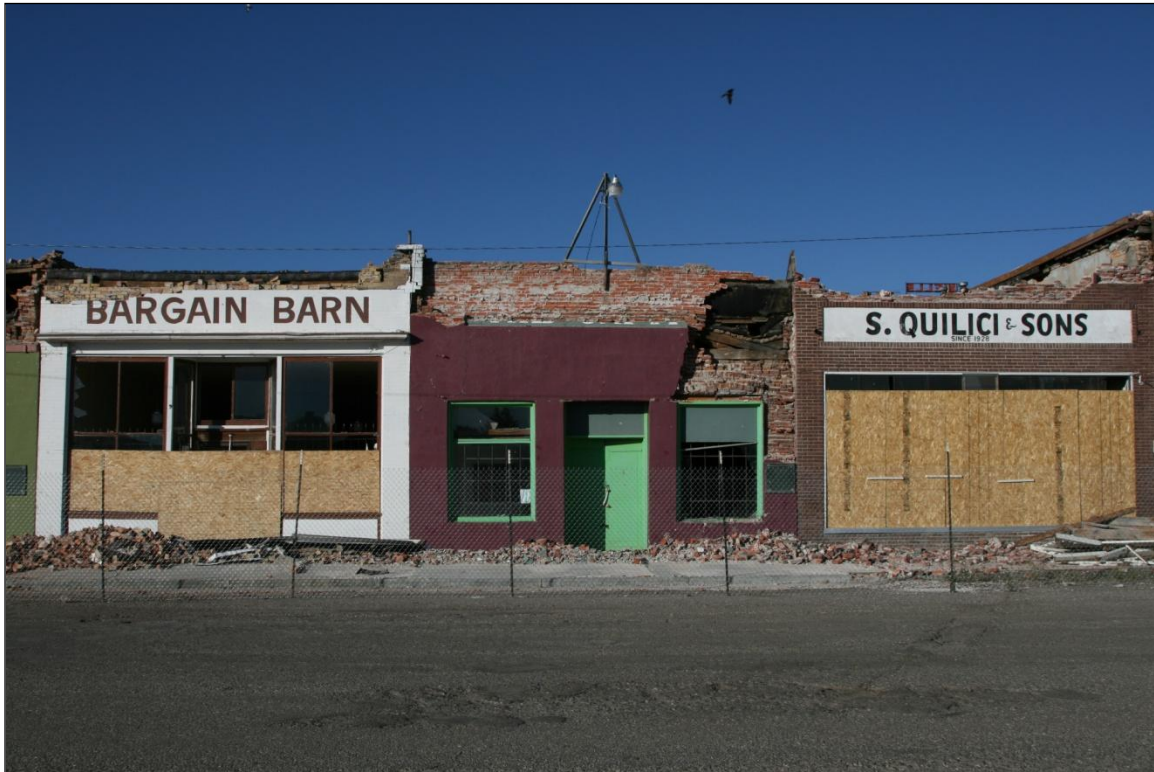
Figure 73. The front of the Capitol Club (purple building in the center with green trim and doors). The upper parts of the parapet and wall have failed and thrown bricks onto the front sidewalk, across the entrance.

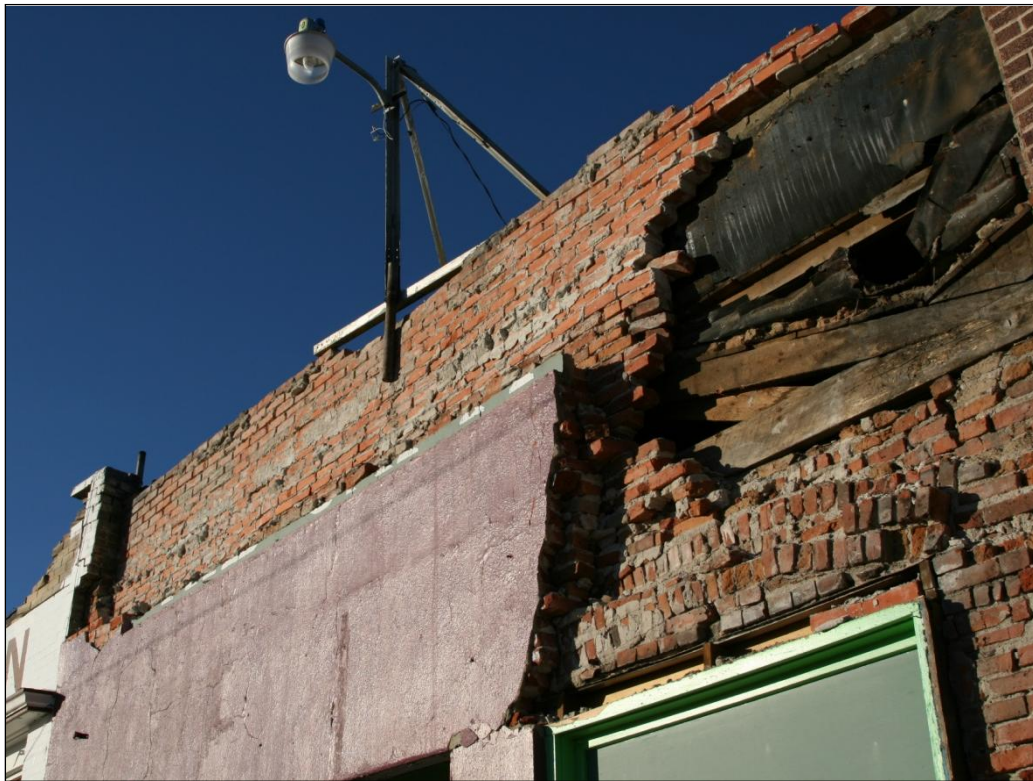
Figure 74. The front of Capitol Club where bricks fell out. Note the even face of the upper part of the remaining wythe of bricks indicating a lack of cross-course bricks to tie the wall together.

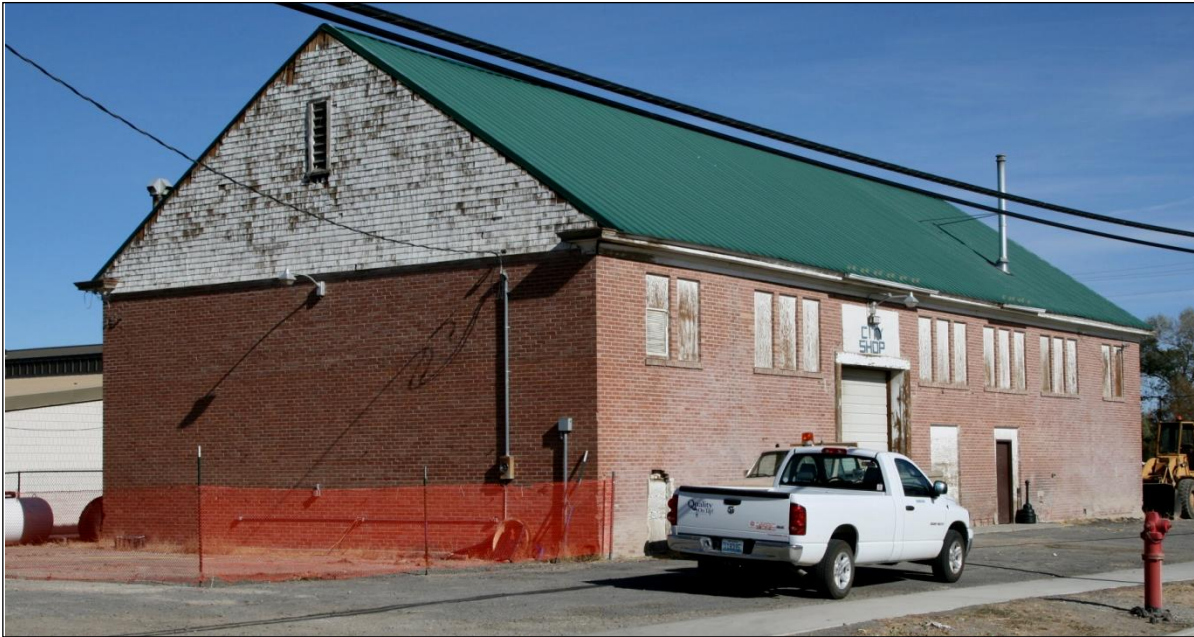
Figure 82. Wells City Shop building. The roof is supported by the unreinforced brick walls.

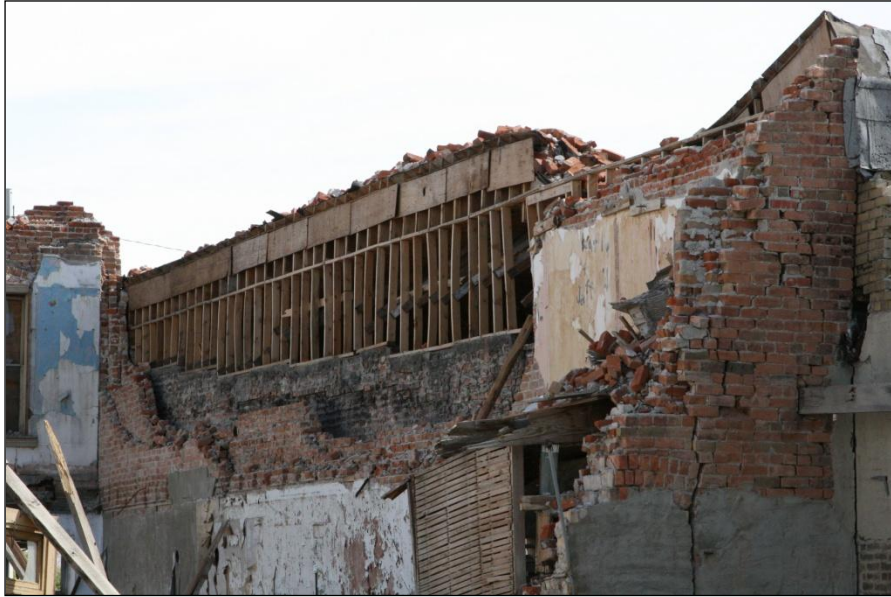
Figure 93. The western wall of the Eagle Club. Although the wall has not failed, the adjacent wall of the San Marin Hotel failed, exposing the top of the Eagle Club to the weather.

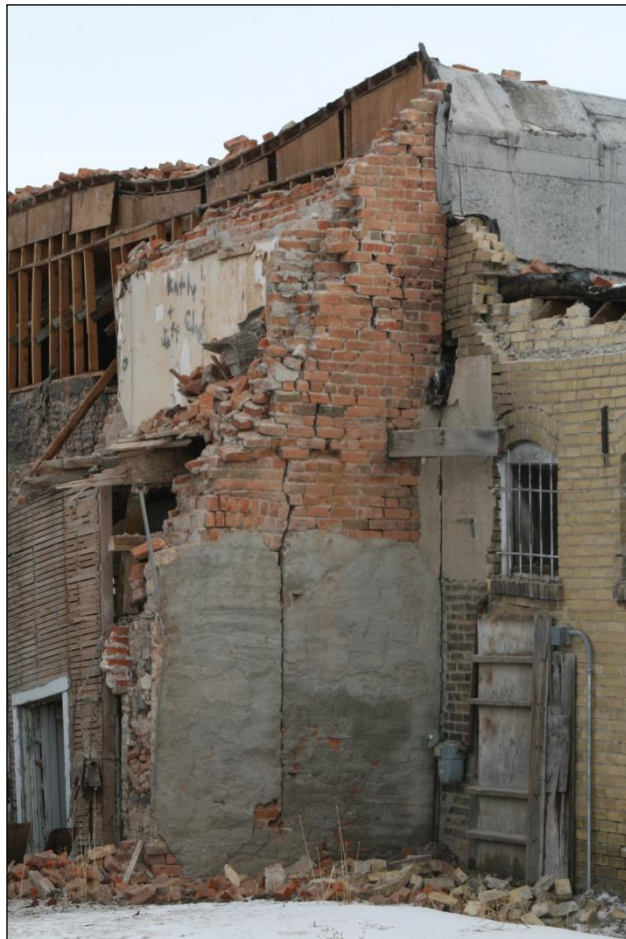
Figure 94. Corner between the back wall of the San Marin Hotel and the Eagle Club. An inactive gas regulator was threatened by falling bricks (shown to the right and below). Active utilities need to be protected from falling bricks around unreinforced brick/masonry buildings, possibly with a protective cage.

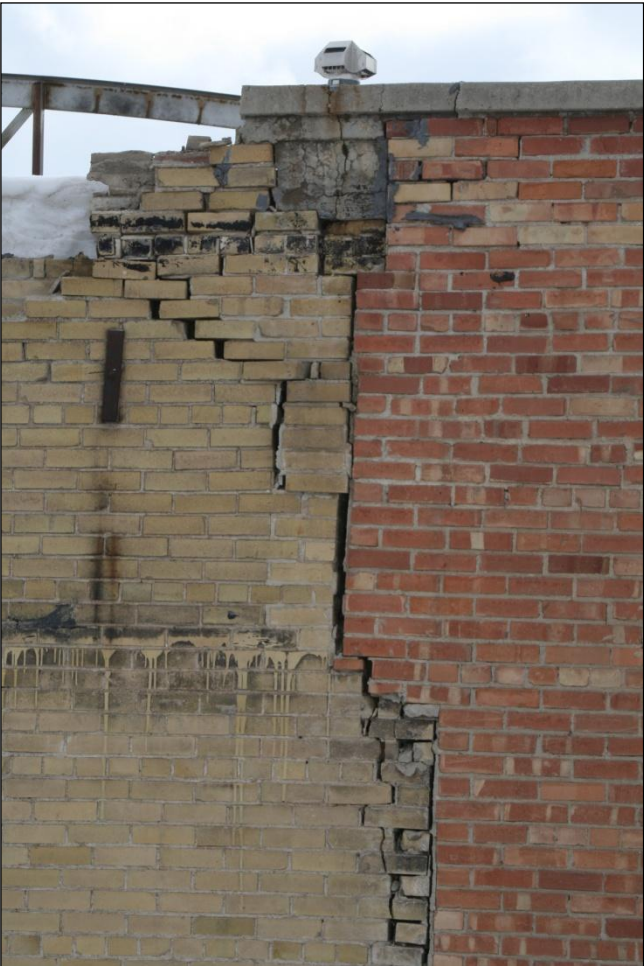
Figure 96. Damaged cold joint between two different added-on rear parts of the Eagle Club.

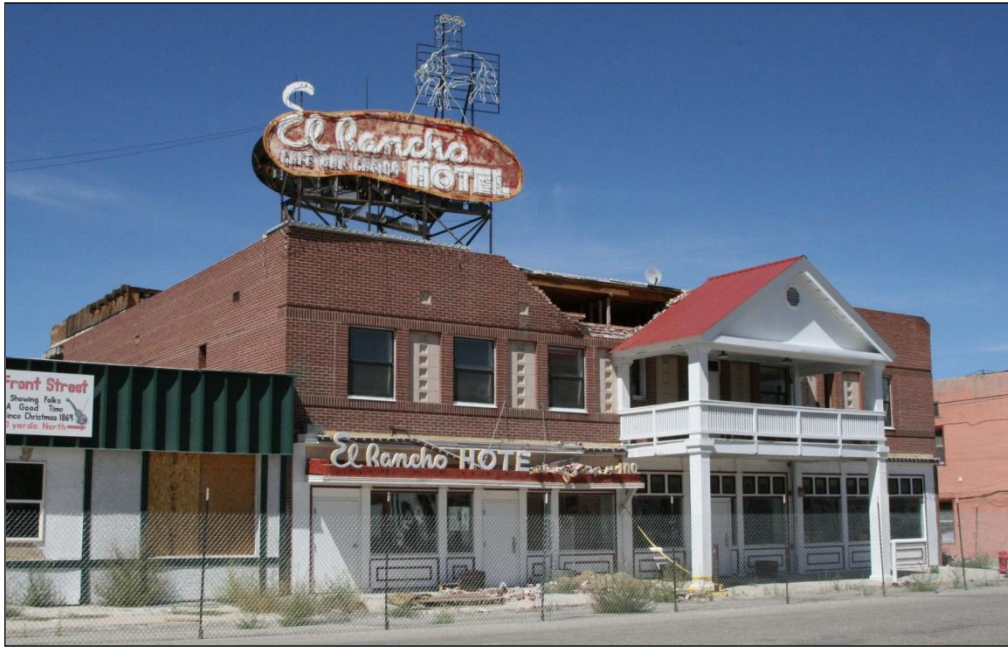
Figure 100. Earthquake-damaged front of the El Rancho Hotel.

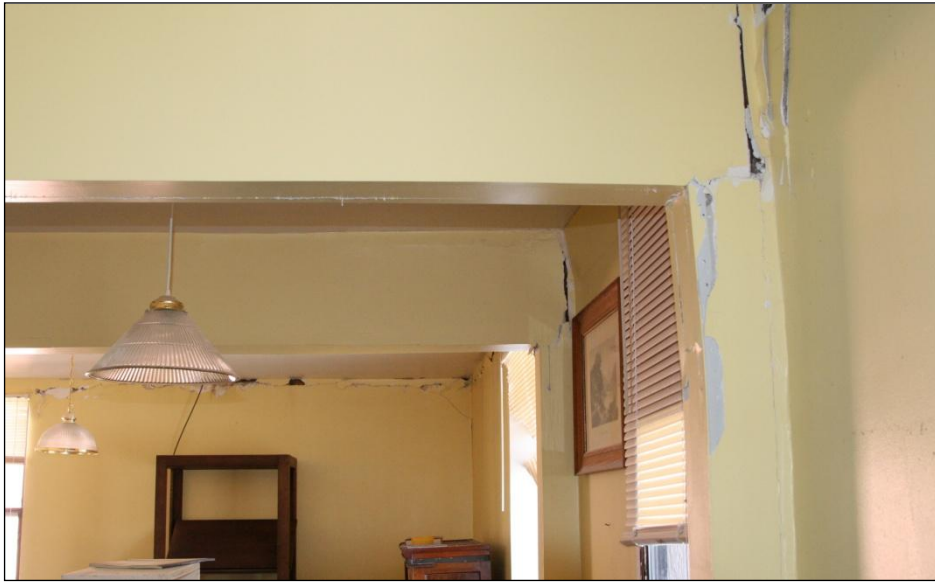
Figure 108. Severe cracking of sheetrock in the upper part of the second story of the El Rancho Hotel.

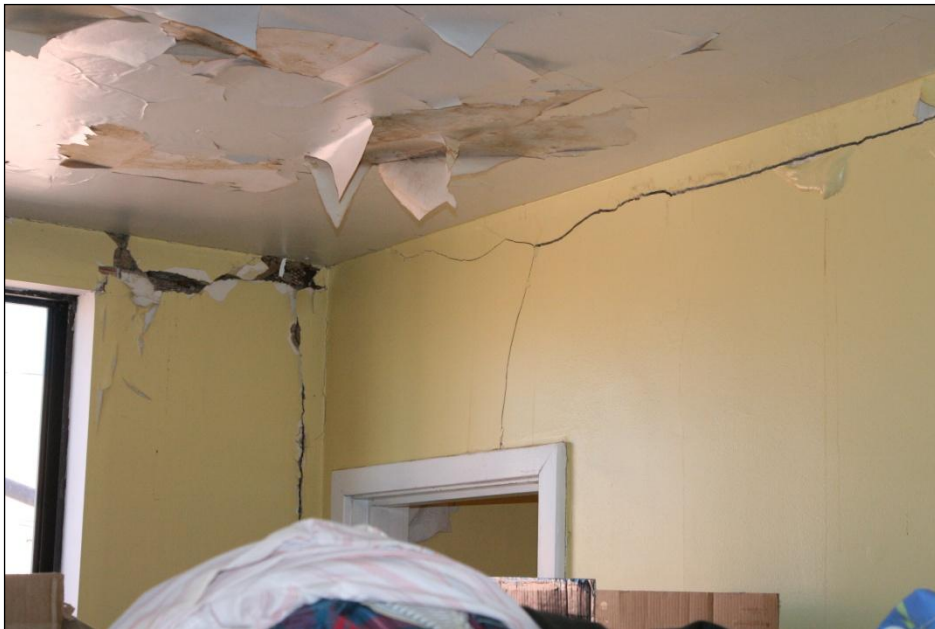
Figure 109. Severe cracking of sheetrock in the upper part of the second story of the El Rancho Hotel.

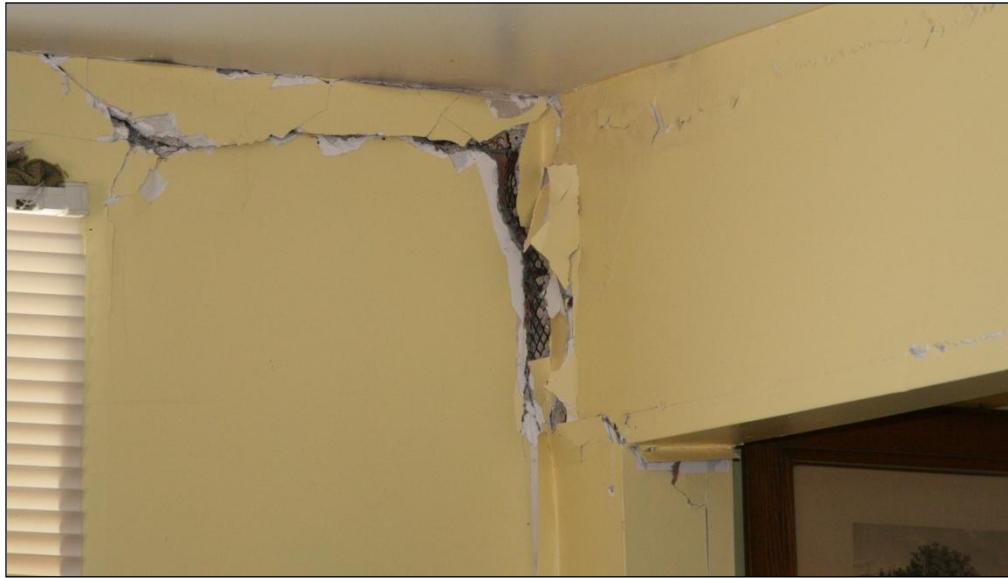
Figure 110. Severe cracking of sheetrock in the upper part of the second story of the El Rancho Hotel.

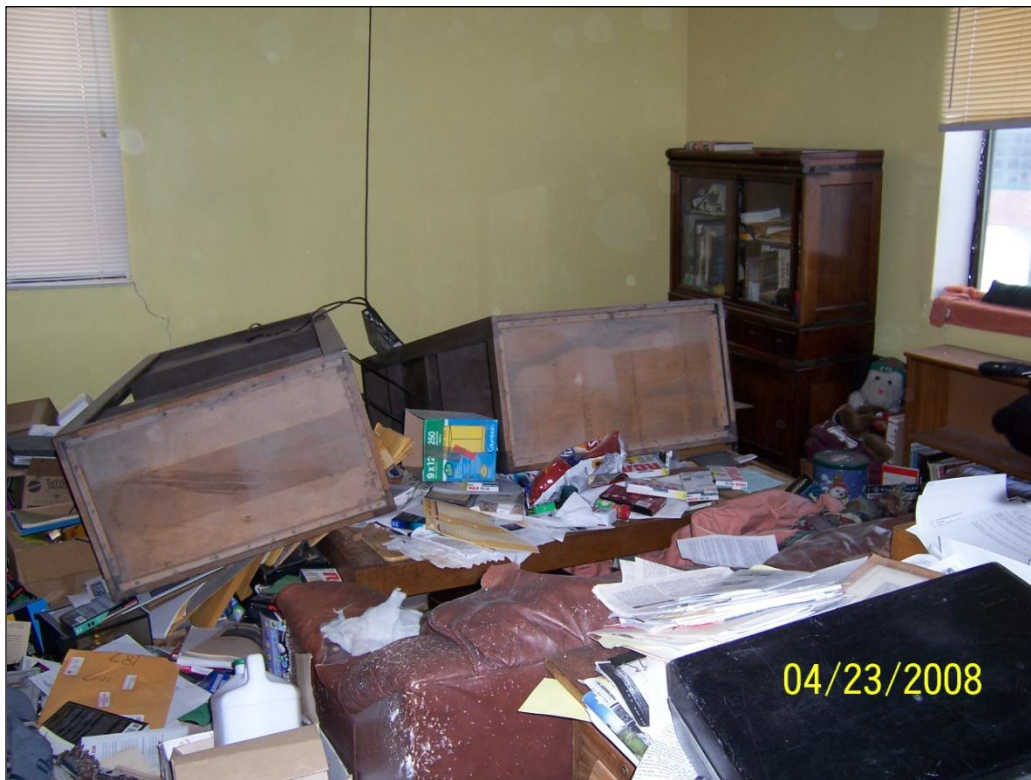
Figure 111. Nonstructural content damage to the El Rancho Hotel. *Photograph by Gene Kaplin.*

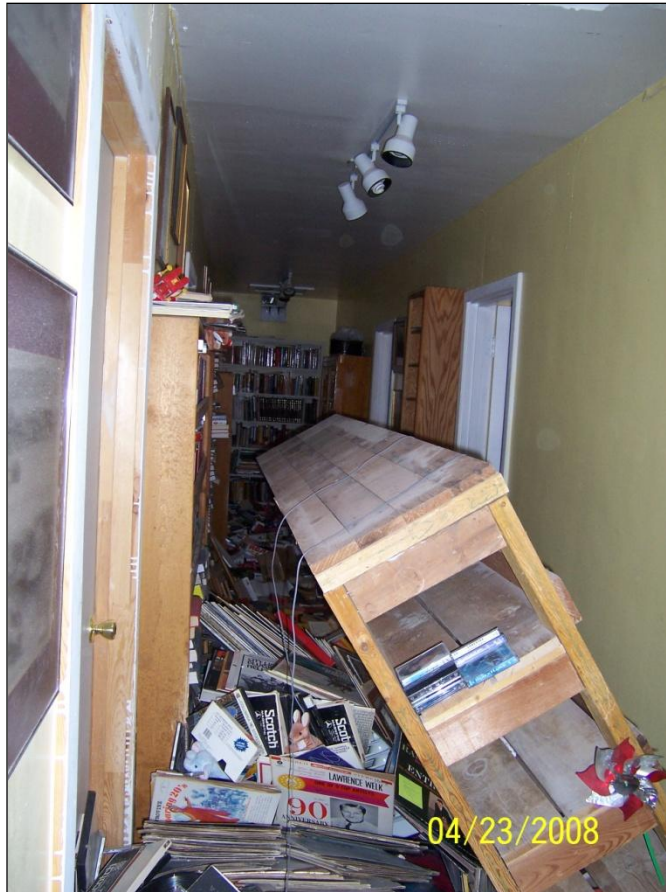
Figure 112. Nonstructural content damage to the El Rancho Hotel. *Photograph by Gene Kaplin.*

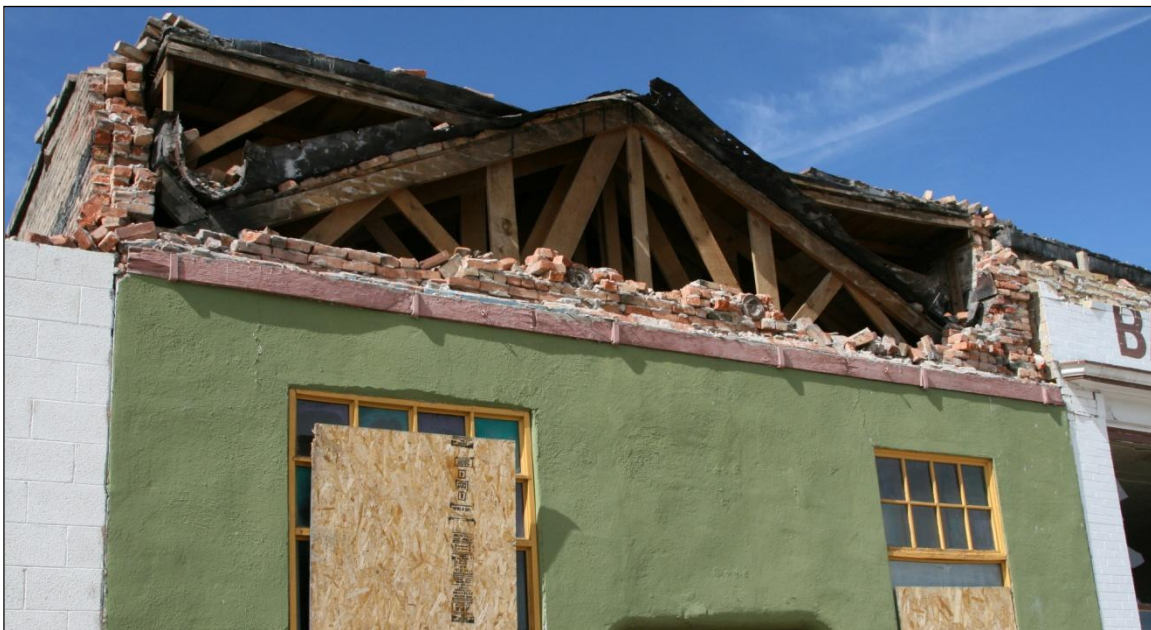
Figure 114. Damaged gable front of the Goble Market.

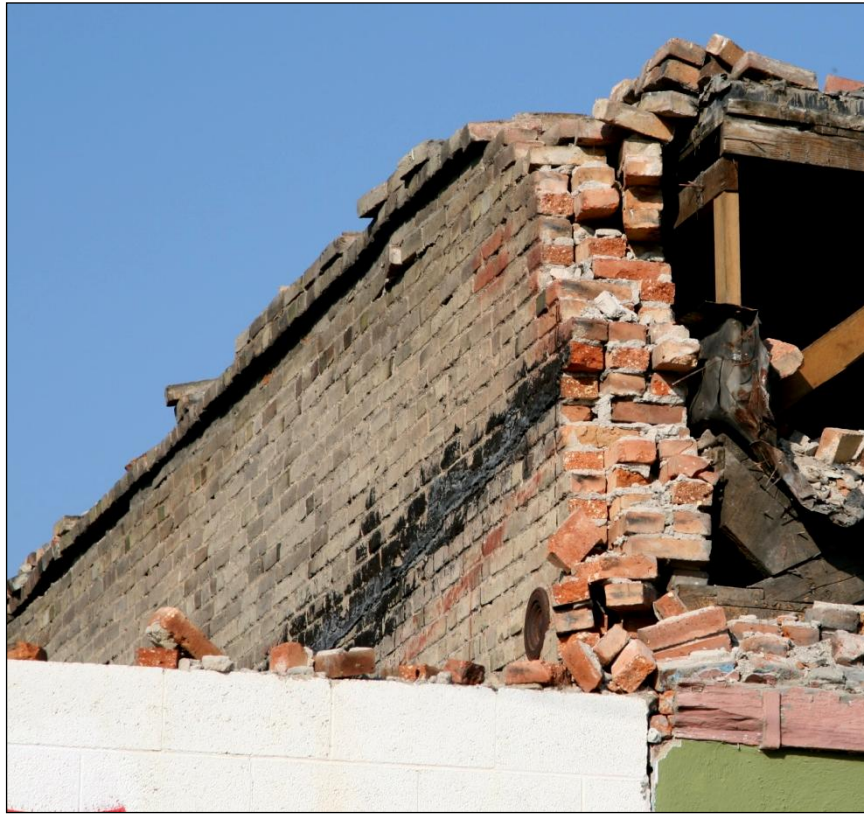
Figure 115. Damage to the eastern wall of the Goble Market has exposed its construction. A later study of the broken wall revealed the cross course bricks that tie the wall together. These appear to be on end along the side of the wall. This is a three-wythe-wide wall. There were also some widely spaced bolts holding the wall to the structure.

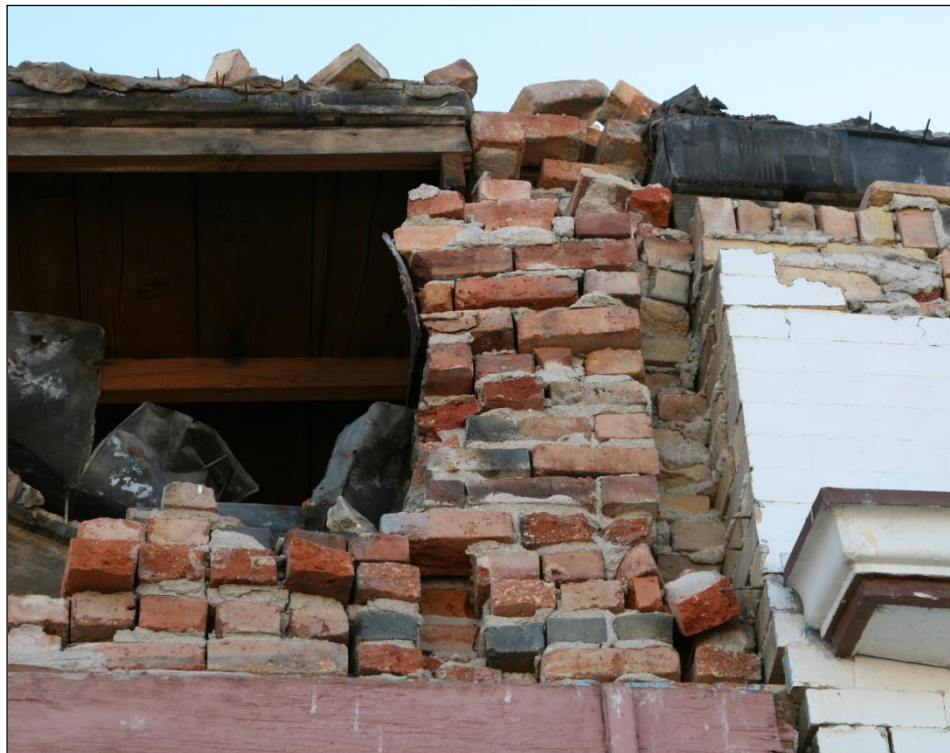
Figure 116. Detail of the bricks of the front of the western wall of the Goble Market. Several vertical contacts between bricks are missing mortar.

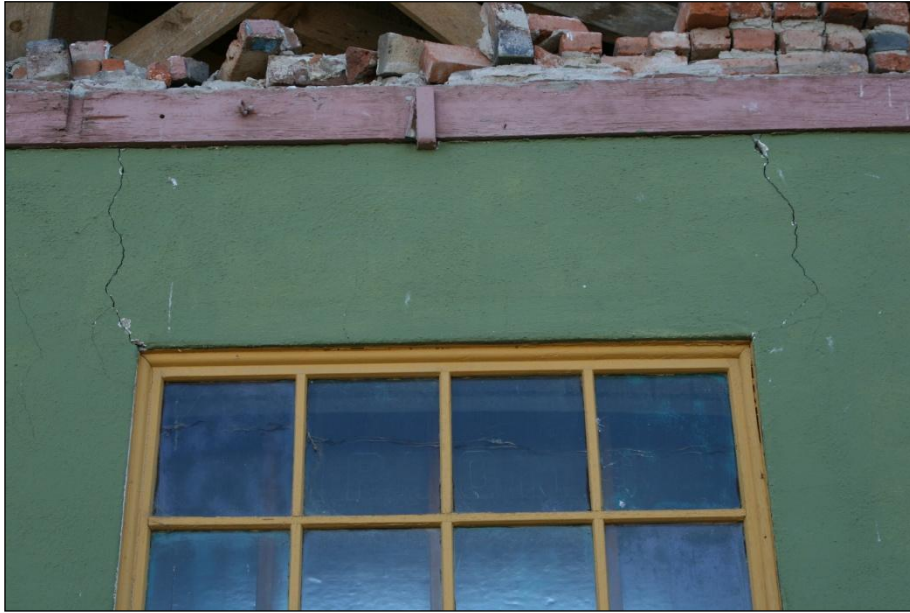
Figure 117. Cracks in the front of the Goble Market.

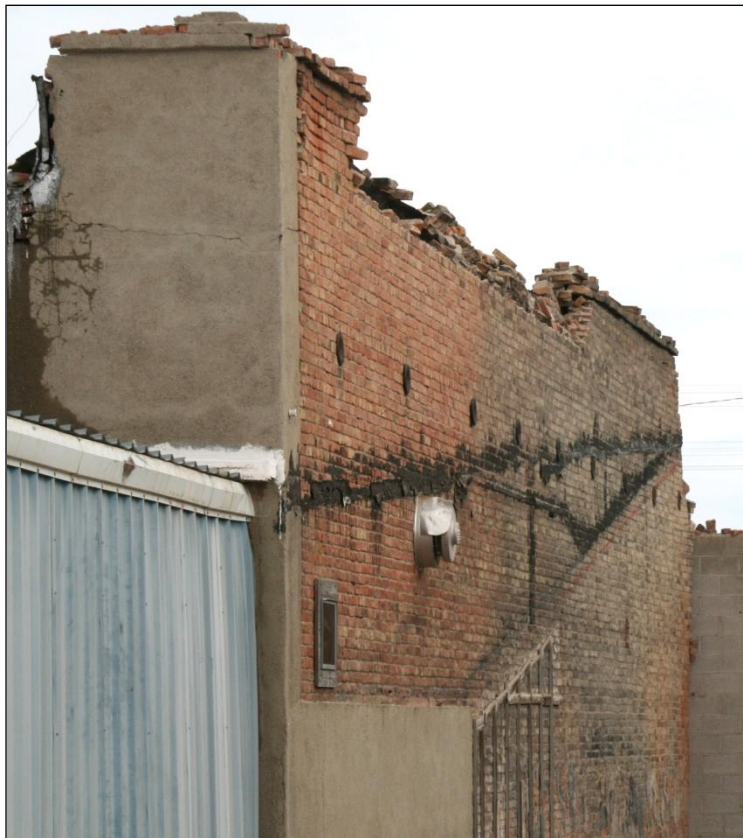
Figure 118. Eastern wall of the Goble Market. Parapet failure of wall and the ends of tie rod anchors are visible.

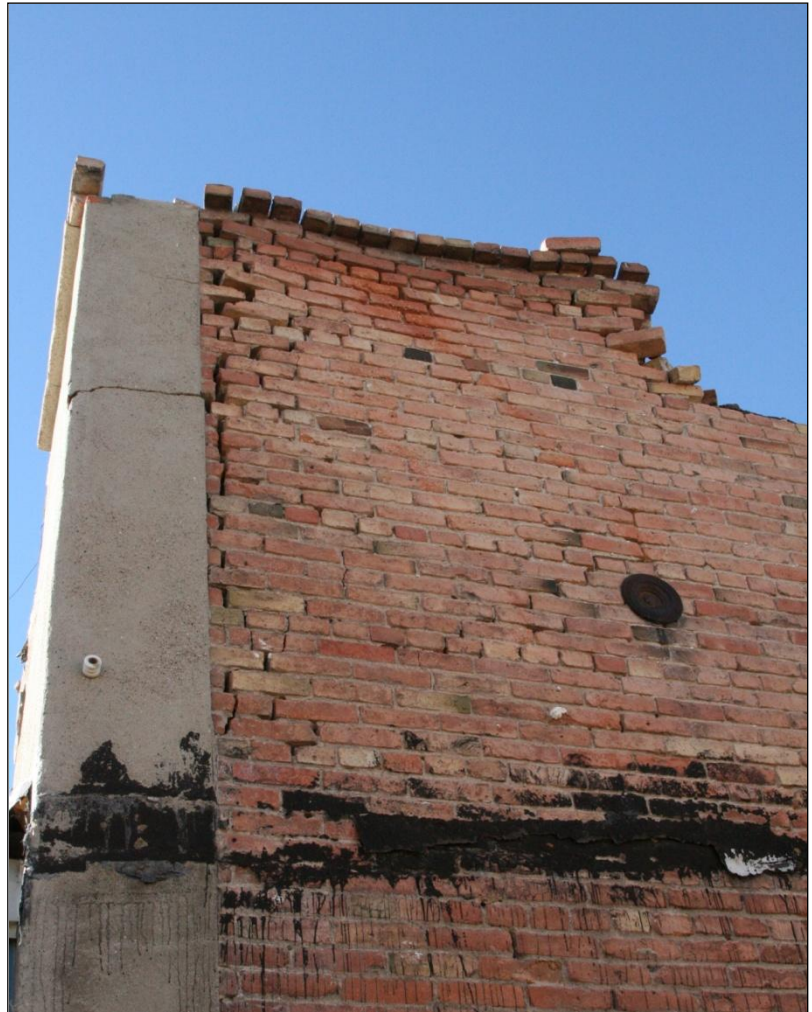
Figure 120. Damaged southeastern corner of the Goble Market.

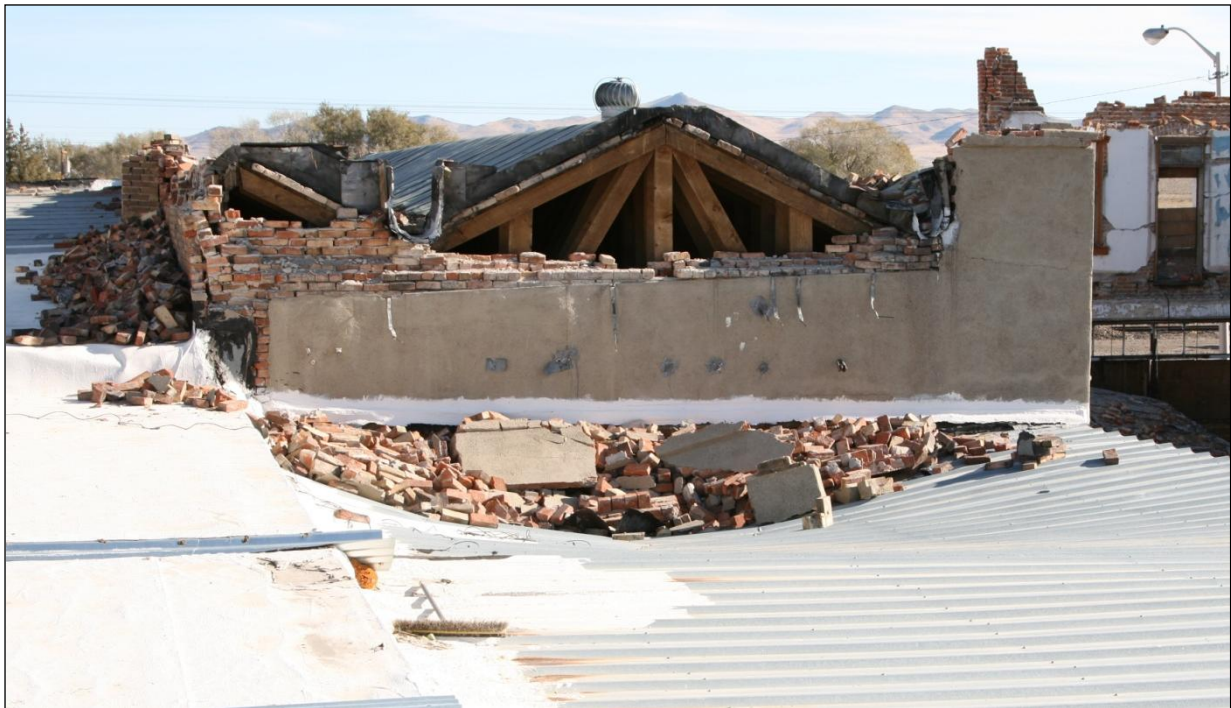
Figure 121. Failed rear gable and western parapet of the Goble Market. The brick wall was caught by the adjacent metal roof, which partially collapsed.

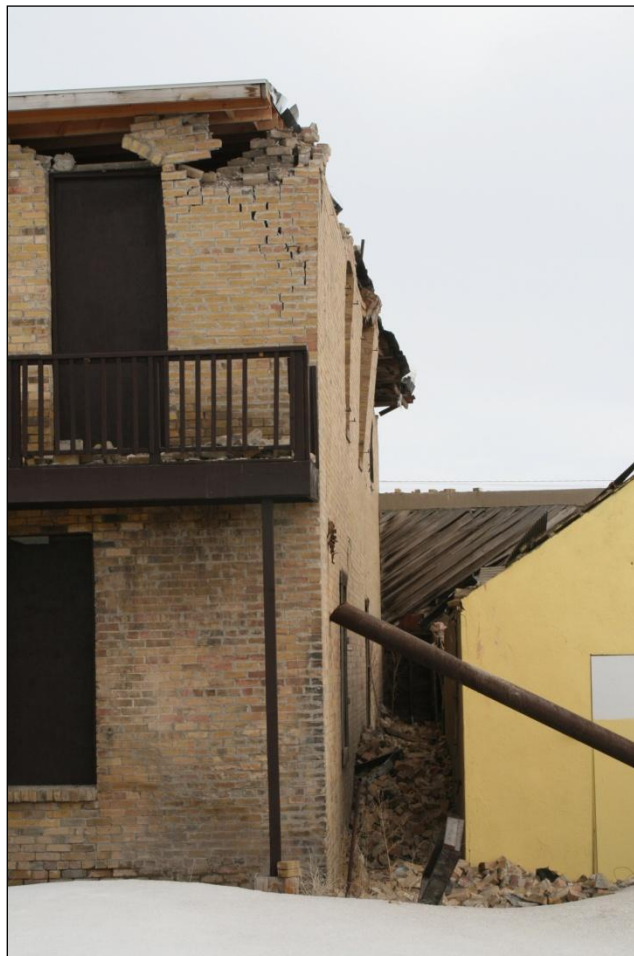
Figure 146. Eastern side of the Nevada Hotel showing rotated roof and out-of-plane parts. The balcony is on the back of the building and caught most of the bricks falling there.

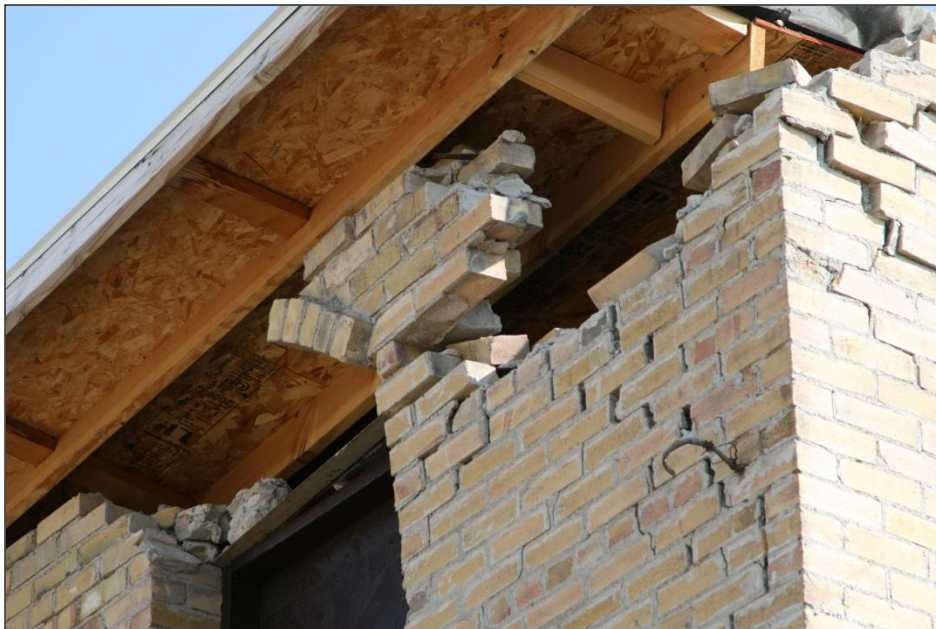
Figure 148. Southeast upper corner of the Nevada Hotel. The corner is badly cracked and is breaking up.

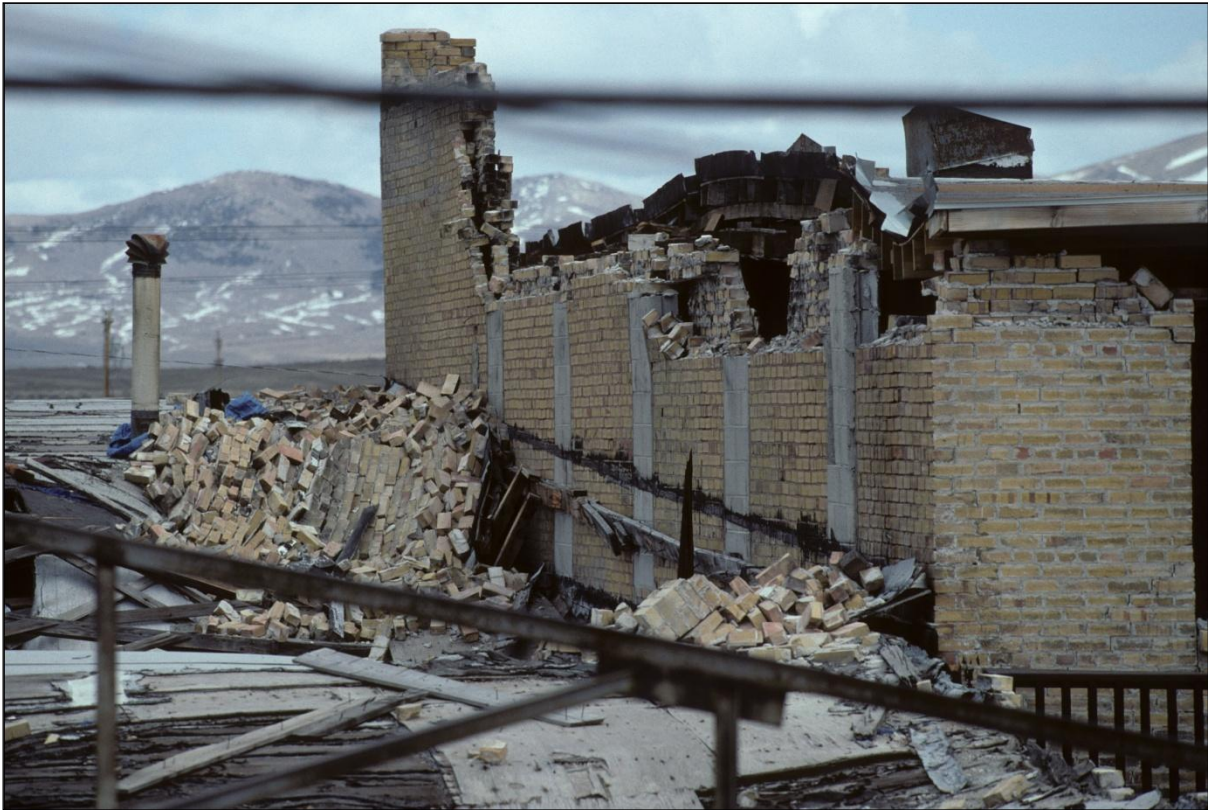
Figure 149. Collapsed western wall of the Nevada Hotel. Concrete block columns can be seen that extended up from the first story ceiling level half way up the wall in the front and relatively higher in the back part of the wall, where the parapet was lower. Many of the bricks that have fallen on Murphy's Bar around the stovepipe are in order and seem to have fallen out as a toppled unit.

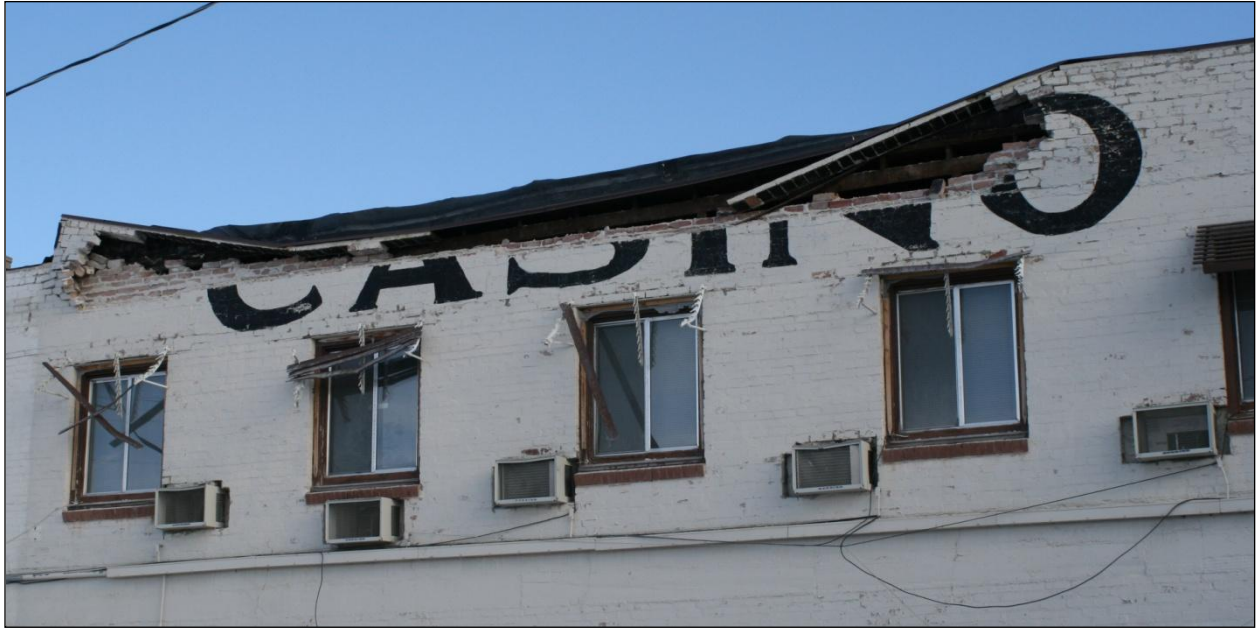
Figure 151. Failure of an upper section of the western wall of the Old West Inn. Most of the bricks fell outwards.

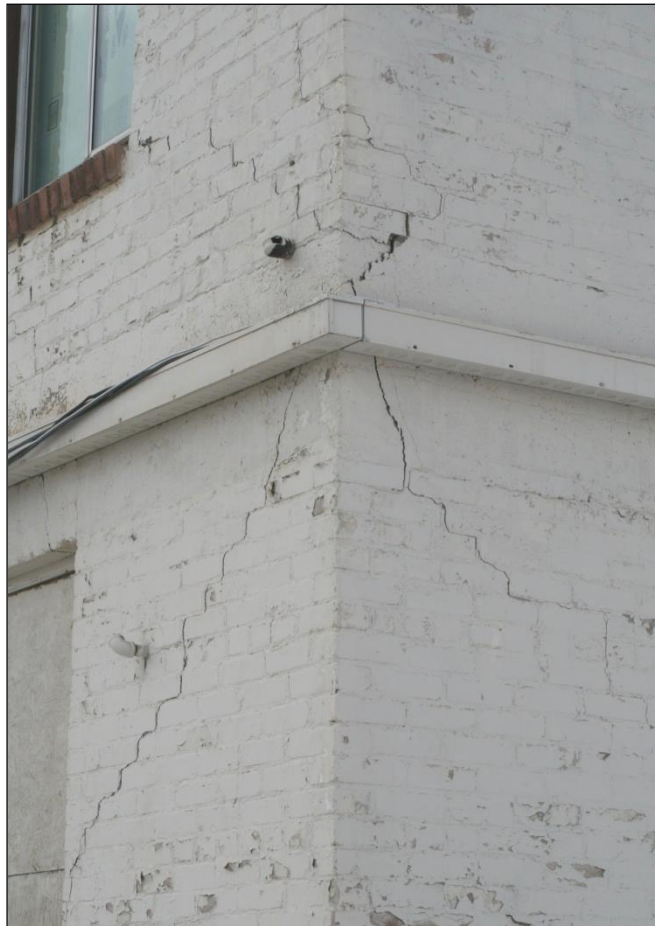
Figure 152. Cracked northwest corner of the Old West Inn.

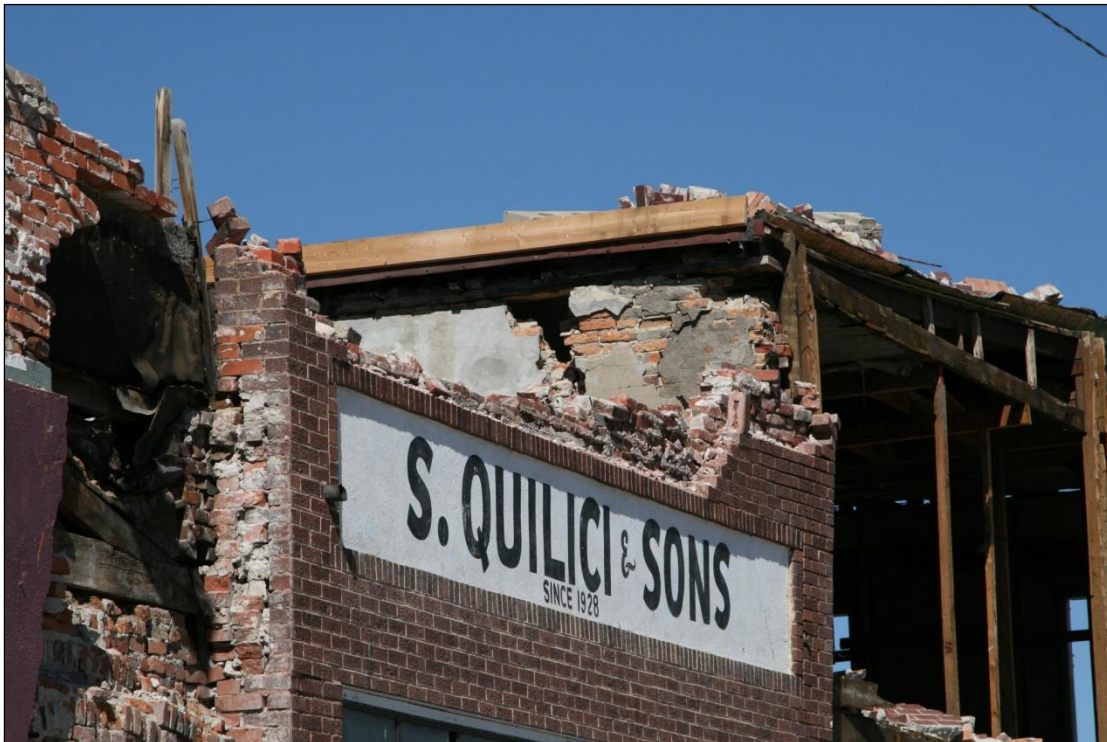
Figure 154. Failed parapet at the front of Quilici and Sons Mercantile.

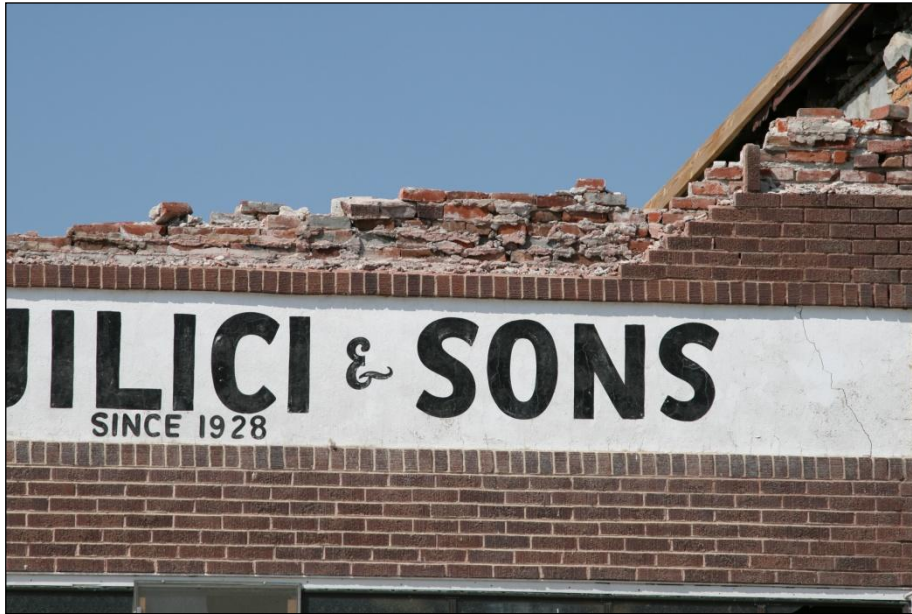
Figure 155. Fallen and delaminated bricks from the front parapet.

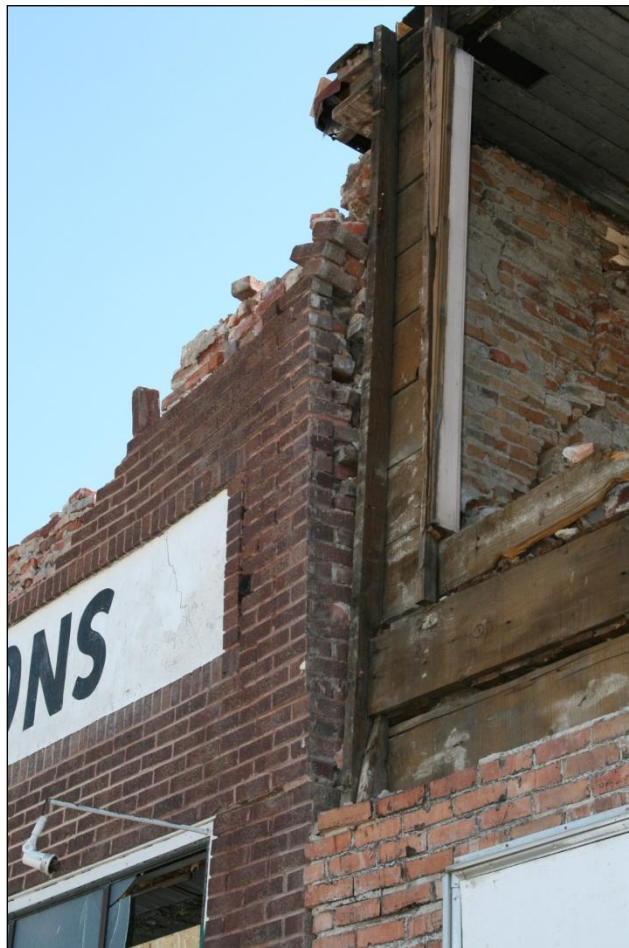
Figure 156. The front corner of the upper part of the front of the Quilici and Sons Mercantile is leaning outwards in a threatening way, despite the cross-course bricks on the end. There is a concentration of shaking damage at the corner of these two buildings.

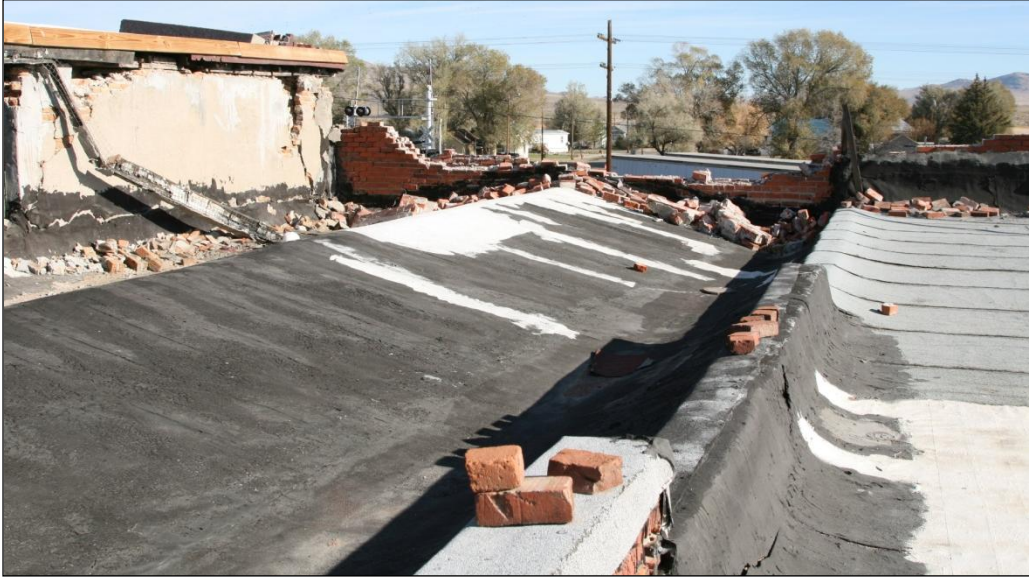
Figure 158. View to the north (front) of the Quilici and Sons Mercantile showing failed parapet from the back.

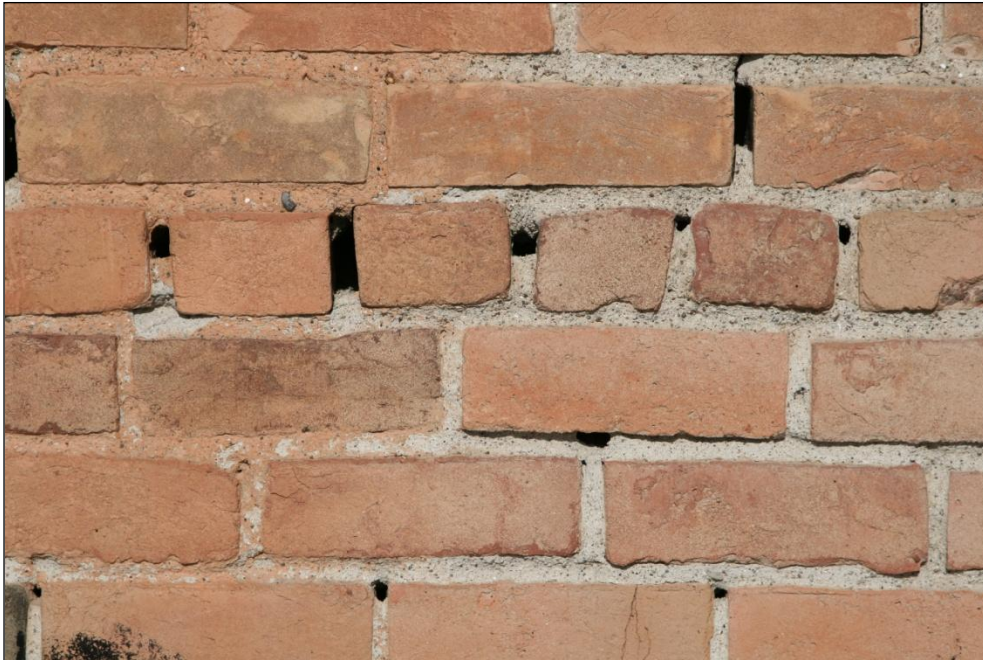
Figure 159. Weather-worn mortar on the top of the mercantile. This weaker mortar may have contributed to some of the dismemberment damage to the back corner.

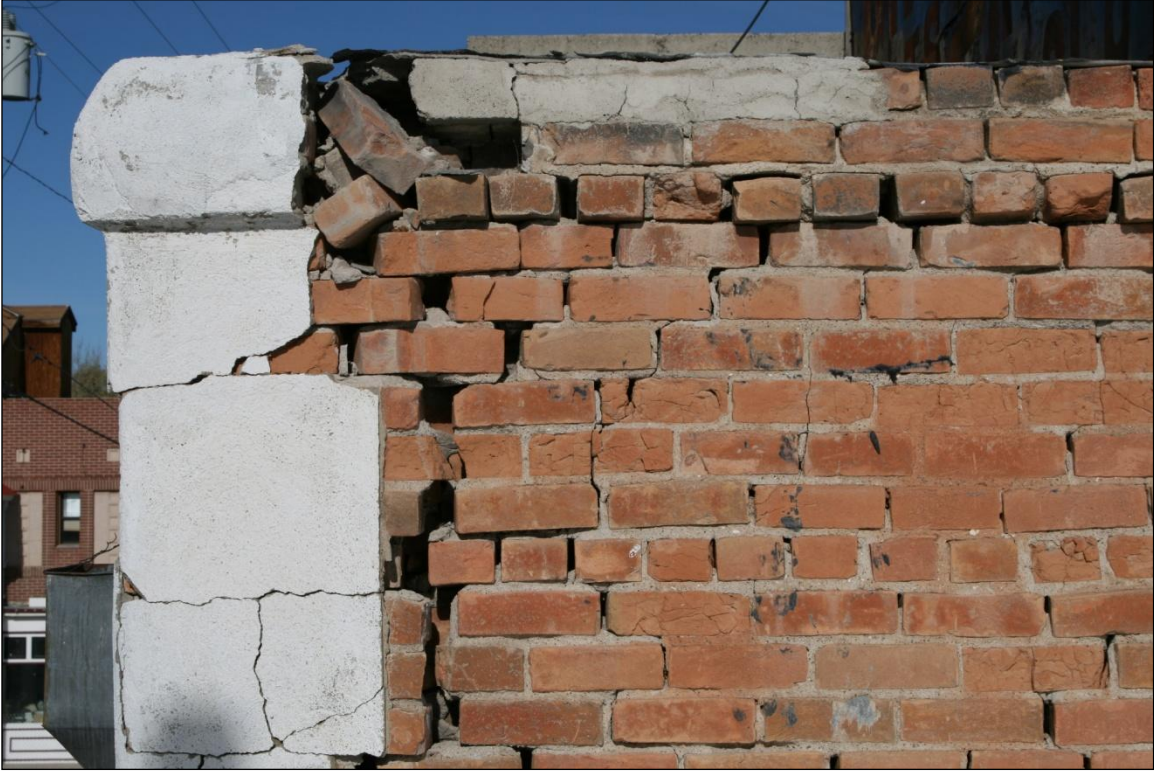
Figure 160. Rear of Quilici Market showing the façade breaking away from the building. Note eroded mortar.
