Building Damage from the 2008 Wells, Nevada Earthquake

Craig M. dePolo
Nevada Bureau of Mines and Geology
University of Nevada, Reno

2011

ABSTRACT

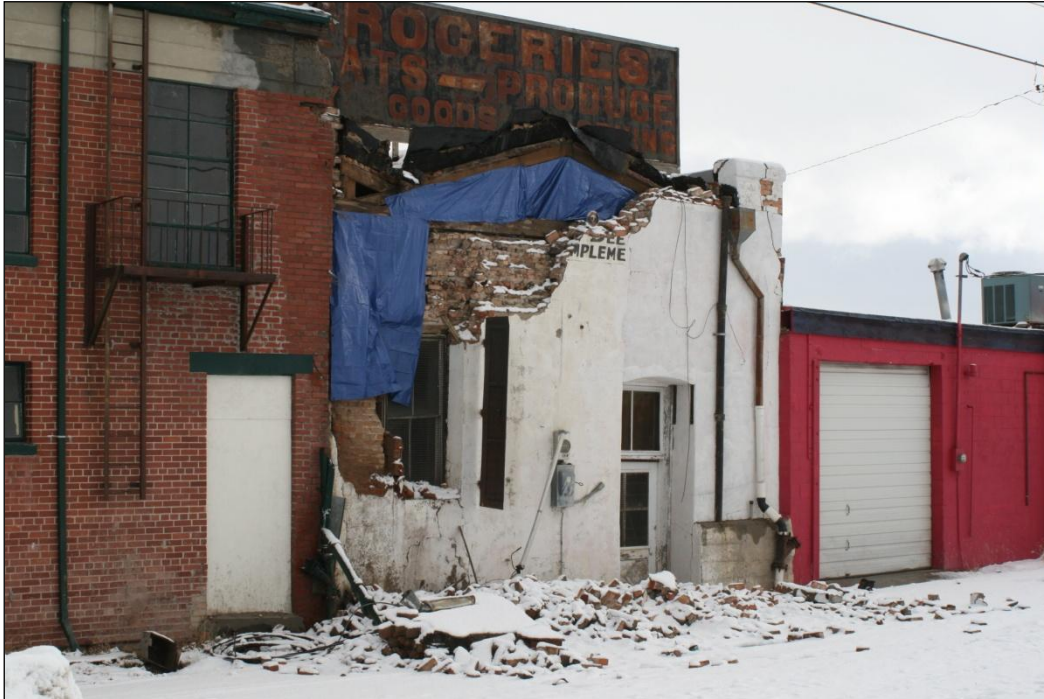
Figure 162. The Quilici and Sons Mercantile showing failed rear parapet, gable end, and wall. More bricks have fallen out of the western side of the back than the eastern side.

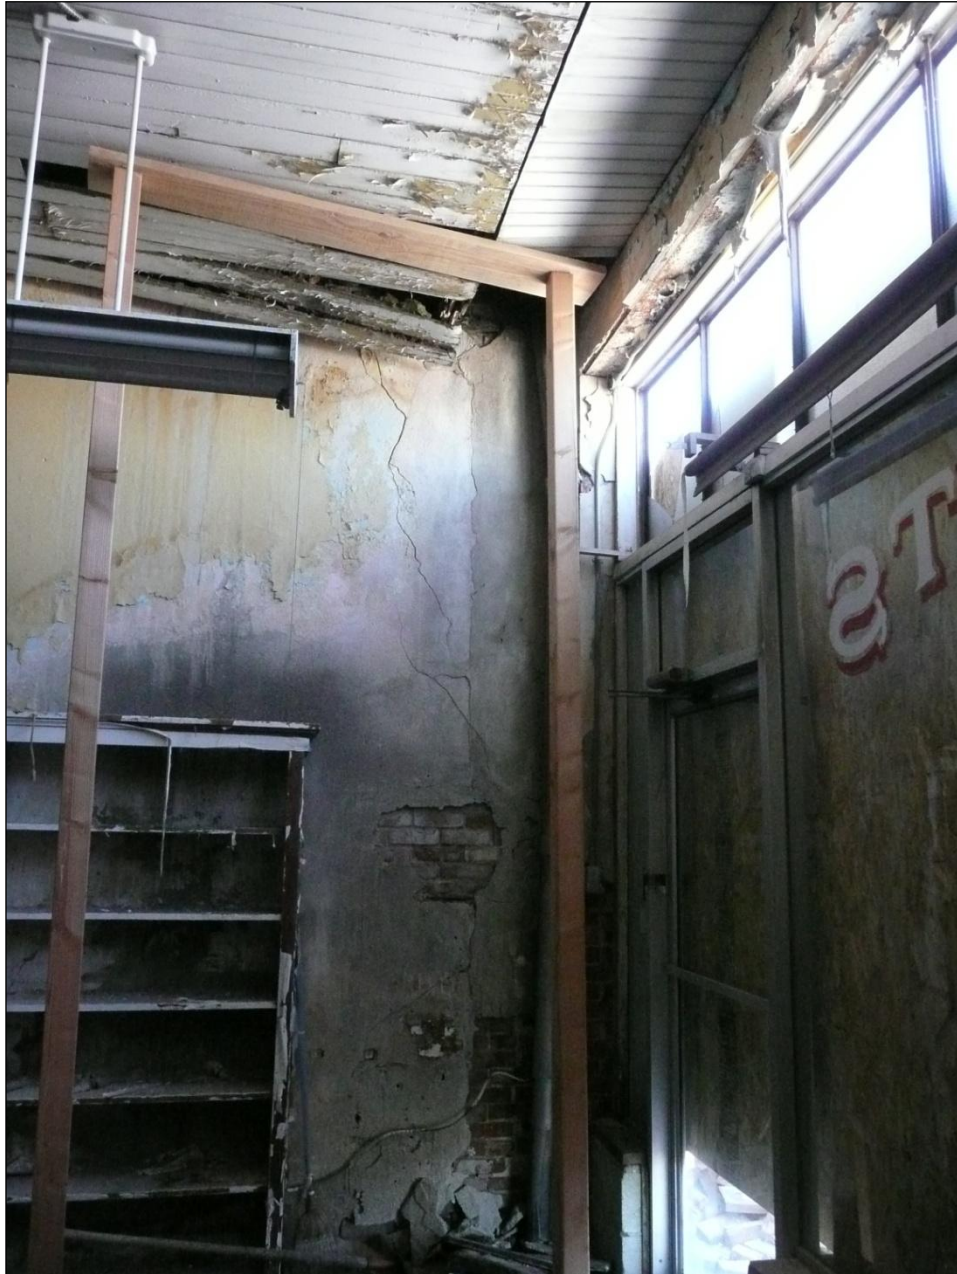
Figure 164. Interior of the Quilici and Sons Mercantile showing the temporary support where roof joists failed. This is directly below the corner shown in figure 157a and 157b. *Photo by Glen Palmer.*

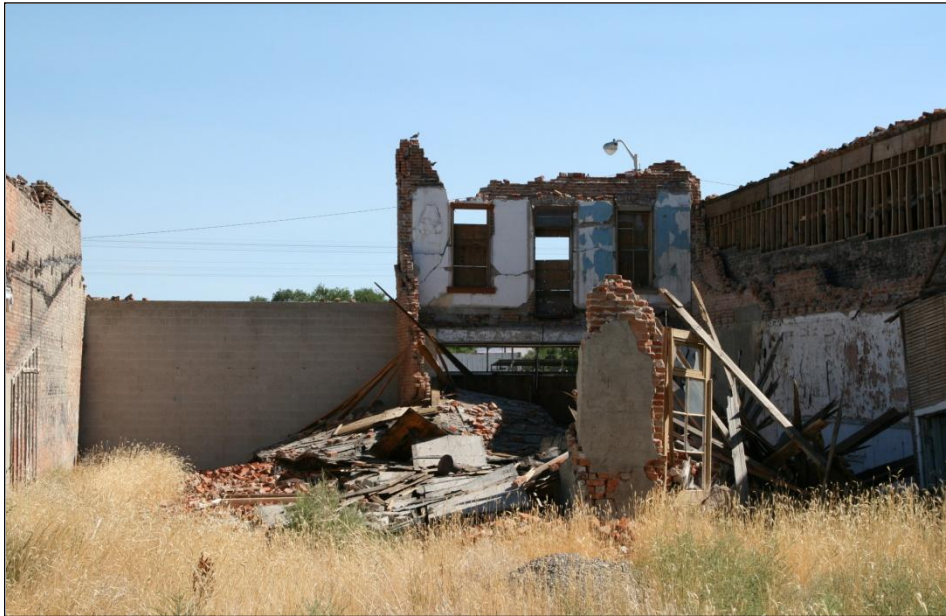
Figure 167. Collapsed San Marin Hotel viewed from the back. The western wall has collapsed bringing down the second story and roof. Only the lower corners remain of the western wall. Displacement may have been relatively limited at the more rigid front of the building, which is buttressed by the concrete block wall. The opposite remaining corner is badly cracked.

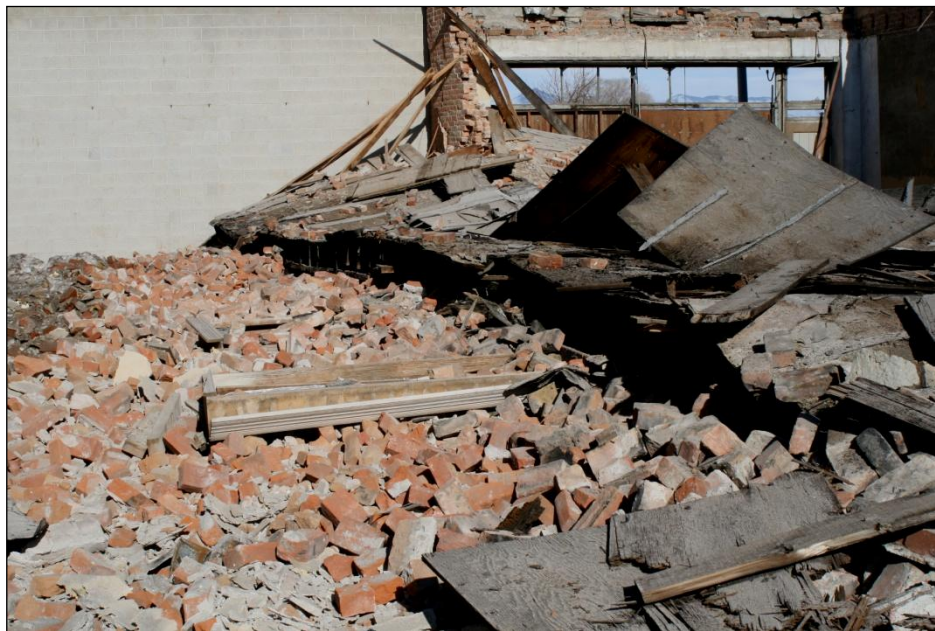
Figure 168. Collapsed western wall of the San Marin Hotel. The wall has disintegrated into bricks, broken bricks, window frames, and bits of mortar. The roof lies on top of this wall and the second story floor on the right.

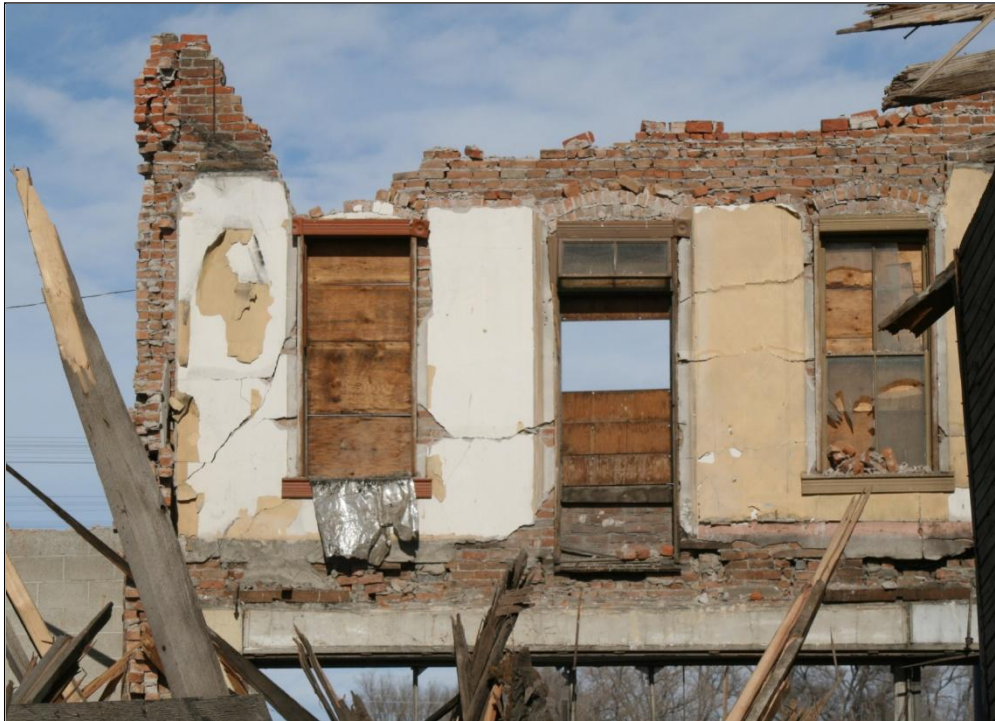
Figure 169. Remaining front of the second story of the San Marin Hotel. Note the concrete beam header for the front which was a relatively coherent part.

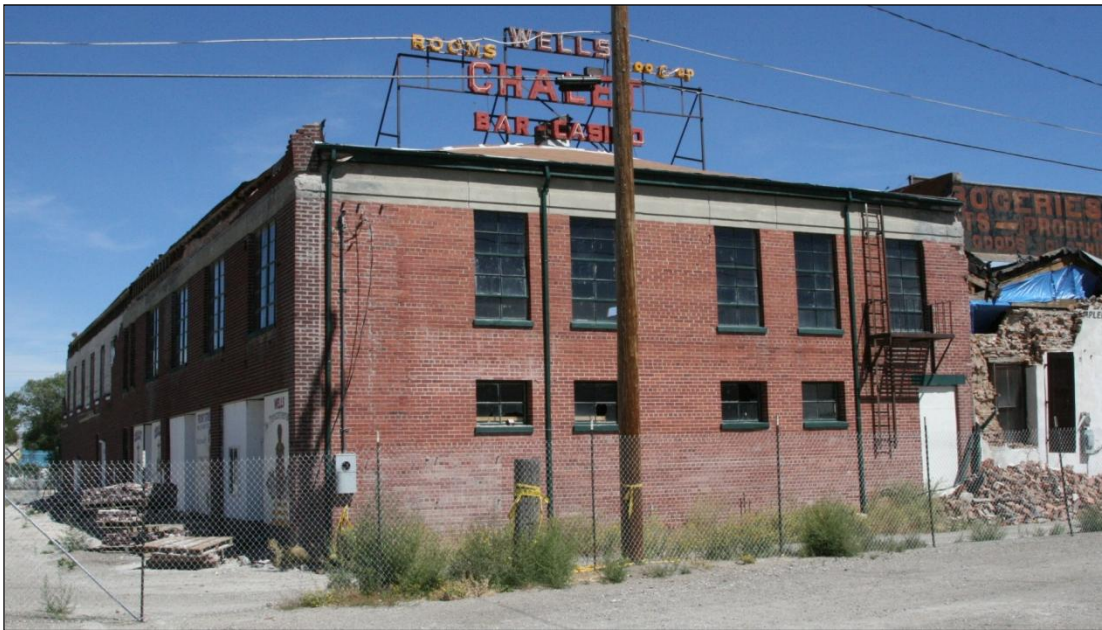
Figure 174. The Wells Chalet building, viewed towards the northeast showing the southern wall (center) and the shaded western wall (left). The building has unreinforced brick walls with large concrete beams at the top, partly to carry large steel trusses that hold up the roof over the second story dance floor. The Wells Chalet building appears to have shaken less than the adjacent Bullshead Saloon (seen farther down the block in the shadows with the fallen veneer) during the earthquake because the veneer on the west side of the chalet has not broken up and fallen away; this may be attributed to the stabilizing effect of the concrete beam, but note that nearly all of the windows are unbroken in the Wells Chalet as well.

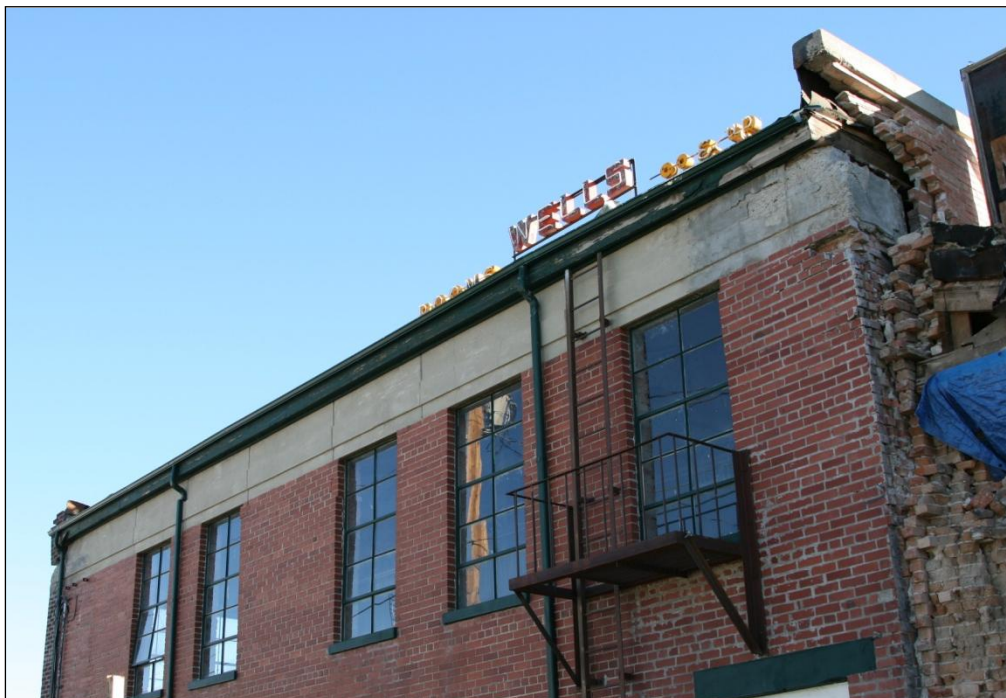
Figure 175. Close-up of the second story concrete beam that apparently moved back-and-forth in an east-west direction. In several places between the windows, the wall is delaminating.

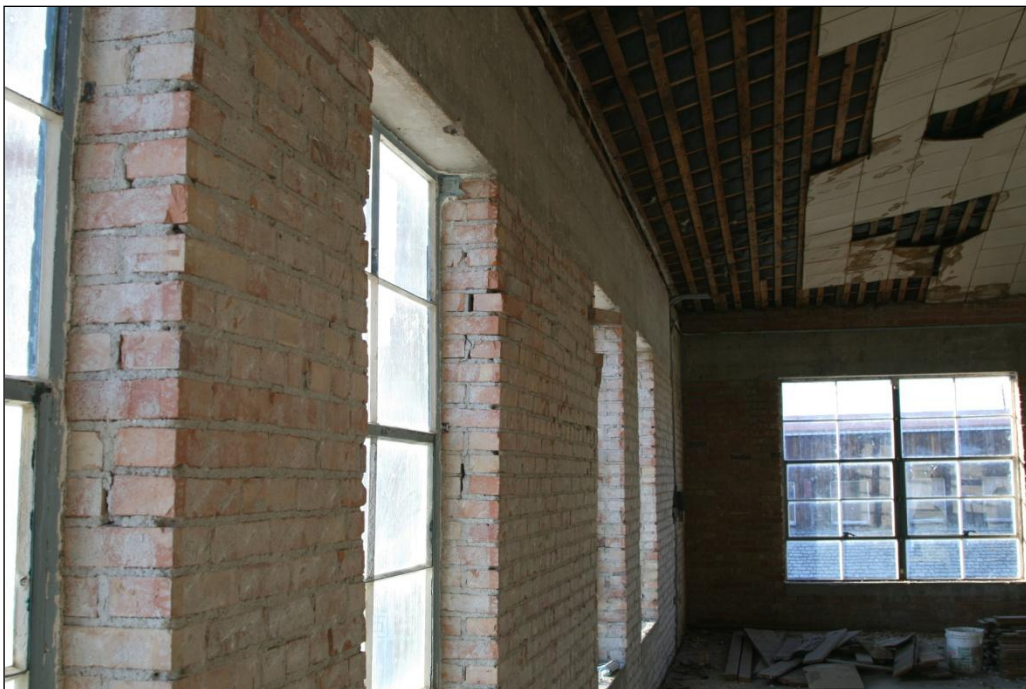
Figure 177. Damage to the second-story southern wall of the Wells Chalet below the concrete beam. Interior picture showing cracking and some displaced bricks of the wall in the center of the picture.
