## 2008 Wells, Nevada Earthquake: Effects on Utility Systems

Craig M. dePolo<sup>1</sup> and Mike Ericksen<sup>2</sup>

2011

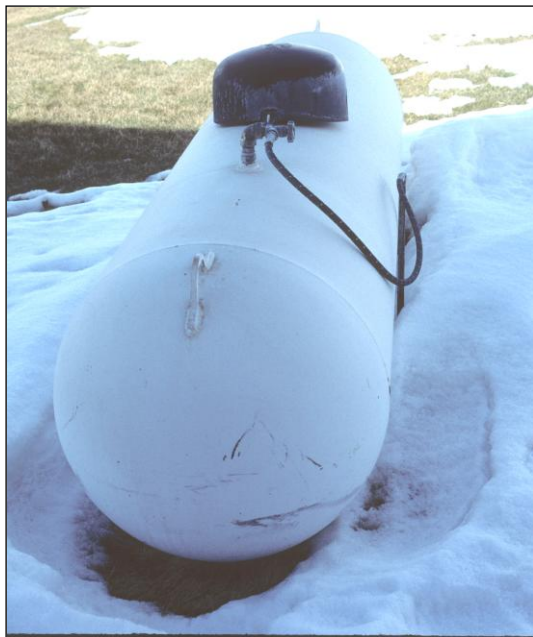
**Figure 1.** The tank has a flexible hose but is leaning on a rigid upright pipe feeder (left). **Figure 2.** Propane tank that shifted on its blocks by a few centimeters (about 1 inch) from the shaking (right).

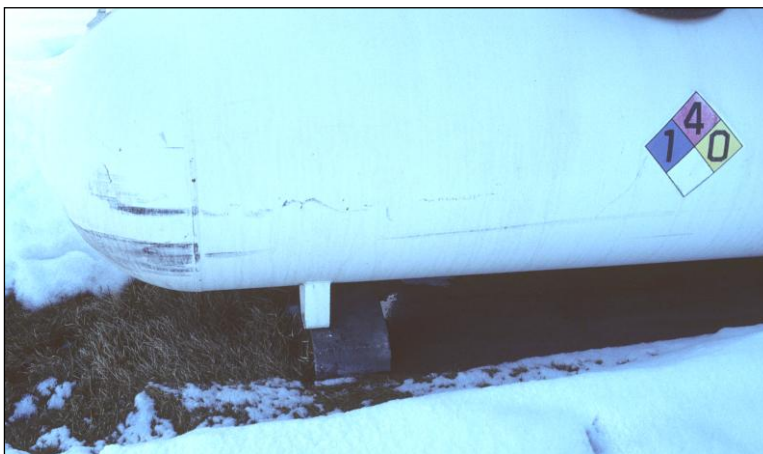
One 120-gallon tank moved off its supporting blocks during the earthquake, but remained in an upright position. A few other tanks were shifted slightly. No propane leaks occurred because of movement from these tanks, and all had flexible connections.

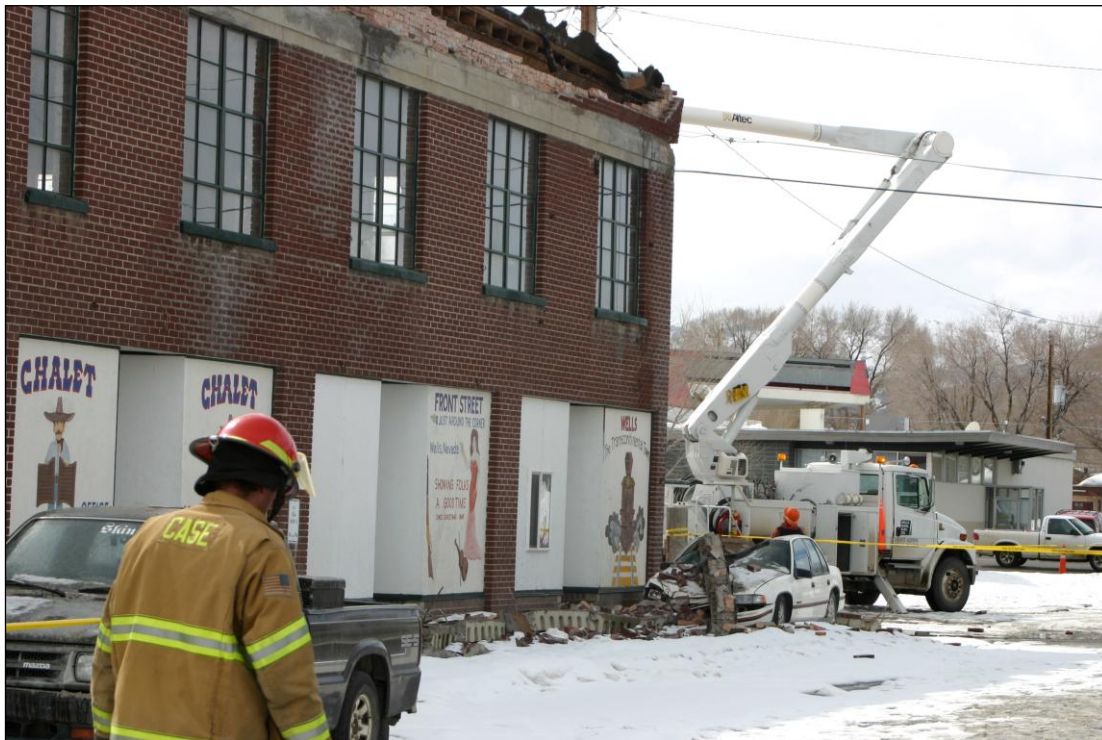
There were no power line or insulator failures from the earthquake. The power had to be turned off to the damaged buildings in the historical district (figure 3), where several service lines were cut to avoid being pulled down by further building damage. There were several requests to disconnect electric power: firemen requested the power be cut to the building under construction next to the liquid propane leak, and several WREC customers asked for power to be disconnected because of damage to homes and businesses. This damage included a meter box pulling away from a home, bricks from a chimney falling on a meter box, and electrical problems at a grocery store.

**Figure 3.** Wells Rural Electric Company linemen disconnecting power to a damaged building in the historical district.  
*Photo by the Utah Division of Homeland Security.*

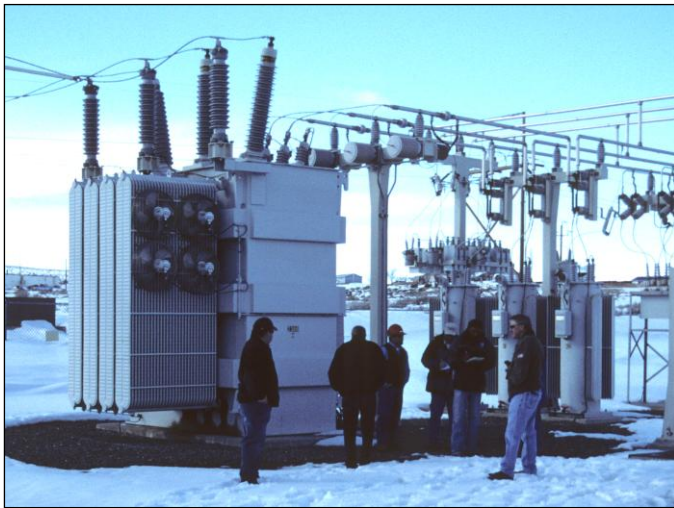
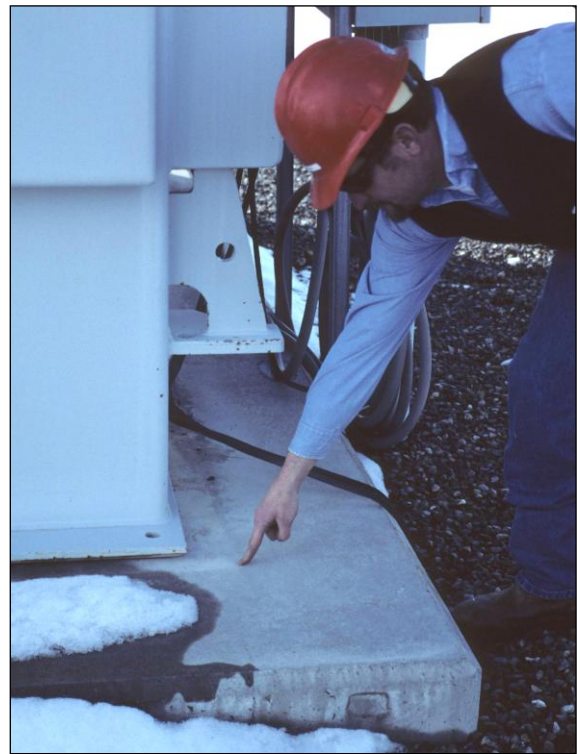
During the Wells earthquake, a large 51-ton 138 kV station-class transformer was rotated slightly and shifted about 14 cm (about 5½ inches), and although it bent a connecting line bracket down a little and made the ground wire taut, the transformer did not fail, have its service compromised, or pose a safety issue (figures 4 and 5). Curiously, an old, unattached 46-ton transformer sitting a few meters away did not move at all.

**Figures 4 and 5.** Above: A 51-ton 138 kV station-class transformer that shifted about 14 cm from the earthquake is shown above. Right: The transformer base is shown shifted from the mark of its prior position on the pad. The taut ground wire can be seen behind the man indicating the prior corner of the transformer. Note the anchorage hole in the base plate that was not used.

The power had to be turned off in a scheduled outage of 6 hours in order to reset the transformer. The power company did this work with its own personnel, and the crane cost \$1,732 to rent. The transformer was reset, but was not anchored to prevent movement from future earthquakes.

- Anchoring heavy and critical equipment properly is important in earthquake country. Large, heavy pieces of equipment, such as transformers, may seem stable at rest, but earthquake shaking can cause such equipment to shift on their foundation. If movement is enough to break connections or otherwise create a hazard, systems may have to be shut down for a period of time. Loss of such equipment can cause power outages that can be days in length.

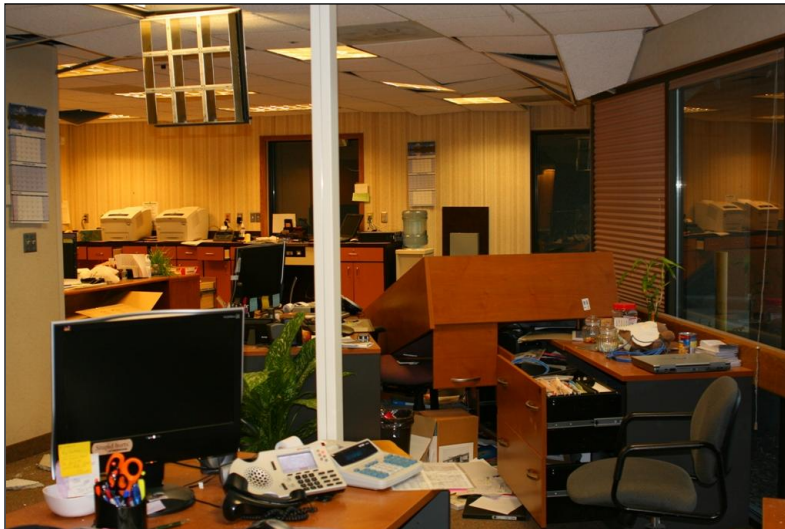
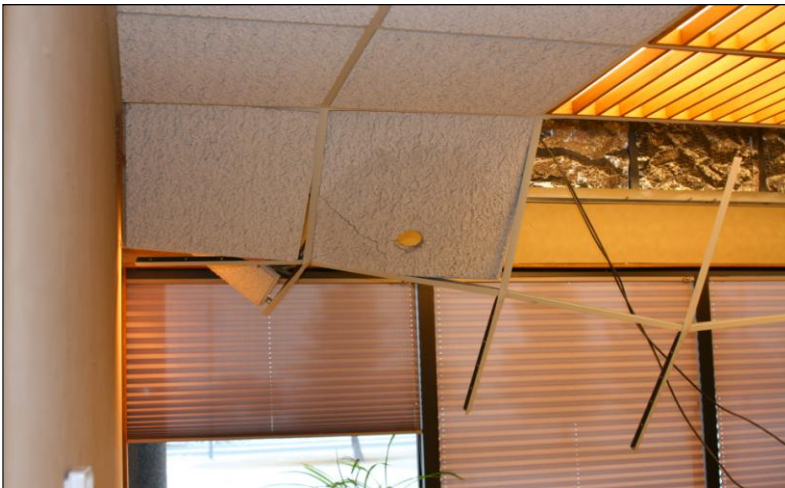
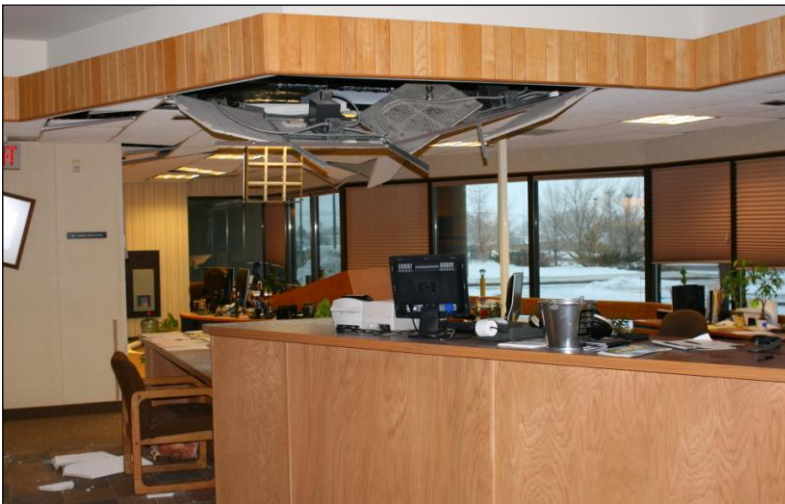
Wells Rural Electric Company's main office sustained some damage and was closed to customer service the day of the event. Ceiling tiles had fallen, bookshelves, flat screen televisions fell and were broken (or had things fall on them), and there was other general content damage (figures 6, 7, 8). The company had several Internet servers operating on shelves that shifted; two of these fell to the desk below, but the servers were restricted from moving too far by the wire connections, and continued to operate during and after the earthquake. The staff cleaned up the offices that day (mostly cleaning up fallen tiles and picking up fallen objects) and the building inspector cleared the building for occupancy about 2 to 3 p.m. in the afternoon of the day of the earthquake.

**Figures 6, 7, and 8.** Nonstructural damage in the Wells Rural Electric Company's front office. Top: A fallen cabinet, open drawers, and damaged ceiling can be seen and a telephone lies off the hook in the foreground. Middle and Bottom: Ceiling tile damage. *Photographs by Layla Walz of Wells Rural Electric Company.*

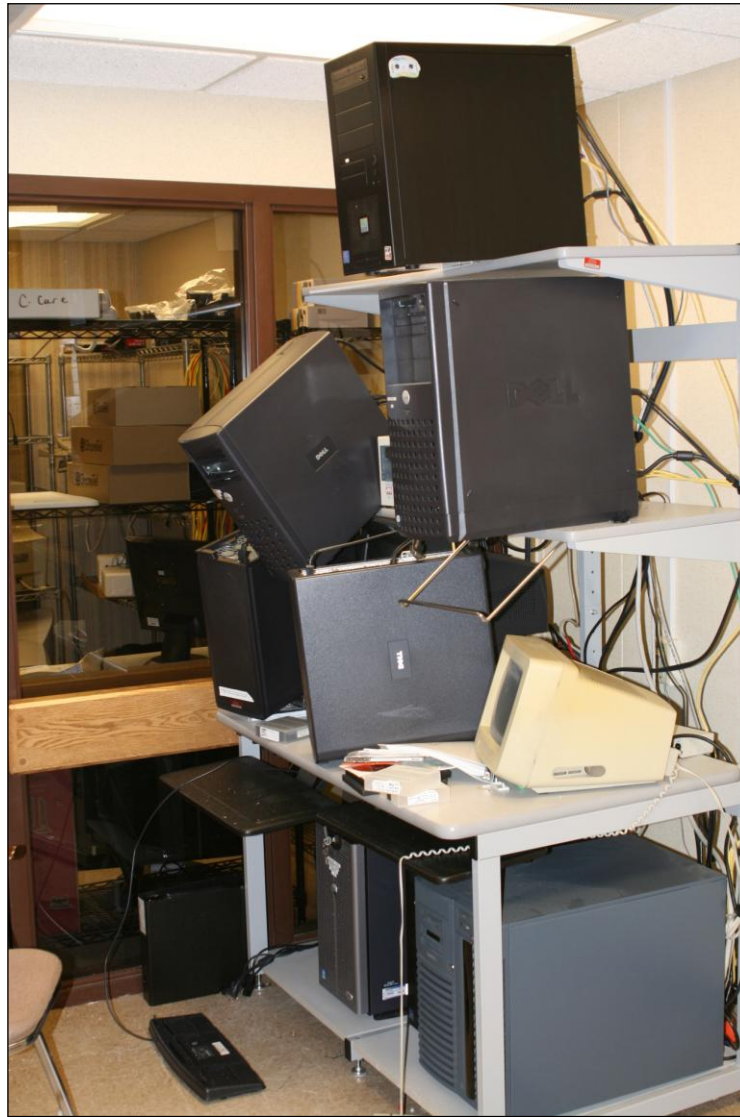
**Figure 9.** Remarkably resilient servers used by Wells Rural Electric. Although two servers fell onto the desk and others shifted, they remained connected and operating through the earthquake and afterwards (the fall was cushioned a little by books and papers on the table). The servers on the floor rack do not appear to have shifted at all. *Photograph taken by Layla Walz of Wells Rural Electric Company.*

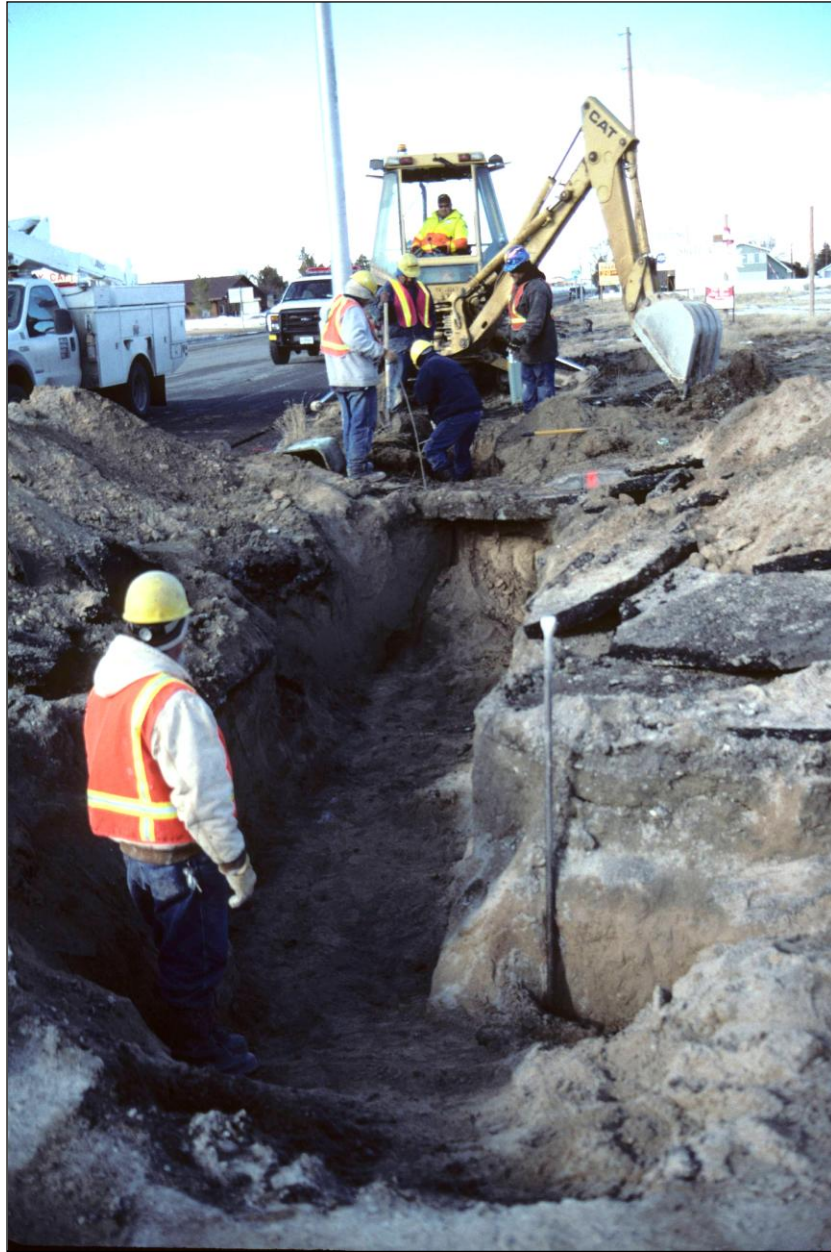
**Figure 10.** Digging to find a break in a water main located under a sidewalk and lamppost.

The broken water main was in the southern part of Wells, just north of the Interstate 80. It was an older line that broke once during the mainshock, and again in a major aftershock on the first day. This resulted in very visible runoff of water across the roadway. The break was isolated, the water line was turned off, and the line was fixed with the help of the maintenance people from Wendover (one of the nearest towns). After re-pressurization, the line failed again from an afternoon aftershock. This second break was more complicated, as it occurred under a sidewalk, near a lamppost (figure 10). All water-line breaks were fixed by the third day after the earthquake (figure 11).

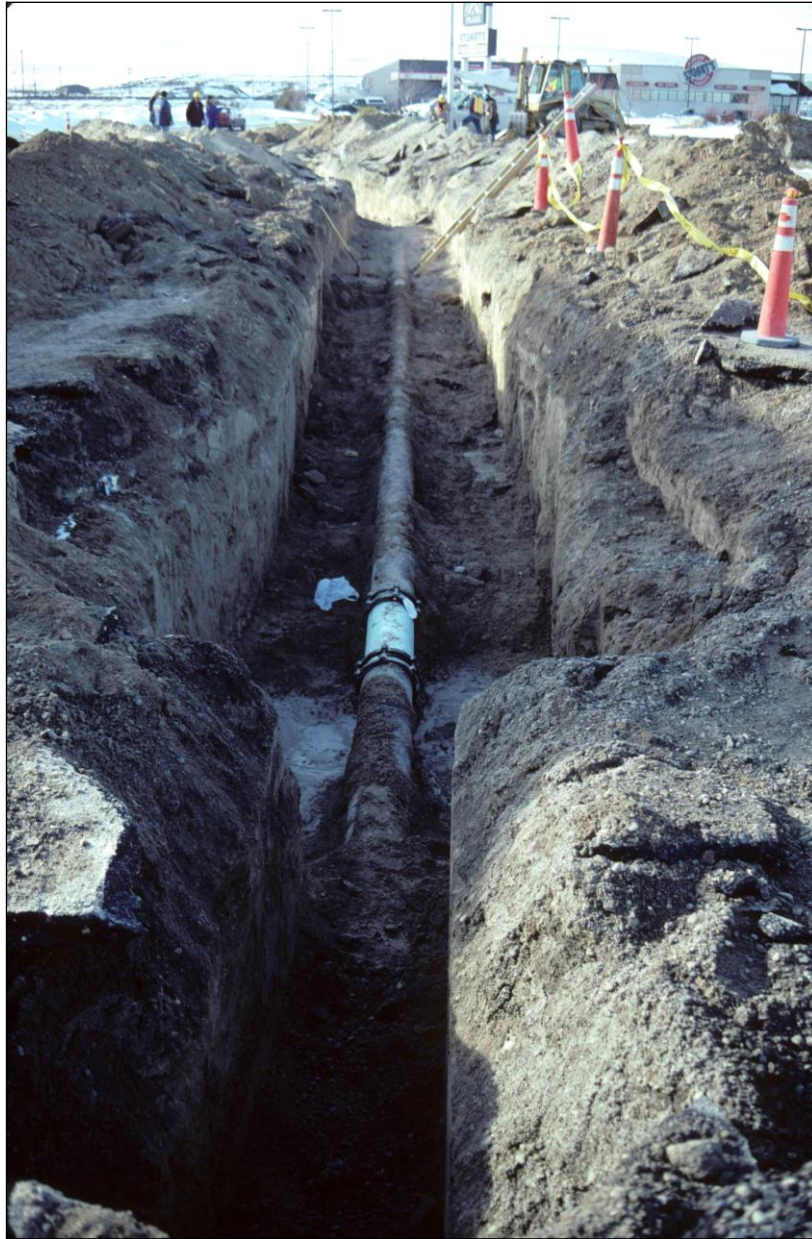
**Figure 11.** The area of the main water break from the mainshock. The patch in the line can be seen in the lower center.

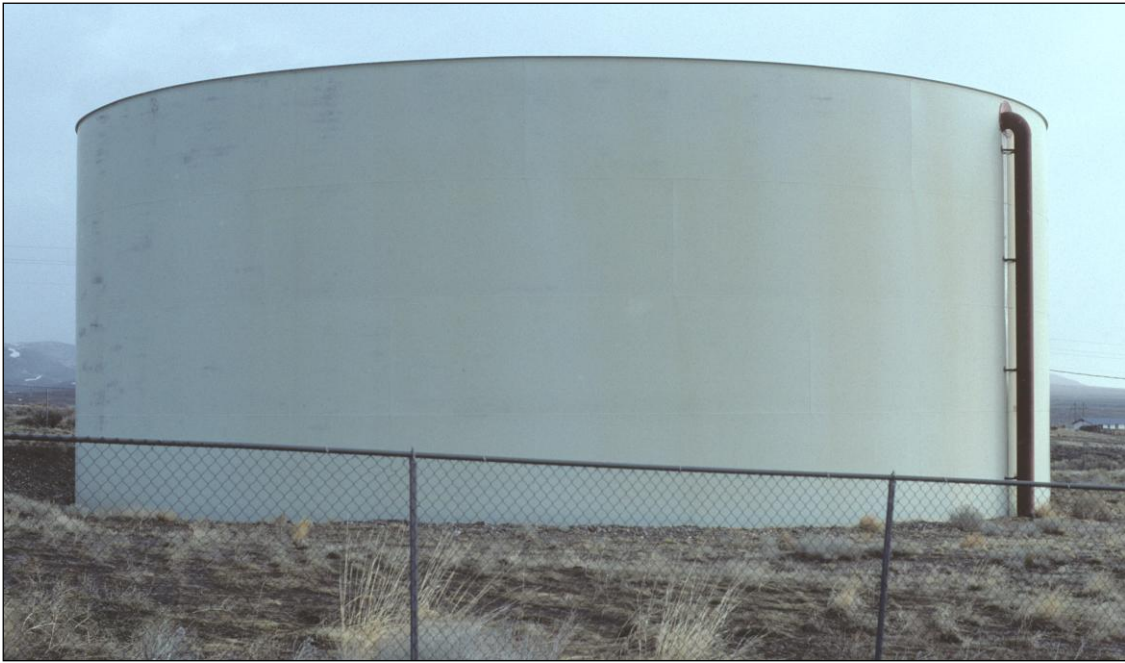
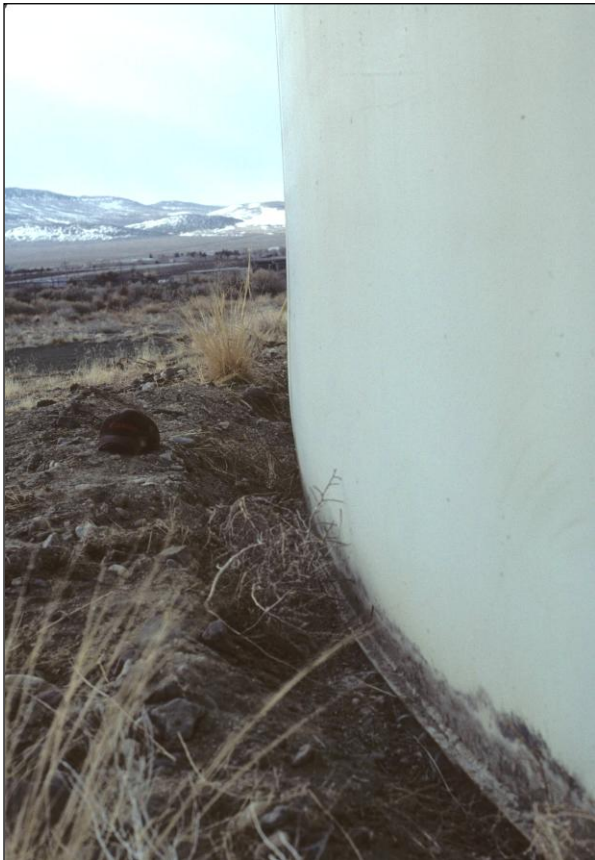
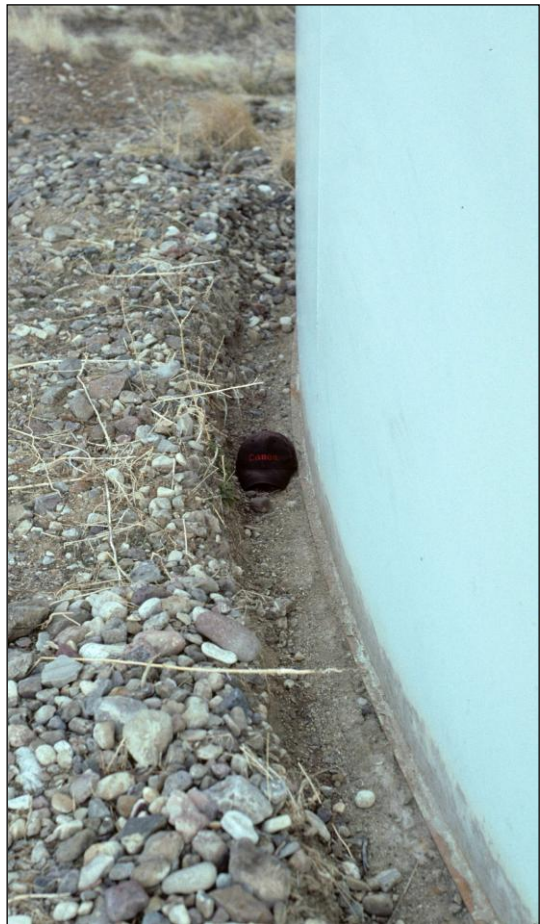
Large water-storage tanks in and near Wells appeared to shift side-to-side as evidenced by gaps in surrounding gravel beds (figures 12 and 13). One 1,000,000-gallon-tank that was nearly full developed a small “elephant’s foot,” or bulge at the base of the tank, on one side from the earthquake. The tank did not fail or leak but vacuuming the tank for better inspection revealed cracks and broken welds on a central column inside the tank. The earthquake rocked and shifted another water tank in a similar manner, slightly damaging an electrical conduit that was connected to it.

**Figures 12, 13, and 14.** Water tank has shifted and developed a bulge at its base (“elephant’s foot”) on one side (lower left). The shifted base is shown on the lower right with a baseball cap for scale.
