Immediate Scientific Response to the 2008 Wells, Nevada, Earthquake

The 2008 magnitude 6 Wells, Nevada, earthquake provided an opportunity to study the effects of a moderate-magnitude Basin and Range Province (BRP) earthquake and initiated a multifaceted response from Nevada and Utah geological surveys and universities. We report the procedures, results, and implications of our scientific response to the earthquake, focusing on our search for primary (fault-related) and secondary (shaking-related) geologic effects and activation of an earthquake clearinghouse Web site. We found no evidence for primary (or sympathetic) surface faulting on known Quaternary-active fault zones within about 20 km of the earthquake epicenter. We did find limited evidence for secondary effects, consisting of isolated rock-falls north and south of Wells and disturbed snow deposits in the epicentral area. We did not find evidence for liquefaction in a river floodplain immediately north of Wells, possibly as a result of unsaturated and partly frozen near-surface soil conditions. The areal extent of the most significant secondary effects, combined with structural damage in Wells, defines a 280 km² minimum ar

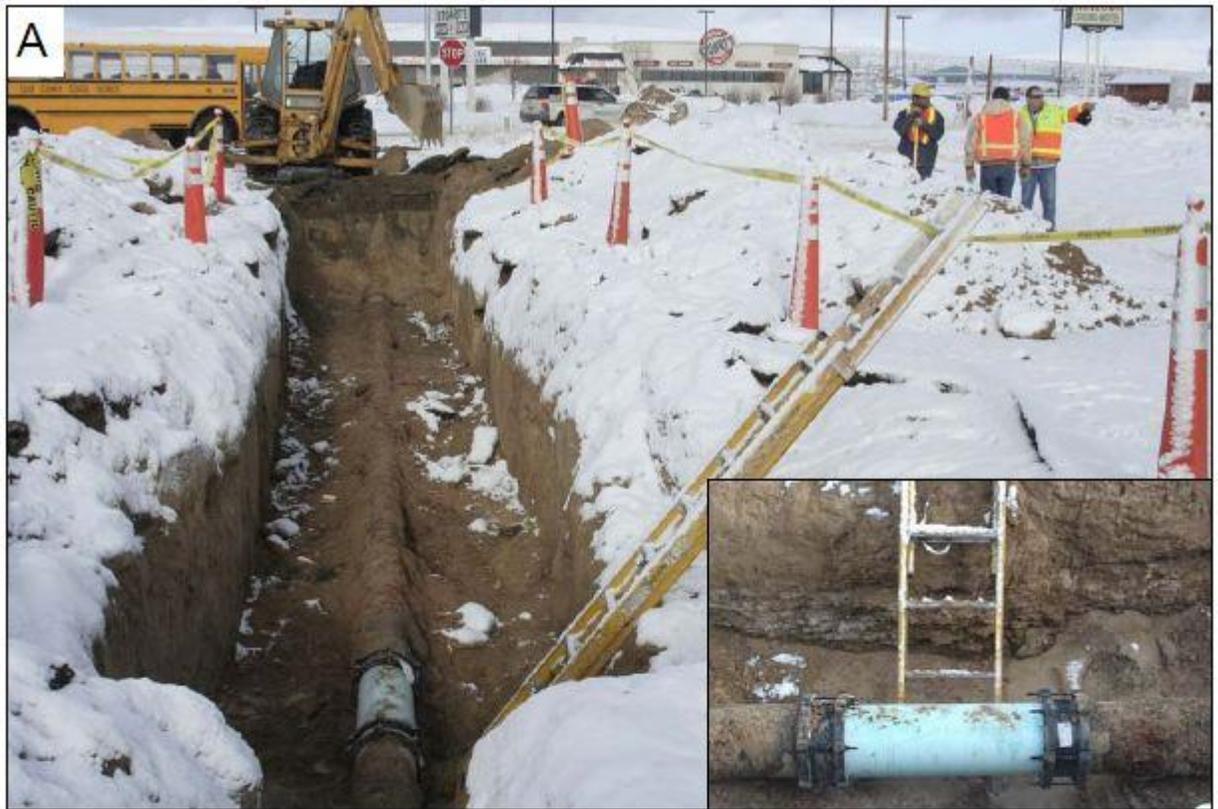
Figure 2. Investigation of (A) a water main damaged in the Wells earthquake (pipe is about 25 cm in diameter; inset shows repaired section), and (B) the partly frozen flood plain of the Humboldt River north of Wells. Neither site contained geologic evidence for strong seismic shaking; photographs taken February 22, 2008.

In Wells, we searched for geologic evidence of strong ground shaking, such as ground deformation or liquefaction. We observed a repaired water main that had been damaged during the earthquake (figure 2a); however, the exposed, approximately 25-centimeter-diameter pipe showed no horizontal or vertical offset. Sediments exposed in the trench walls showed no signs of liquefaction or displacement and the surrounding area showed no evidence for ground cracks or liquefaction features; however, snow cover limited our investigation. We also investigated the Wells airport and volunteer fire station areas after receiving reports of possible “ground swales,” but observed no evidence for surface deformation clearly associated with the Wells earthquake.

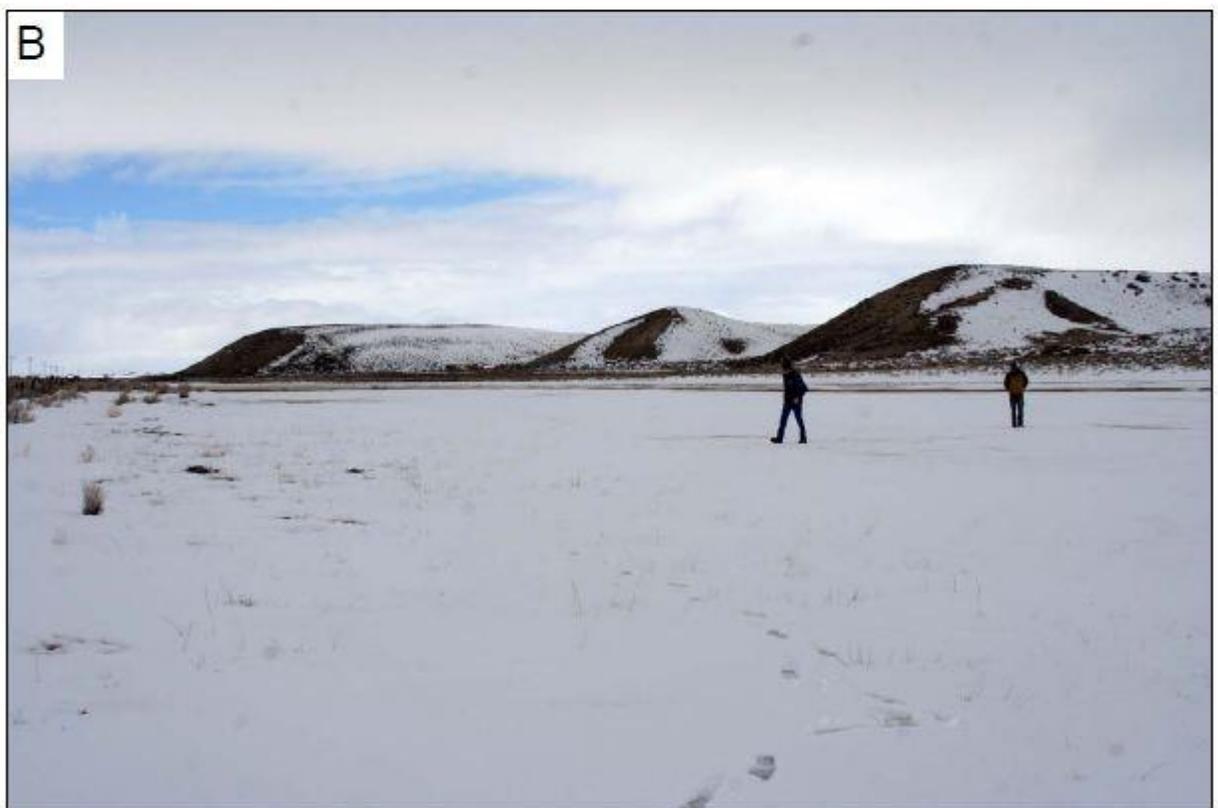
The Humboldt River, immediately north of Wells, provided a likely location for liquefaction features. We traversed parts of a wide, snow-covered, and mostly dry flood plain, but did not find evidence for liquefaction or ground deformation (e.g., sand blows or ground cracks). We also looked for liquefaction features northwest of Wells, where surface water was flowing and the banks and marsh areas were mostly covered by snow and ice (figure 2b). We did not observe evidence for liquefaction or lateral spreading along stream banks. We did not investigate the Humboldt River or Town Creek northeast of Wells due to impassible road conditions.

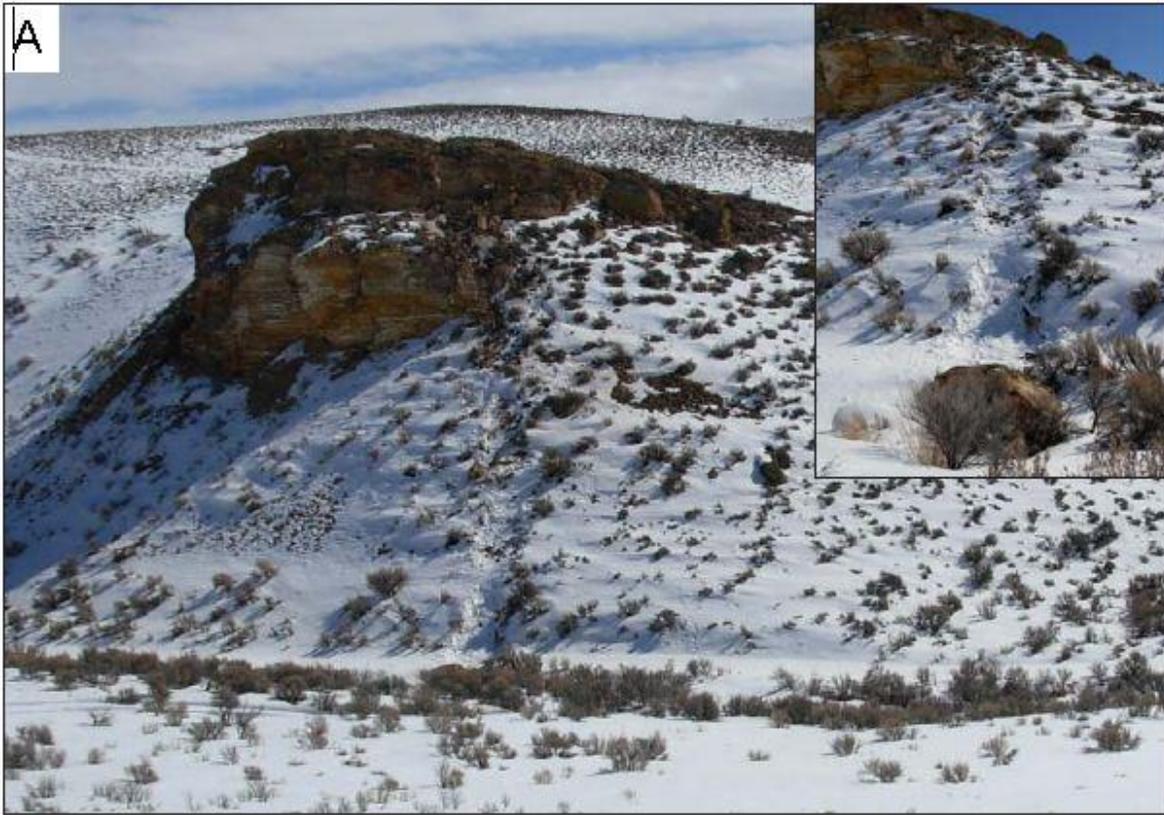
About 9 km west-northwest of the Wells earthquake epicenter, in the southern Oxley Peak area (southernmost Snake Mountains; figure 1), M. Meremonte (U.S. Geological Survey, written communication, 2008) reported rock falls that occurred during (or shortly after) the Wells earthquake. At the site, numerous cobbles and boulders, including an approximately 2-m-high by 3-m-wide boulder (figure 3a), were dislodged from an exposed ridge of Miocene sedimentary and volcanic rocks that dips 25° southwest (Thorman and others, 2003). Based on M. Meremonte’s account and the unit description of Thorman and others (2003), the source rock was likely interbedded volcanic tuff, fluvially reworked tuff, and conglomerate.

Figure 3. Rock falls related to the Wells earthquake, showing (A) dislodged boulder (approximately 2 m high and 3 m wide) north of Wells (courtesy of M. Meremonte, U.S. Geological Survey); view is to the southeast; and (B) cobbles and boulders southwest of Wells along Secret Pass road in the East Humboldt Range. Photographs taken February 23 (A) and 22 (B), 2008.

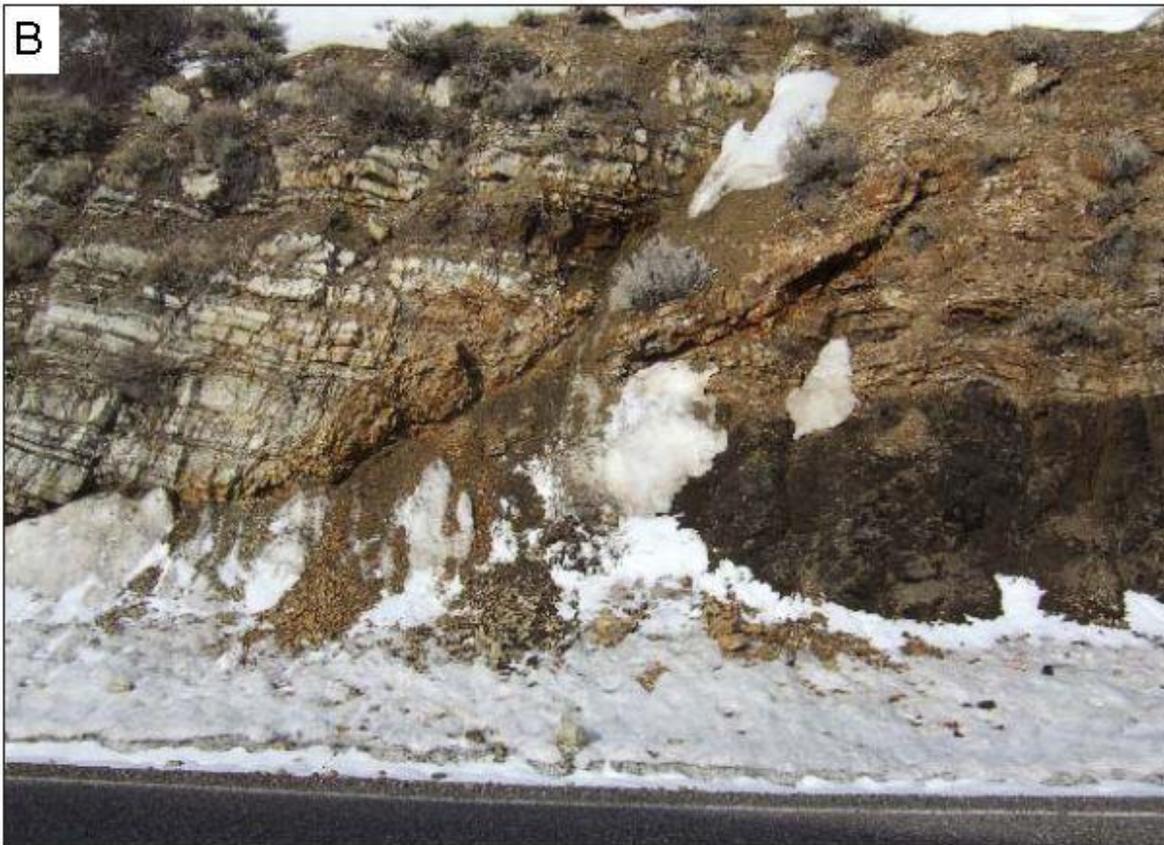
About 45 km southwest of the Wells earthquake epicenter, we observed minor rock falls along the Secret Pass road in the East Humboldt Range (figures 1 and 3b). The rock falls typically consisted of one to four boulders generally having maximum dimensions of 20 to 30 cm. At one location, we observed two small rock-fall debris cones deposited on snow. We infer that seismic shaking from the Wells earthquake caused the rock falls as they were deposited on snow that fell a few days prior to the earthquake.

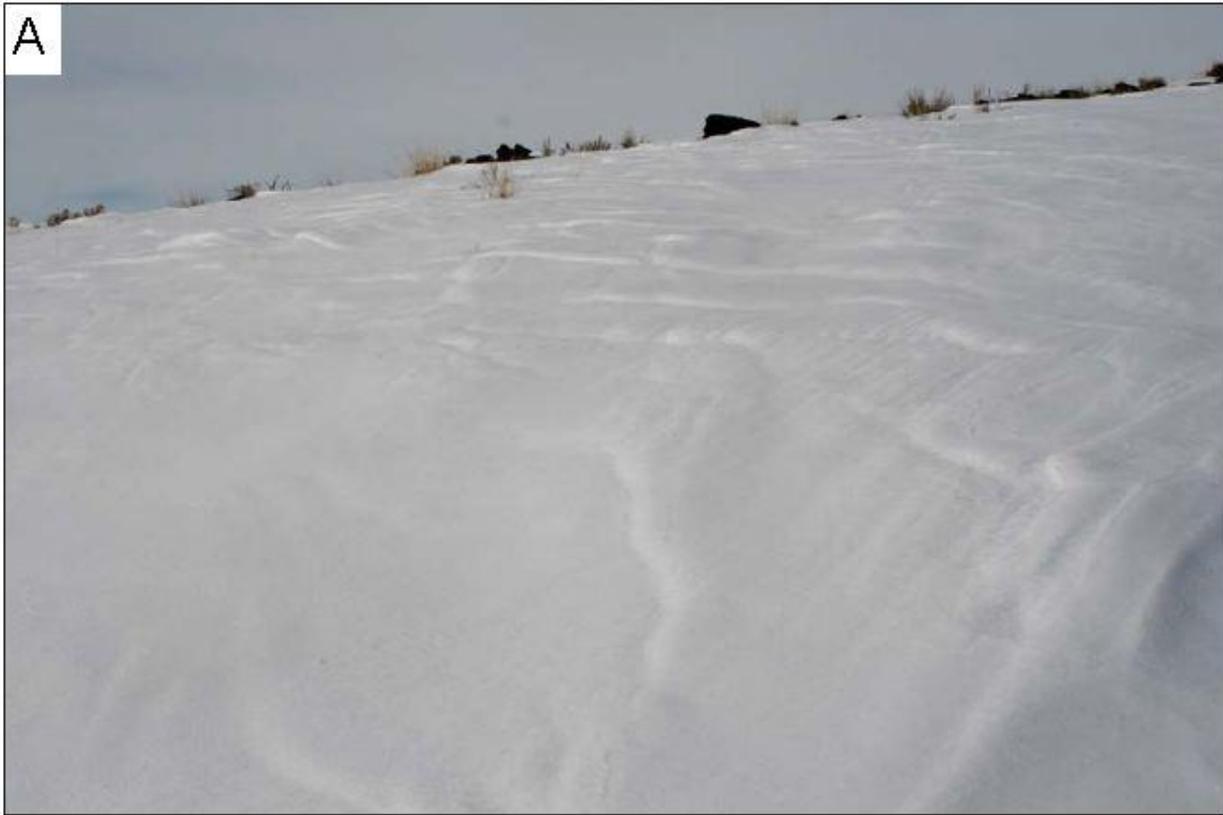
We found limited evidence for shaking-related disturbance of snow deposits in the epicentral region. About 4 km northeast of the epicenter, near the northern terminus of the FWWP (figure 1), we found sloughed snow on steep south-, east-, and west-facing hillslopes. Numerous small fractures, spaced 10 to about 50 cm apart (figure 4a) in snow 4 to 30 cm thick, were present on most of the hillslopes. The fractures were concentrated in the upper parts of the slopes, suggesting that the snow deposits failed and moved slightly. We also observed a failed deposit of wind-blown snow along a north-facing railroad cut slope about 5 km southeast of the epicenter (figure 4b). We did not observe any other sloughed-snow features in or outside of the epicentral area, and thus interpret these features as evidence of relatively strong seismic shaking.

Figure 4. Snow disturbed in the Wells earthquake, showing (A) fractures, spaced about 10 to 50 cm apart, on a hillslope northeast of the epicenter; and (B) a failed deposit of wind-blown snow along a north-facing railroad cut slope southeast of the epicenter. Photographs taken February 27 (A) and 28 (B), 2008.
