# **An Introduction to the February 21, 2008, $M_w$ 6.0 Wells Nevada Earthquake and the Earthquake Documentation Volume**

Craig M. dePolo  
Nevada Bureau of Mines and Geology  
University of Nevada, Reno

2011

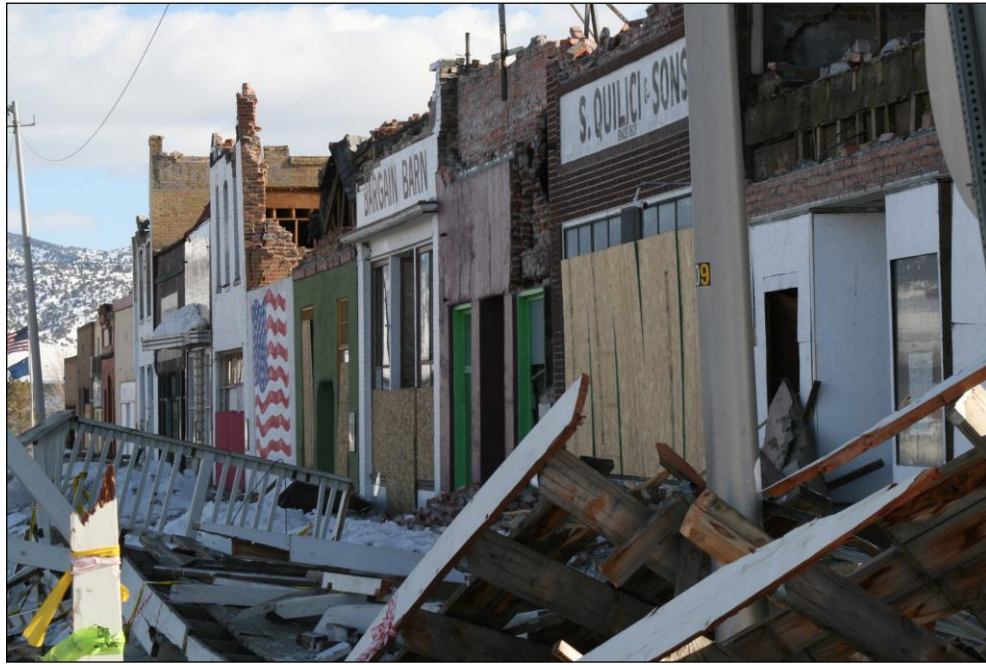
**Figure 2.** Wells historical district, where several unreinforced masonry buildings were damaged by the 2008 earthquake.

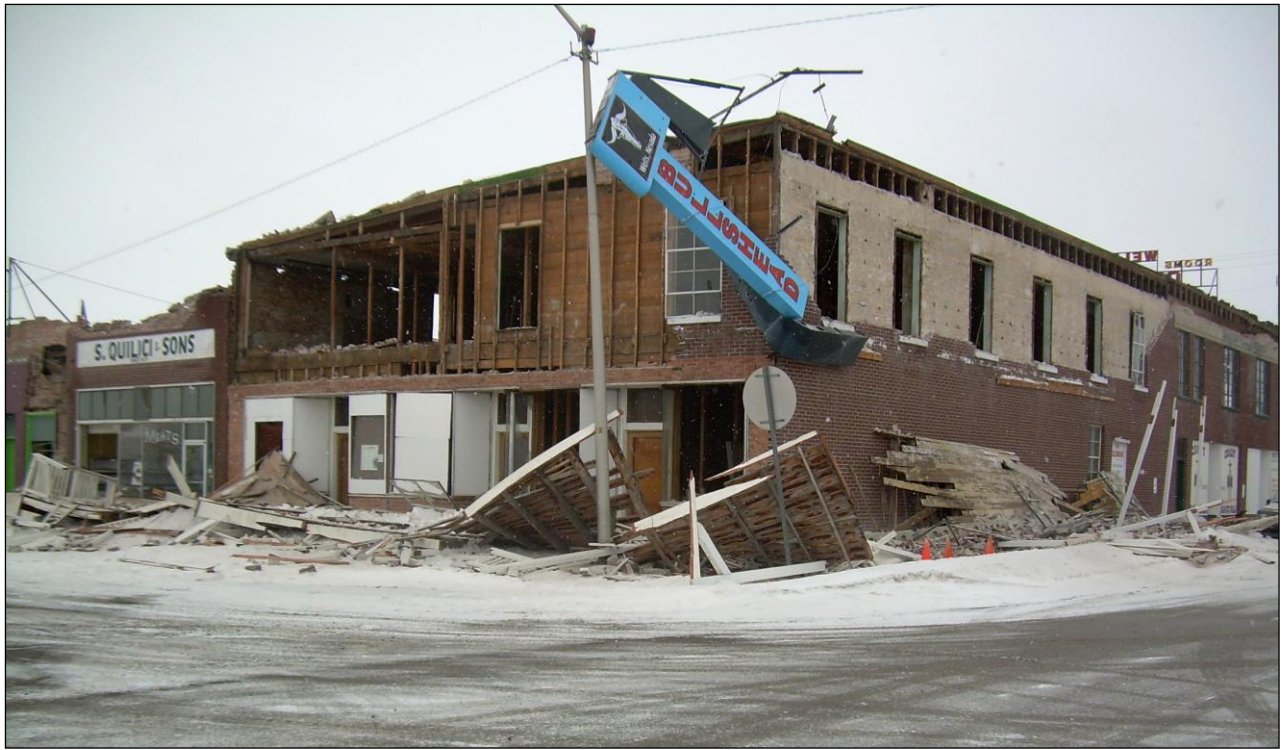
**Figure 7.** Damage to the Bullshead Bar from the 2008 Wells earthquake. Brick veneer fell from the second story along with a crowning concrete bond beam, which both smashed the balcony to the ground. *Photograph by Nick Stake.*

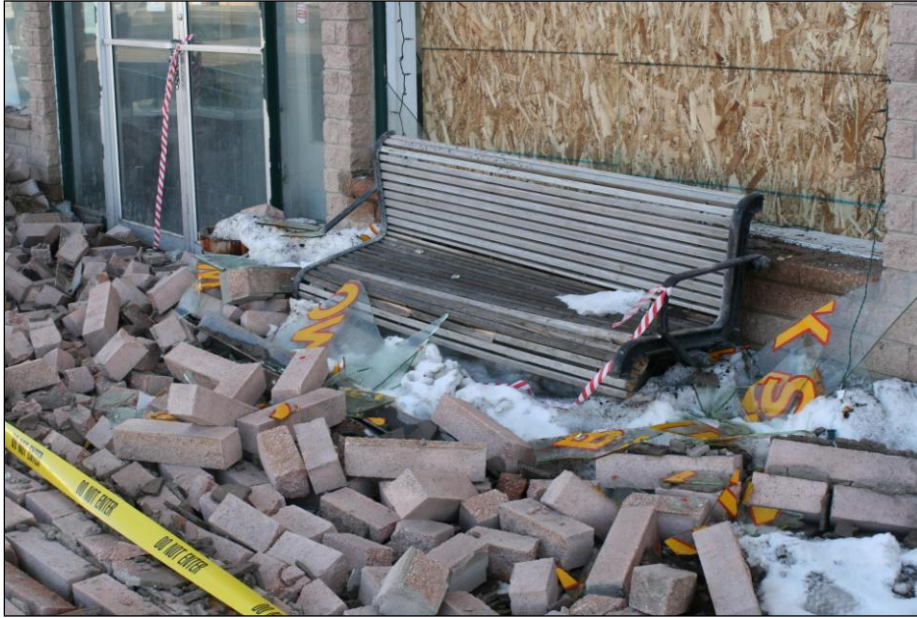
**Figure 9.** Bricks from an unreinforced veneer and broken glass from the front plate glass window are strewn about a bench on the sidewalk and the building's exit in front of the Overland Hotel. The early morning time of the earthquake helped prevent more injuries and possible deaths.

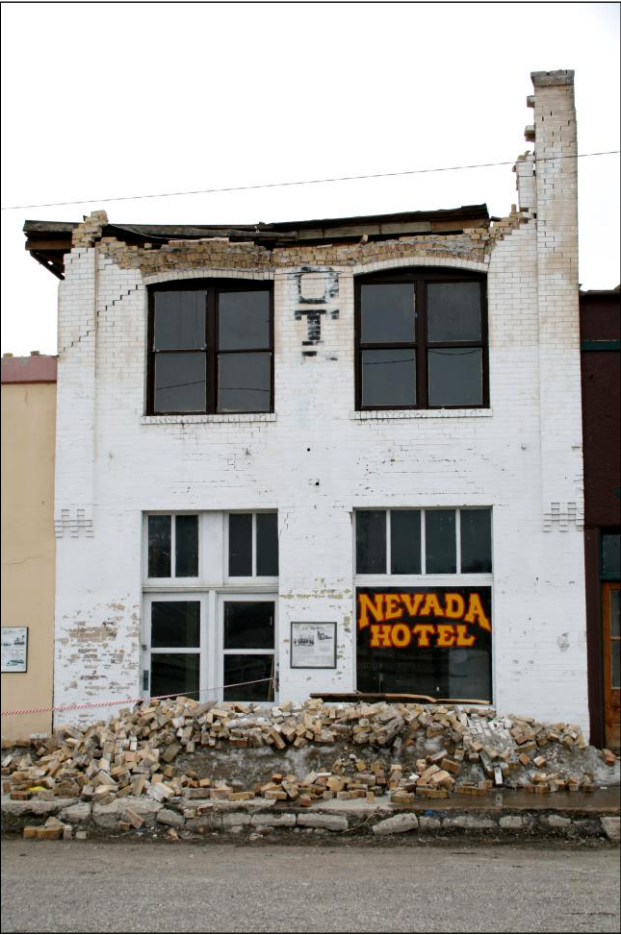
**Figure 10.** Partial collapse of the Nevada Hotel. Nearly all of the upper parts of the walls and parapets failed, dropping the roof down on the second story ceiling. Many bricks fell across the front exit of the hotel. Remarkably, for all this damage caused by shaking, none of the windows are broken.

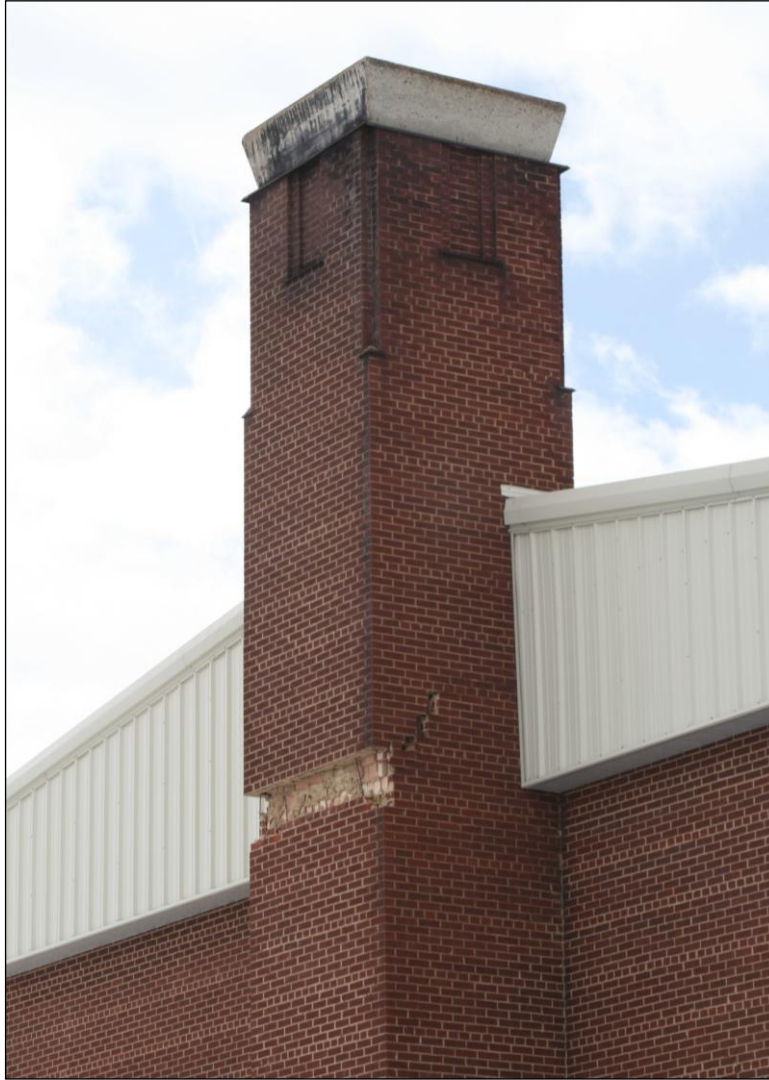
**Figure 11.** Large chimney on side of the Wells High School auditorium that was cracked from the earthquake. Note the bricks that were thrown out as the top of the chimney was cocked back towards the building from the shaking.

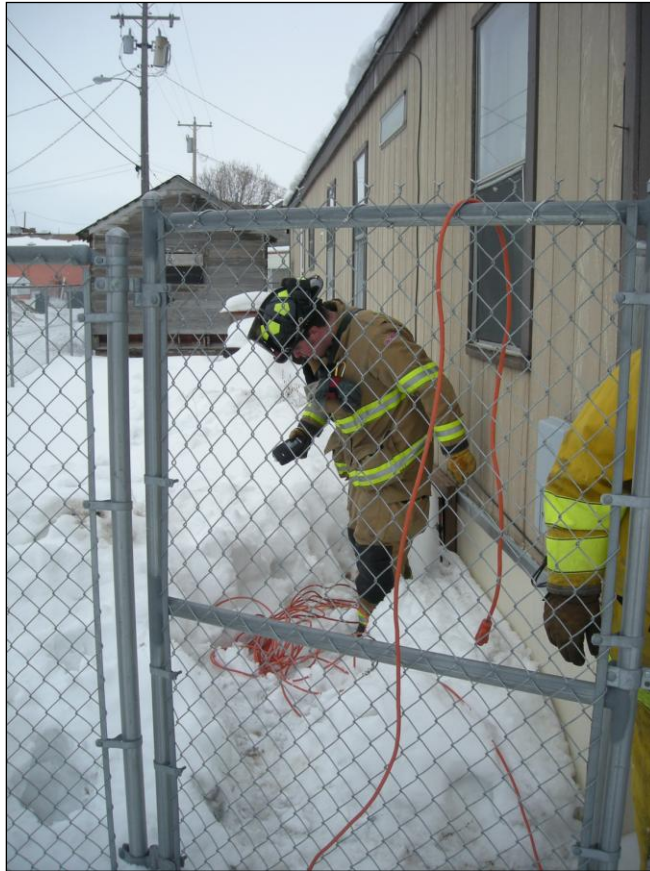
**Figure 12.** Firemen check for leaking gases from a manufactured building that had shifted on its blocks. *Photograph by Wells resident.*

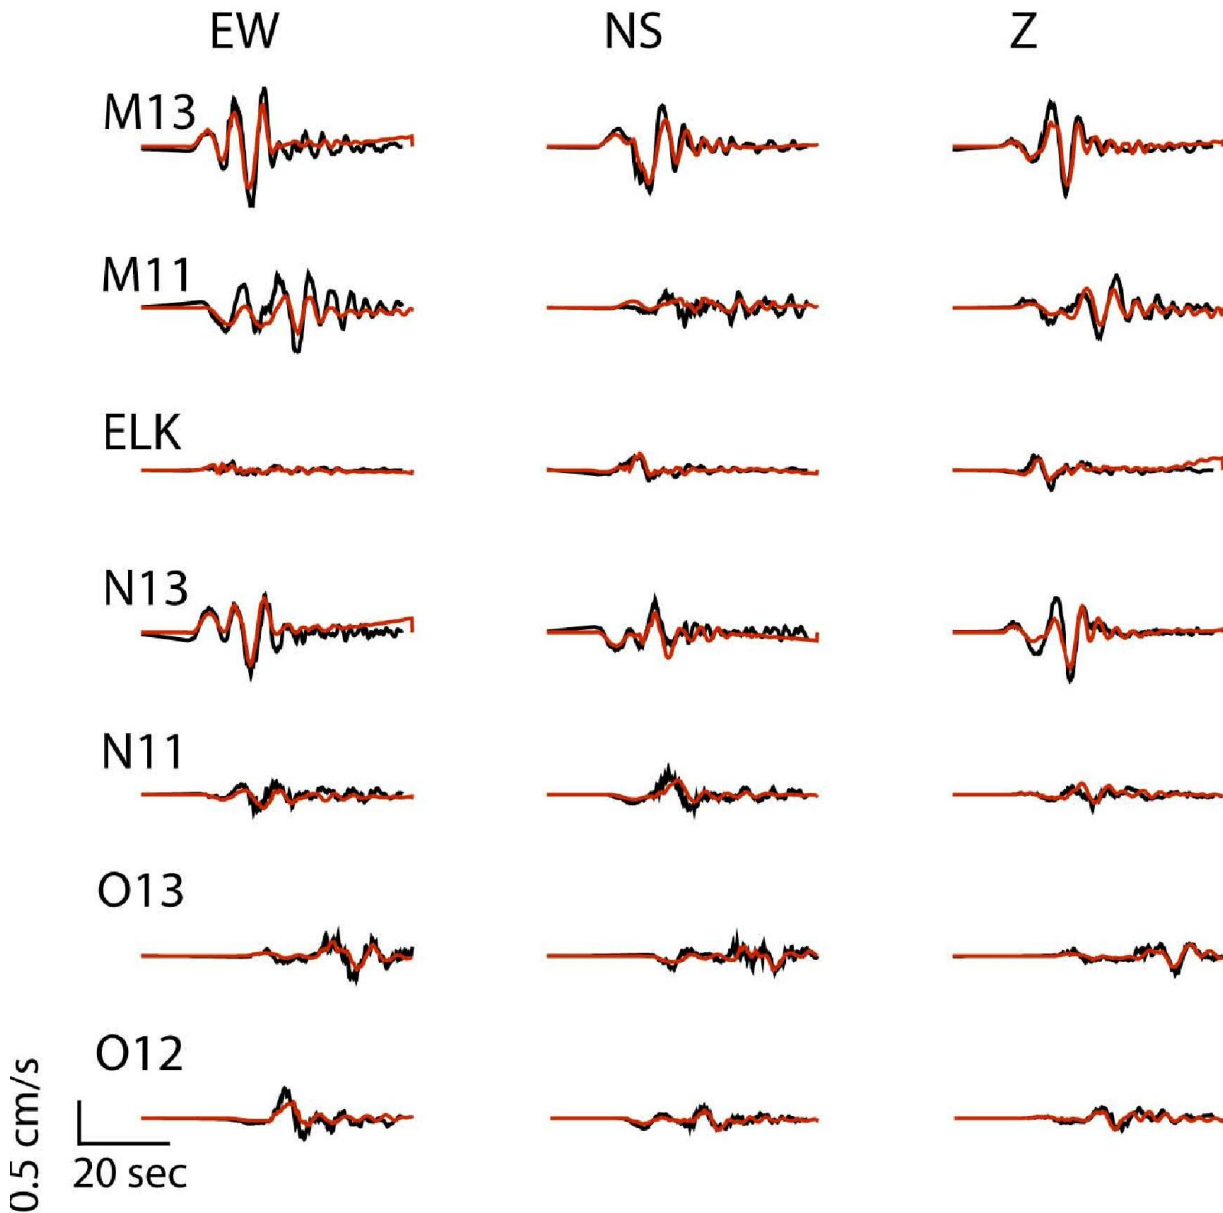
**Figure 16.** Seismic waves from stations used in modeling the earthquake source by Dreger and others (this volume). The black lines are the recorded seismograms and the red lines are the wave results from the modeled earthquake source shown in figure 17 (please see Dreger and others for further information). The closer the red modeled waves are to the black recorded waves, the more likely the earthquake model is correct. Generally only the main forms of the wave can be modeled.

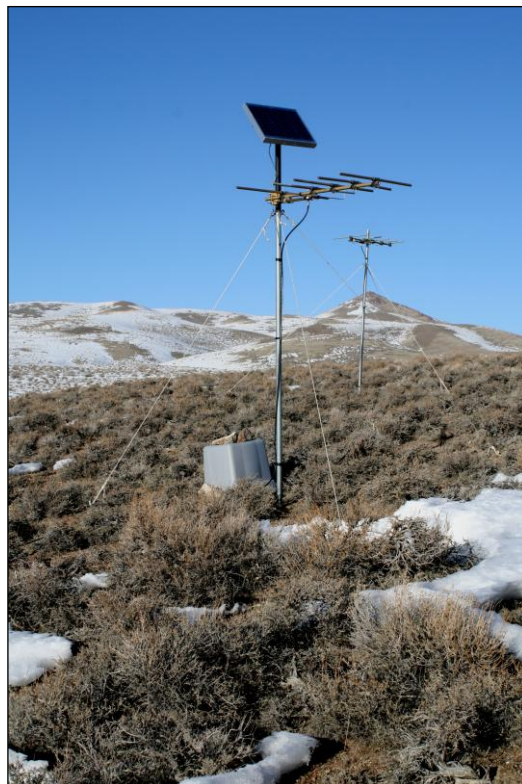
**Figure 20.** Temporary seismic array station with transmission antennas installed to record aftershocks from the Wells earthquake. These stations are used to precisely locate the aftershocks and also to provide the characteristics of ground motion at the site.

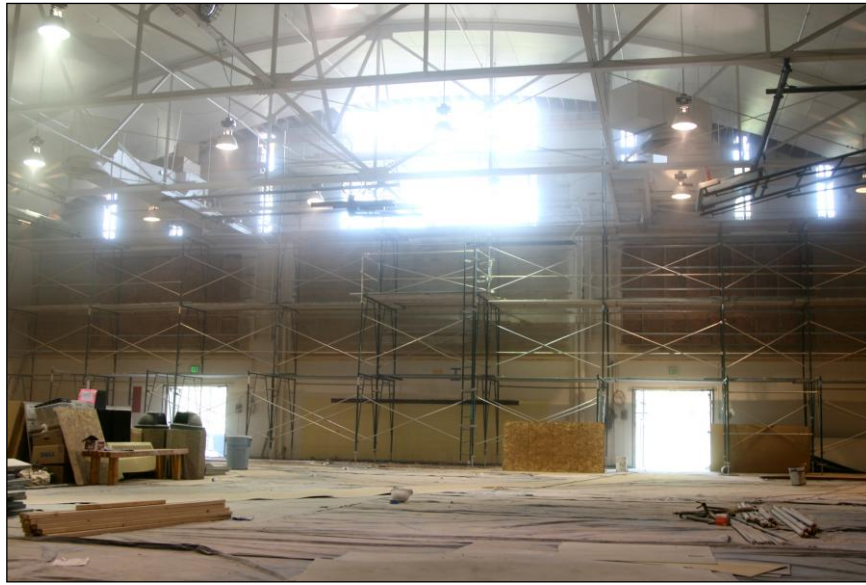
**Figure 21.** Reconstruction of the Wells High School gymnasium. This will be a safer building for the high occupancy the gym occasionally has during any future earthquakes.

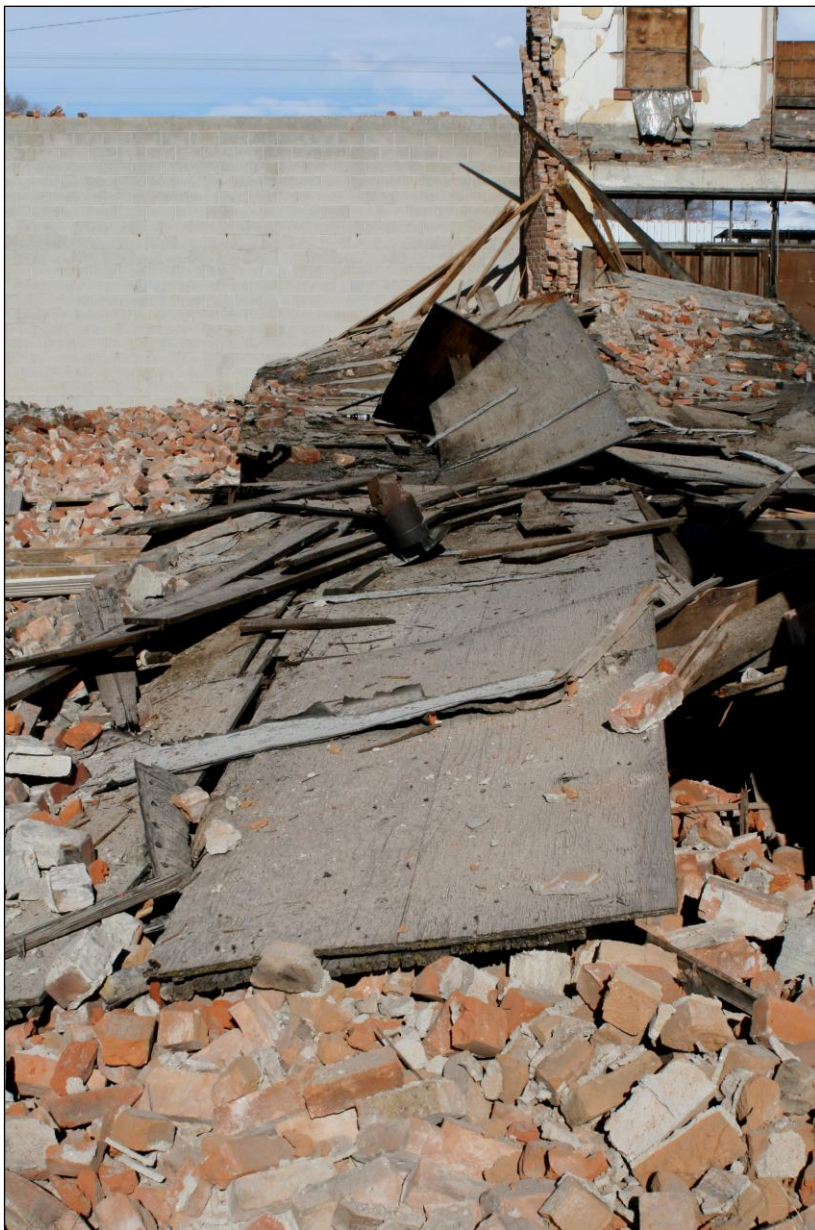
**Figure 25.** The roof of the unreinforced masonry San Marin Hotel lies on top of the second story floor and the collapsed and disintegrated two-story western wall.

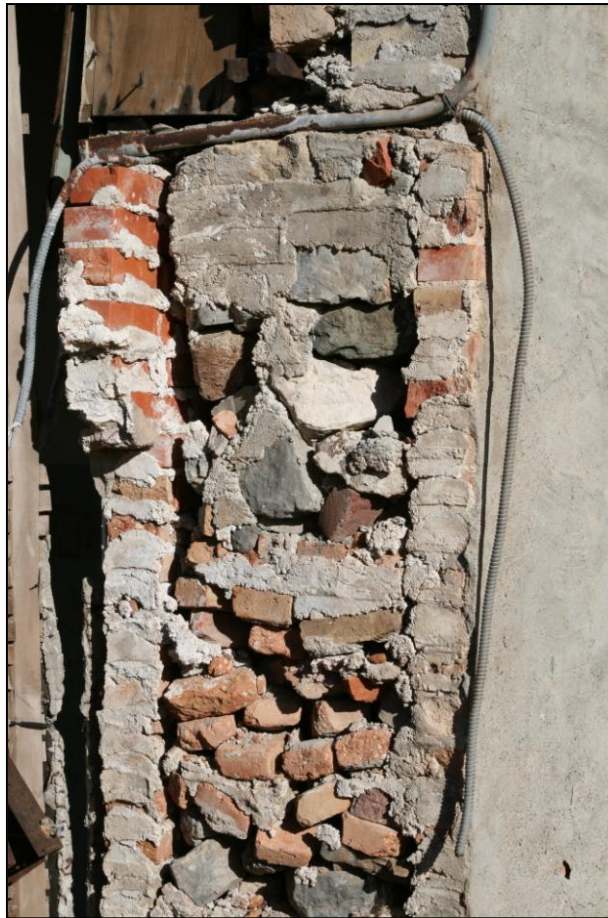
**Figure 26.** A damaged wall exposed a rubble infill of broken bricks and rocks with intermittent mortar dumped in, all hidden behind a single thickness of laid brick wall. This kind of construction offers an uncertain performance during an earthquake.

parapets. In addition, many poor construction practices were evident in the damage. These included lack of cross-tying of brick courses together (header courses), rubble infill walls, unlaidd bricks in the central parts of walls, lack of mortar between bricks—particularly along vertical faces, and only partially filled concrete block columns that should have been completely filled to support the weight of ceiling beams. Poor building materials were also observed in damaged buildings, such as unfired bricks and rocks with rounded edges thrown in the rubble infilling of walls (figure 26). The maintenance and condition of the buildings also seemed to be a factor. Prior to the earthquake, some buildings had been unoccupied for decades, were not maintained, and had developed weakened parts, such as mortar between bricks that had been eroded away and partially collapsed areas.
