Seismic Risk of Unreinforced Masonry Buildings in Nevada

Craig M. dePolo

Nevada Bureau of Mines and Geology

September 10, 2019

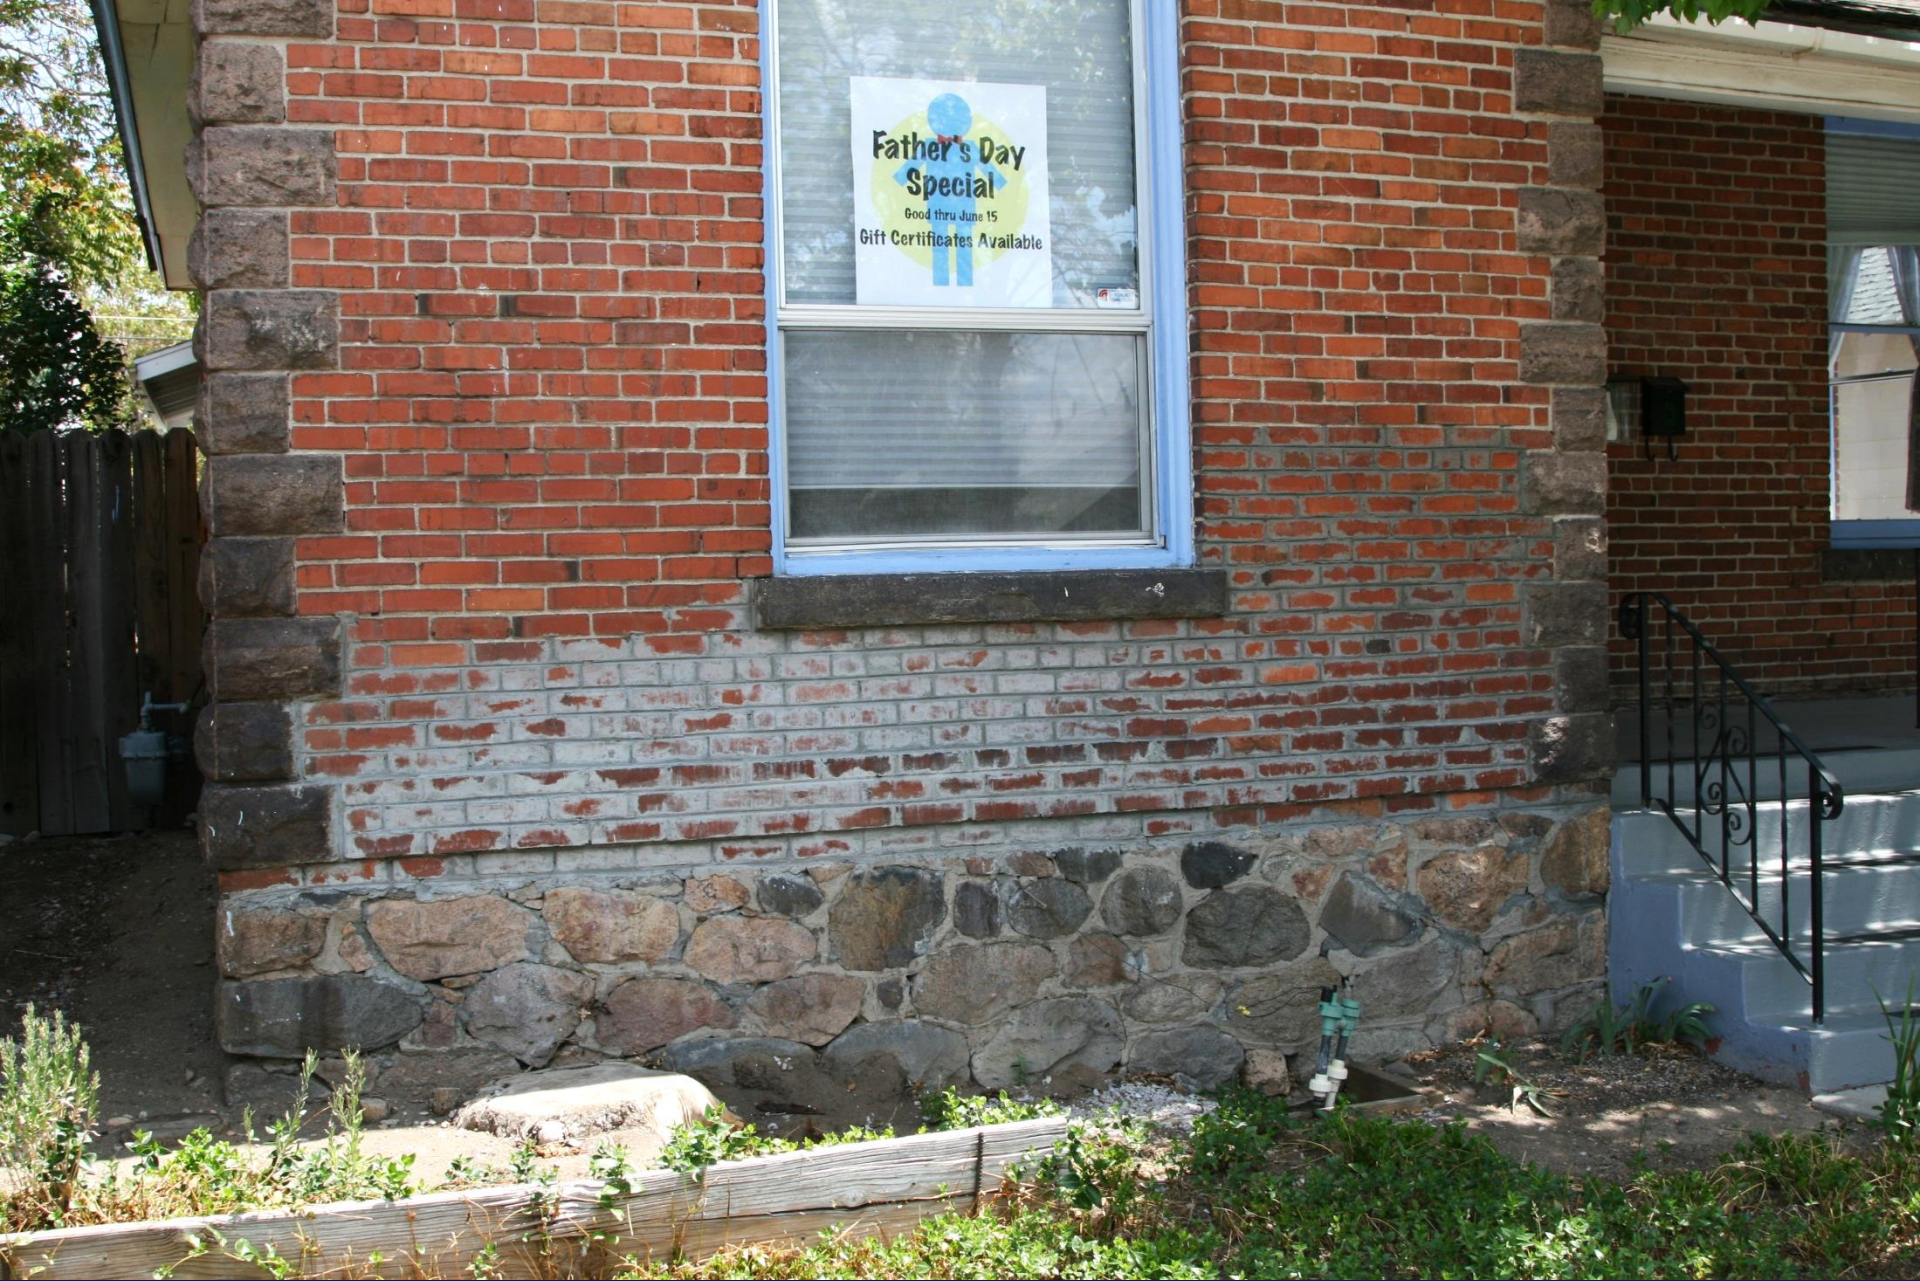
Rock rubble foundation; every 8th brick course in on end to tie wall together

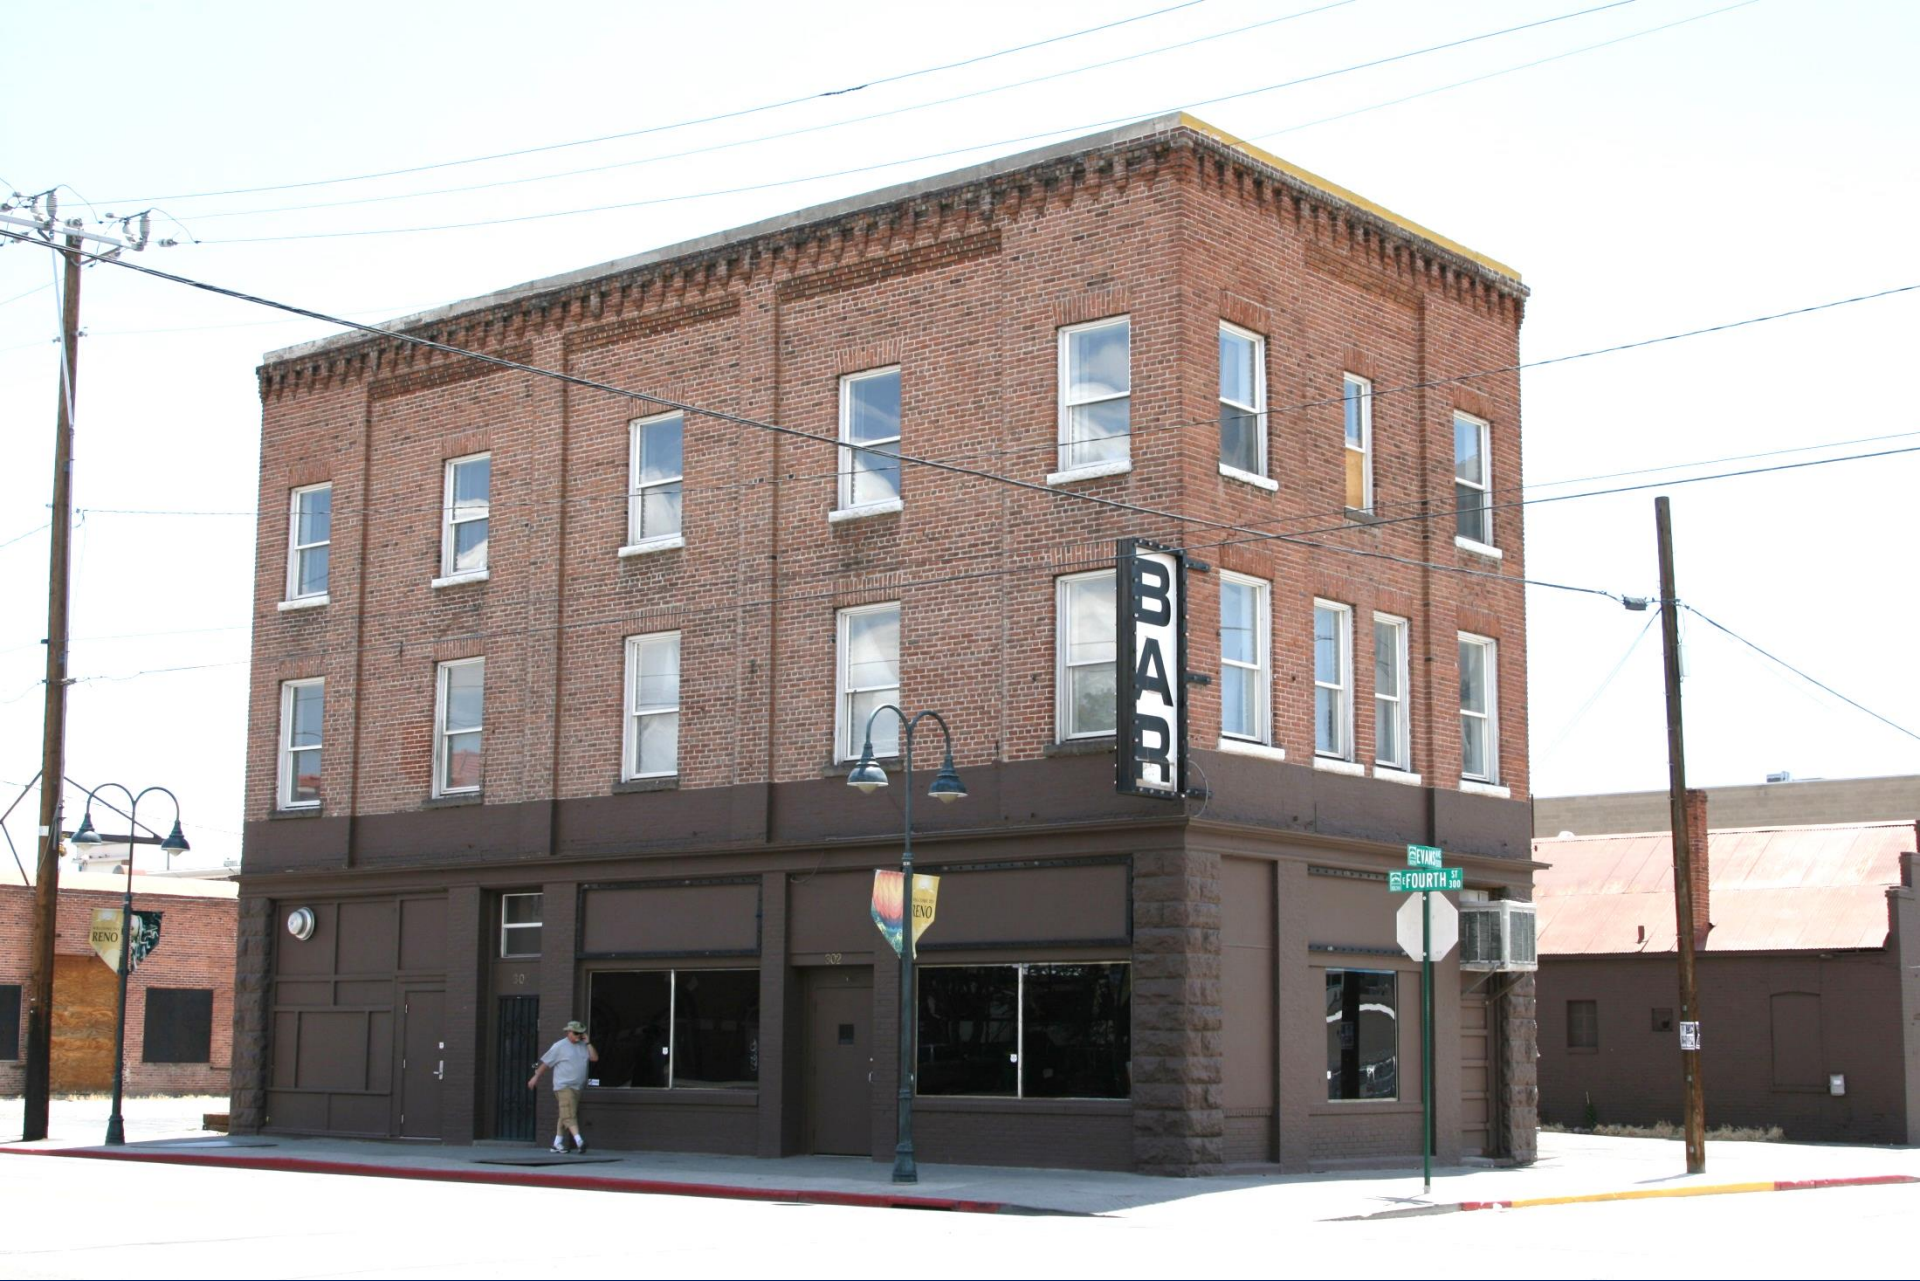
Three story URMB with some earthquake cracks; occupancy is variable

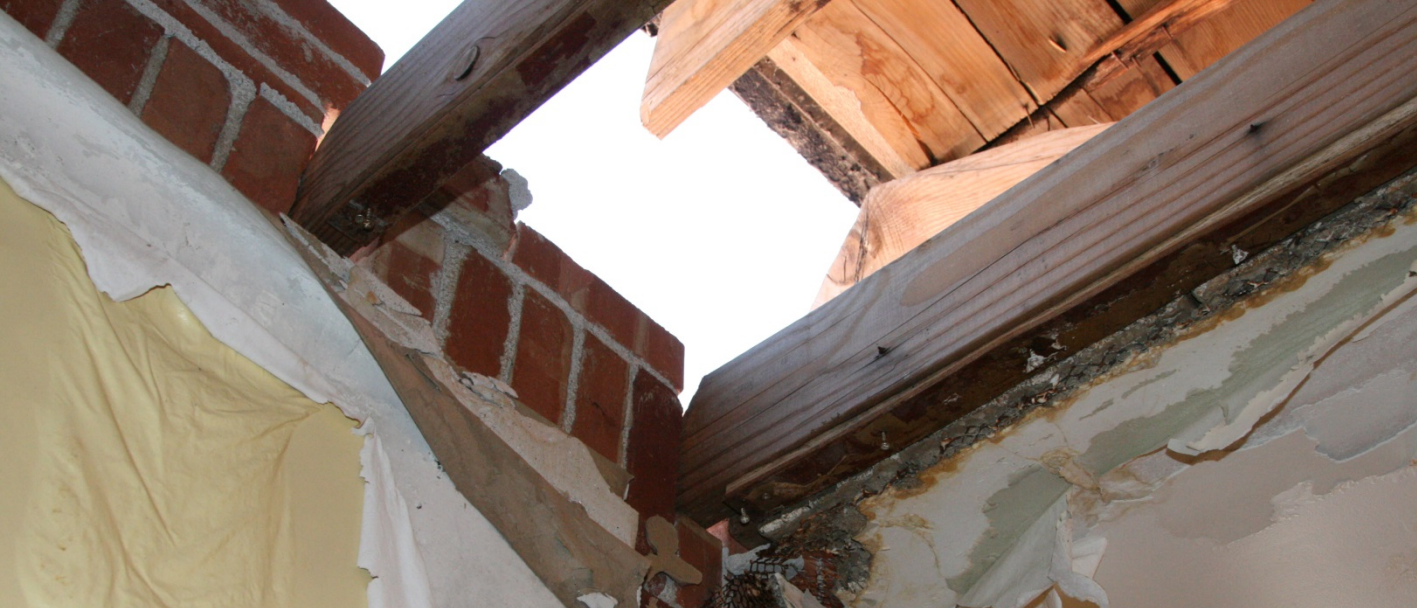
Ceiling joist pulling out of
wall socket; note diagonal
fire cut on end of beam

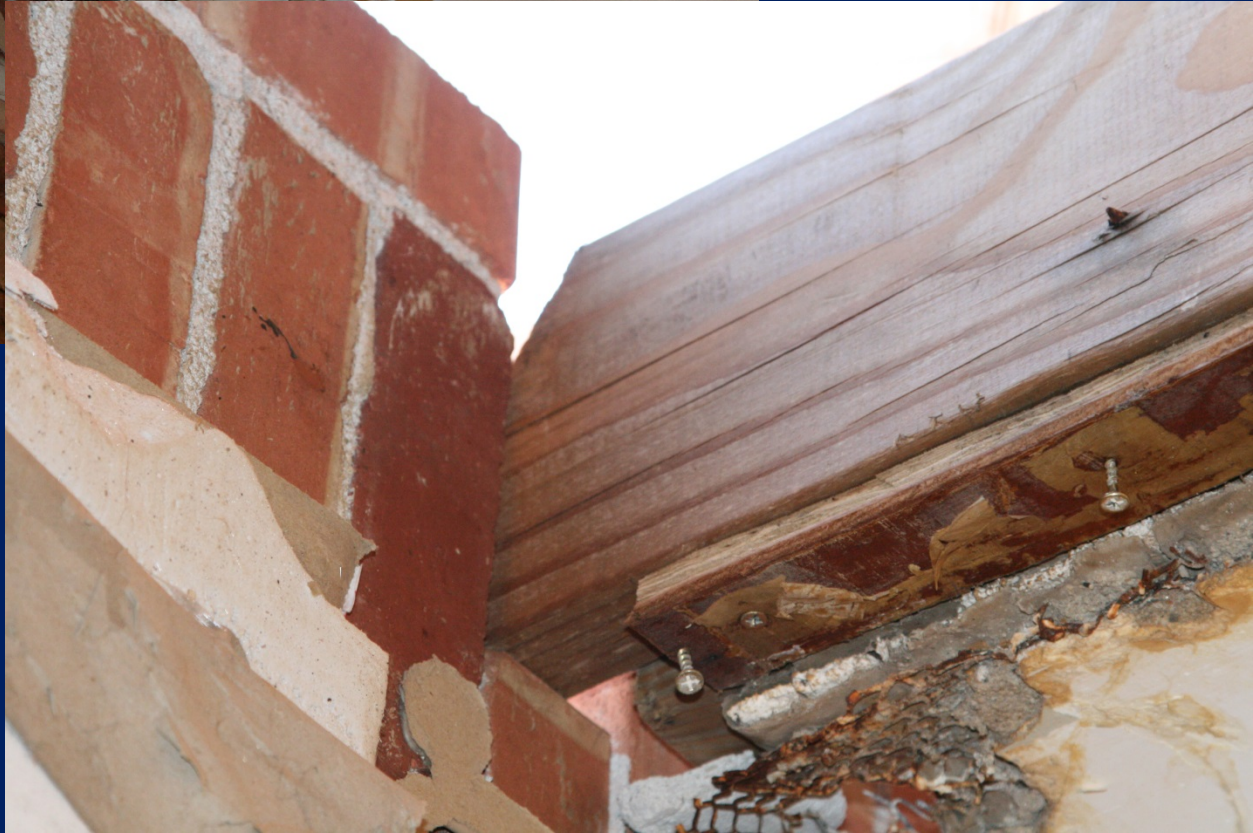
Below – Lincoln Hall has an air gap between the interior wall that holds up the floors and the outside wall that holds up the roof

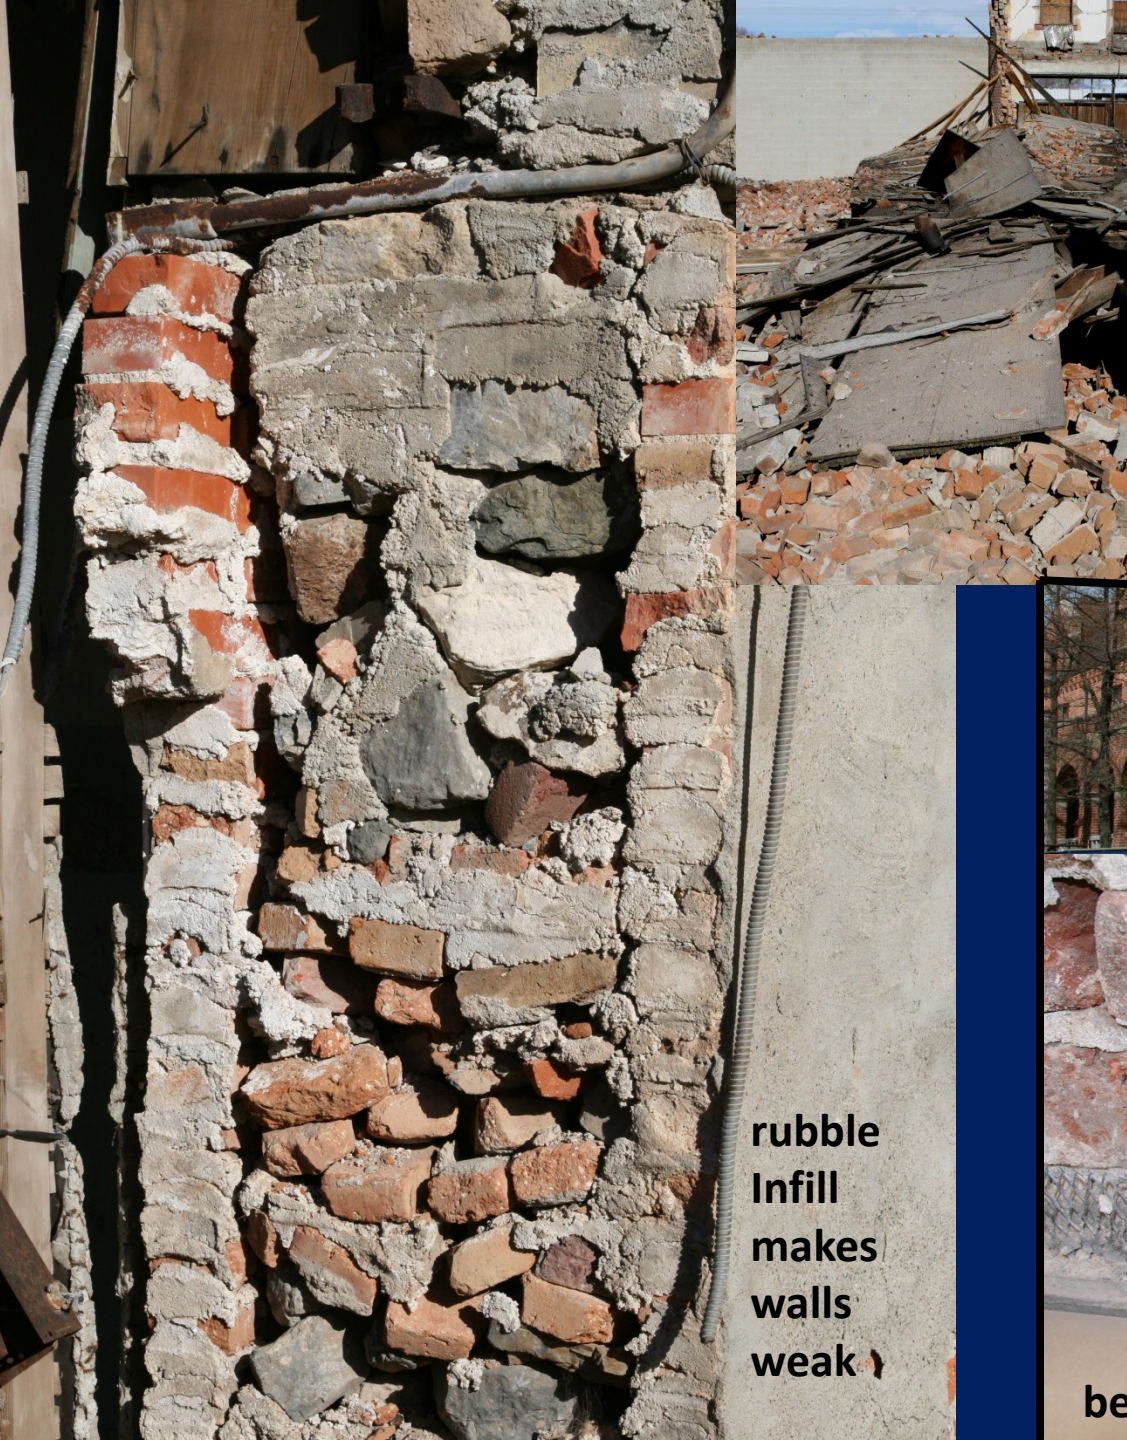
rubble
Infill
makes
walls
weak

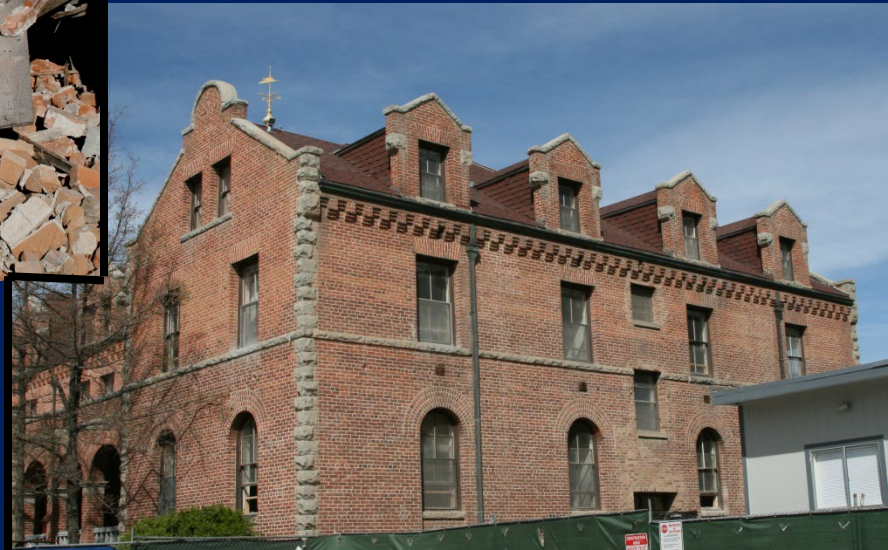
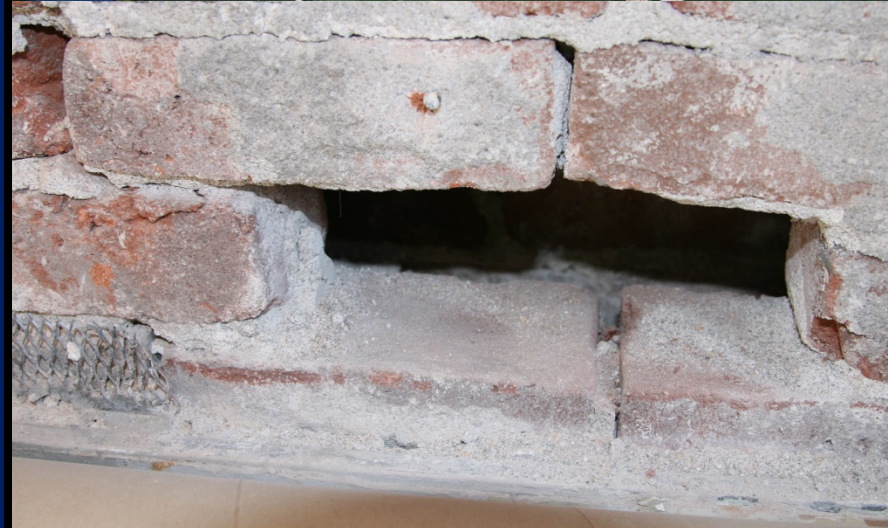
beyond interior brick wall is open space

Crowning bond beam failure

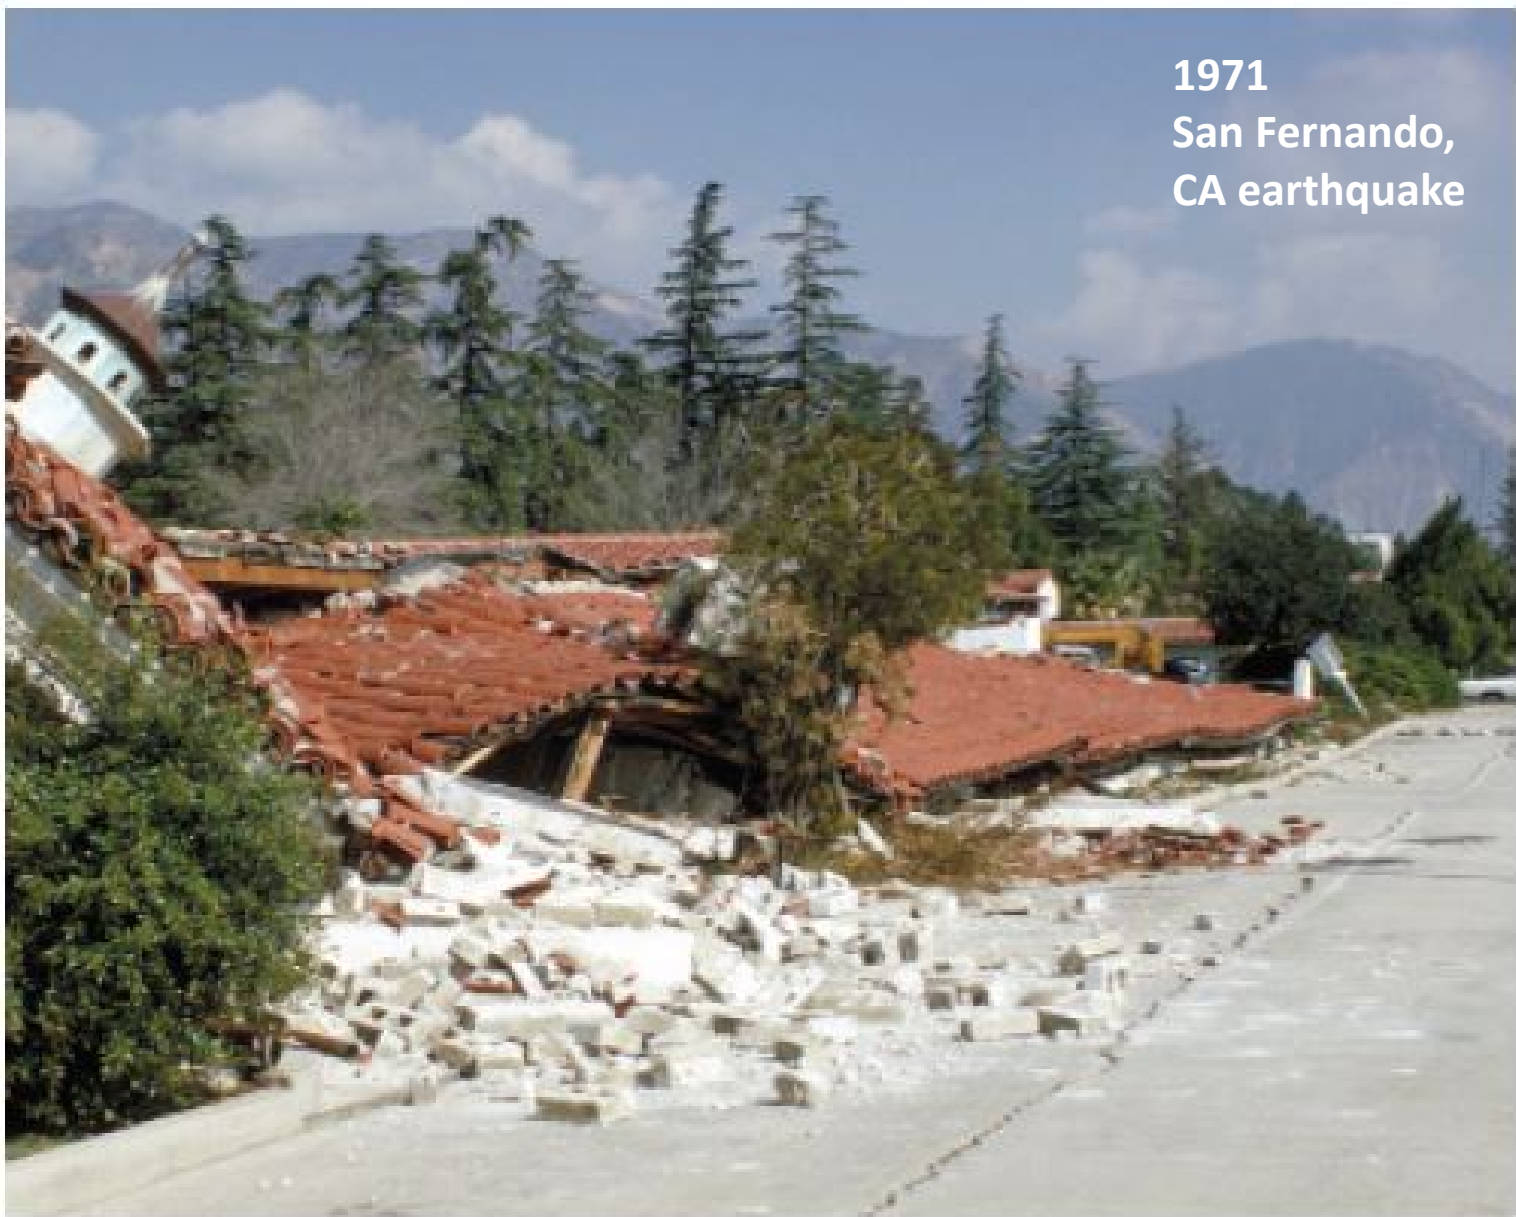
1971
San Fernando,
CA earthquake

CMU – concrete masonry unit – *unreinforced* cinder block buildings

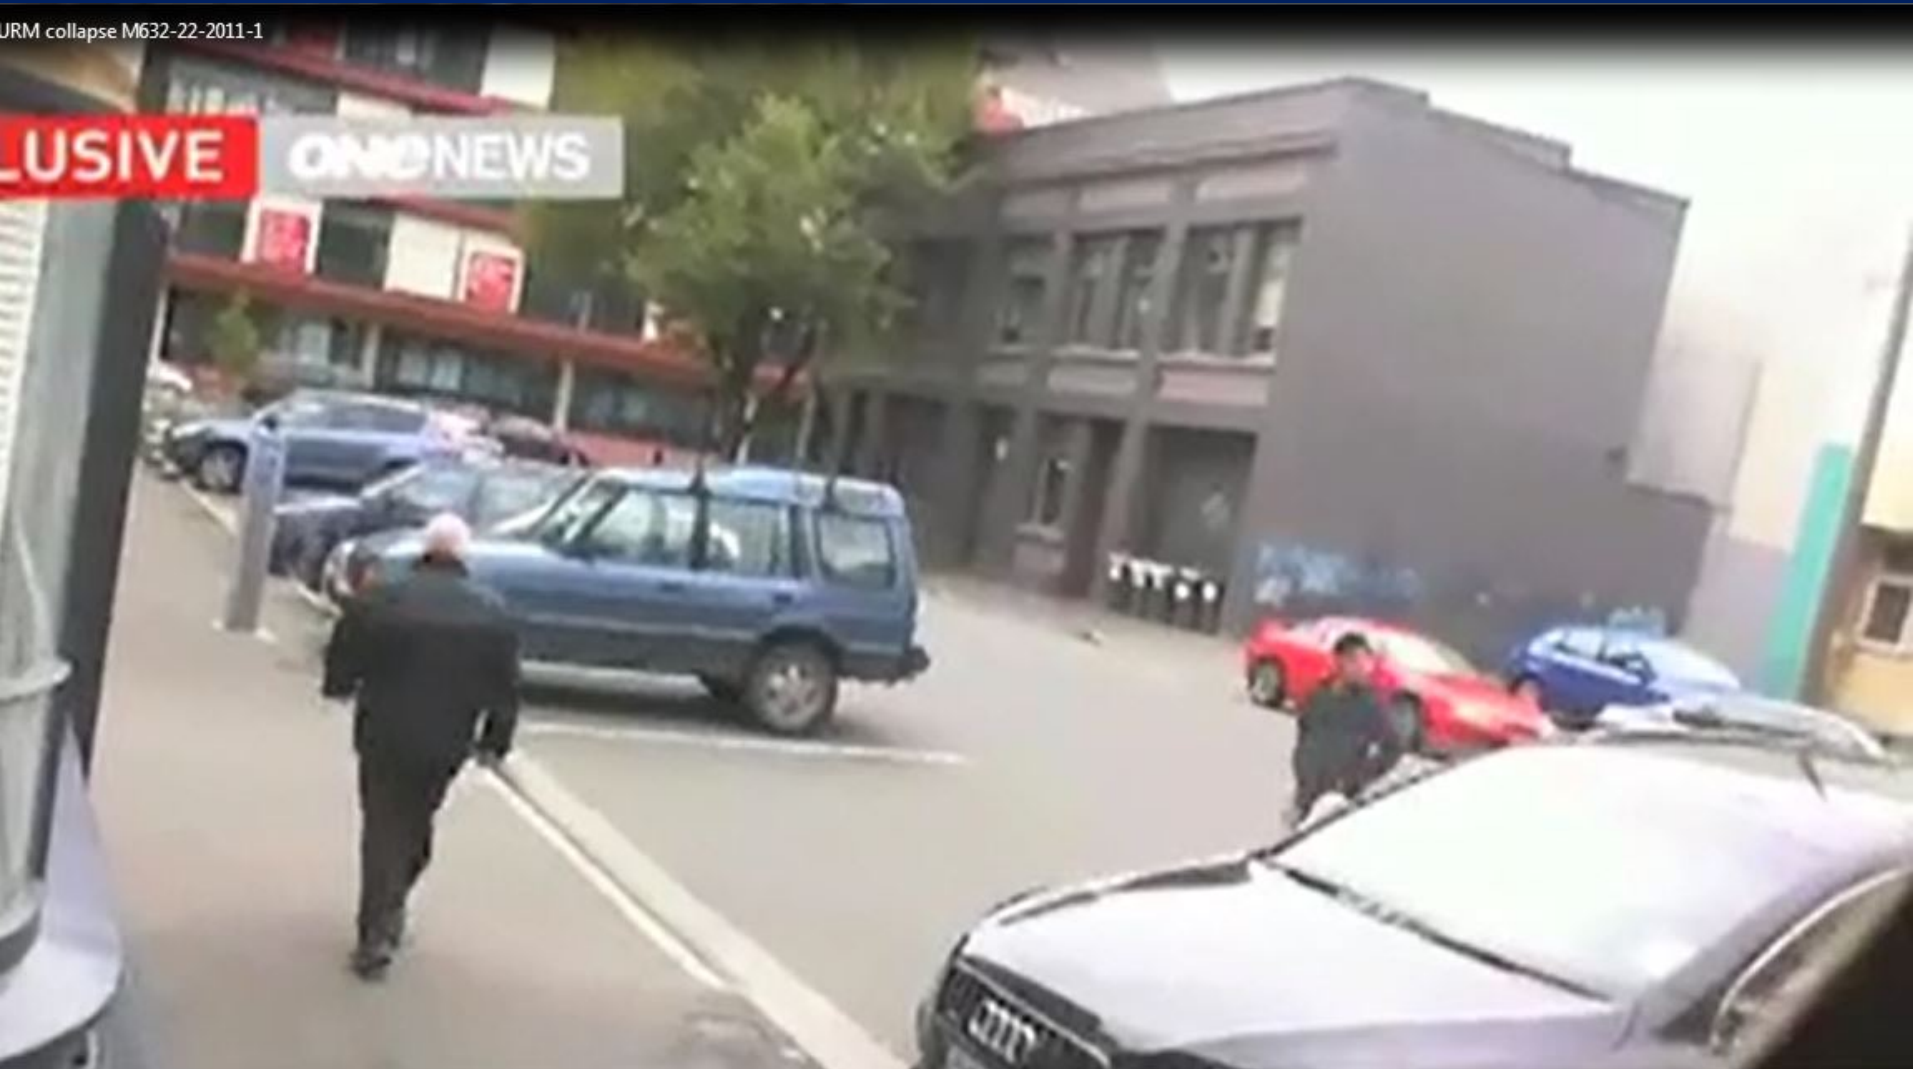
Brown URM (upper right quarter) immediately before the earthquake

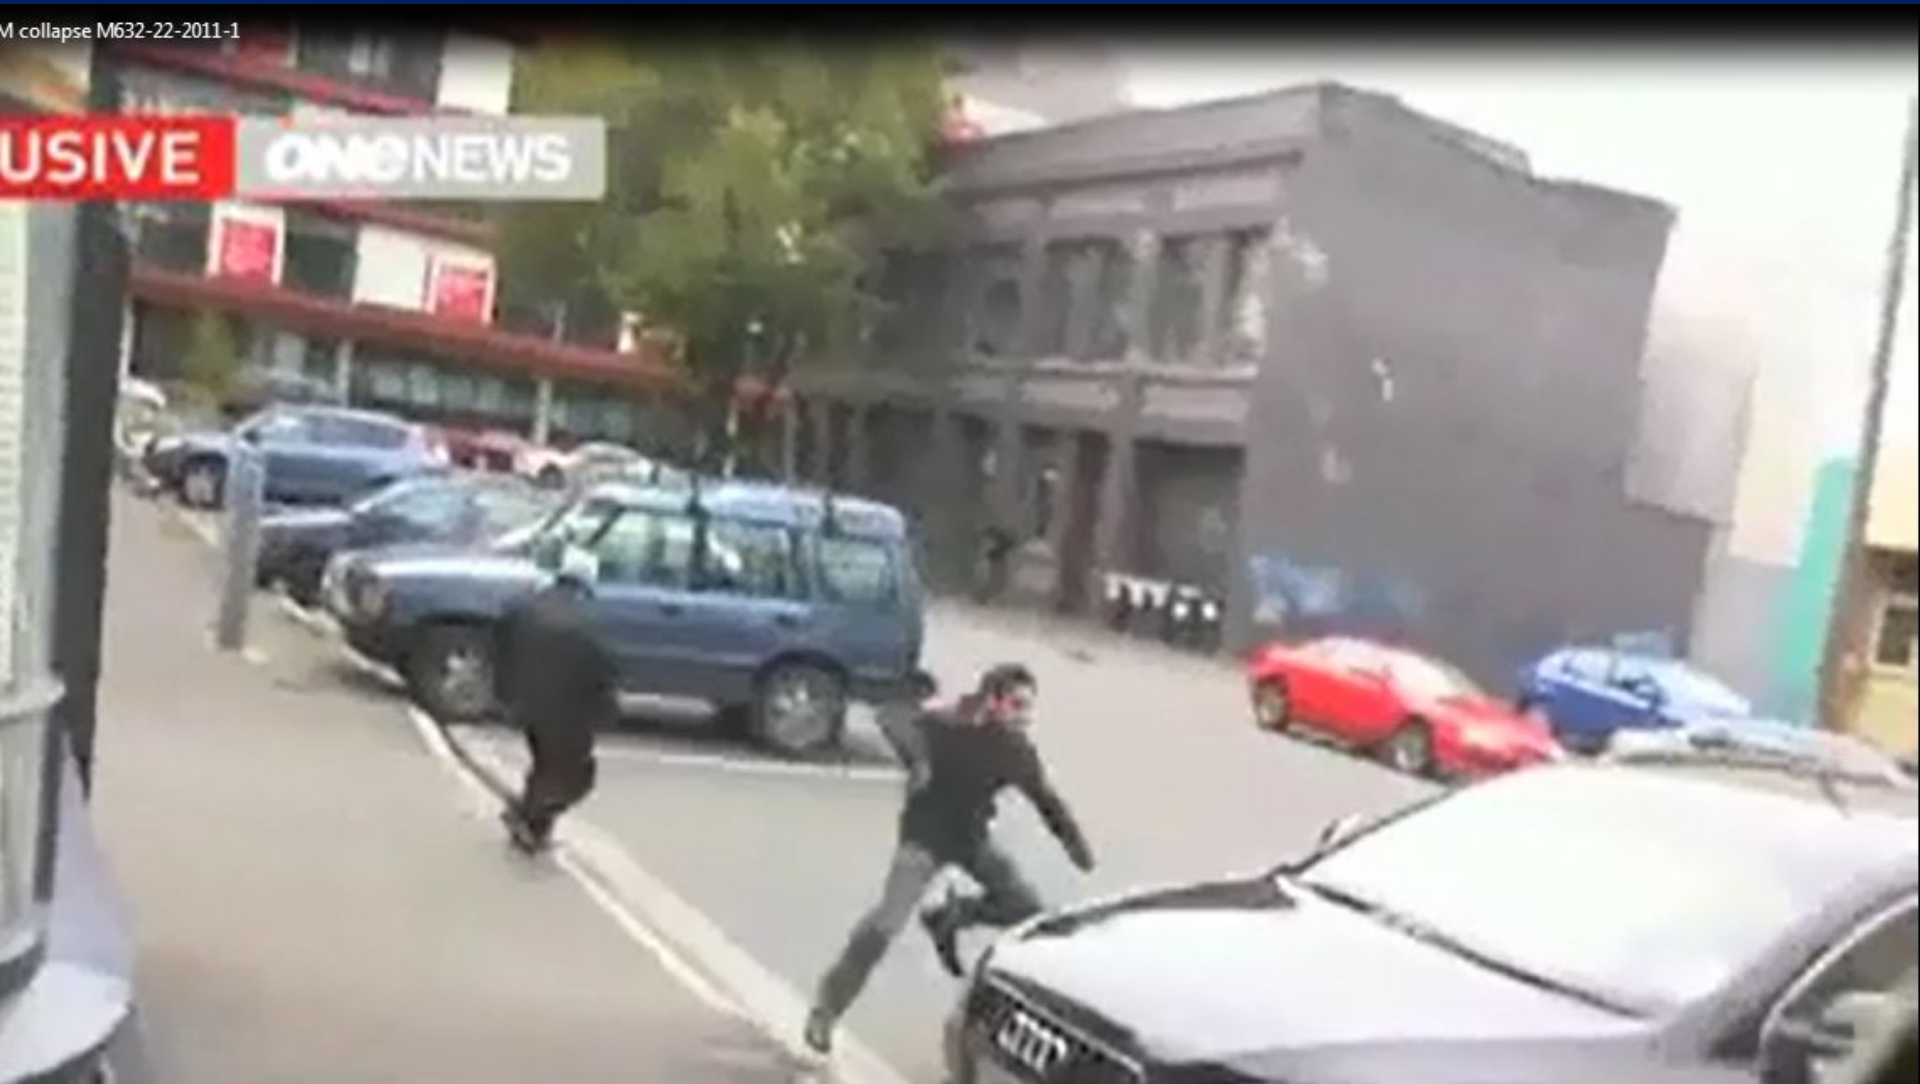
Near the beginning of the eq., people reacting, upper part of right-facing wall is starting to fall outwards from top. Some cracks are forming in this wall shown by dust.

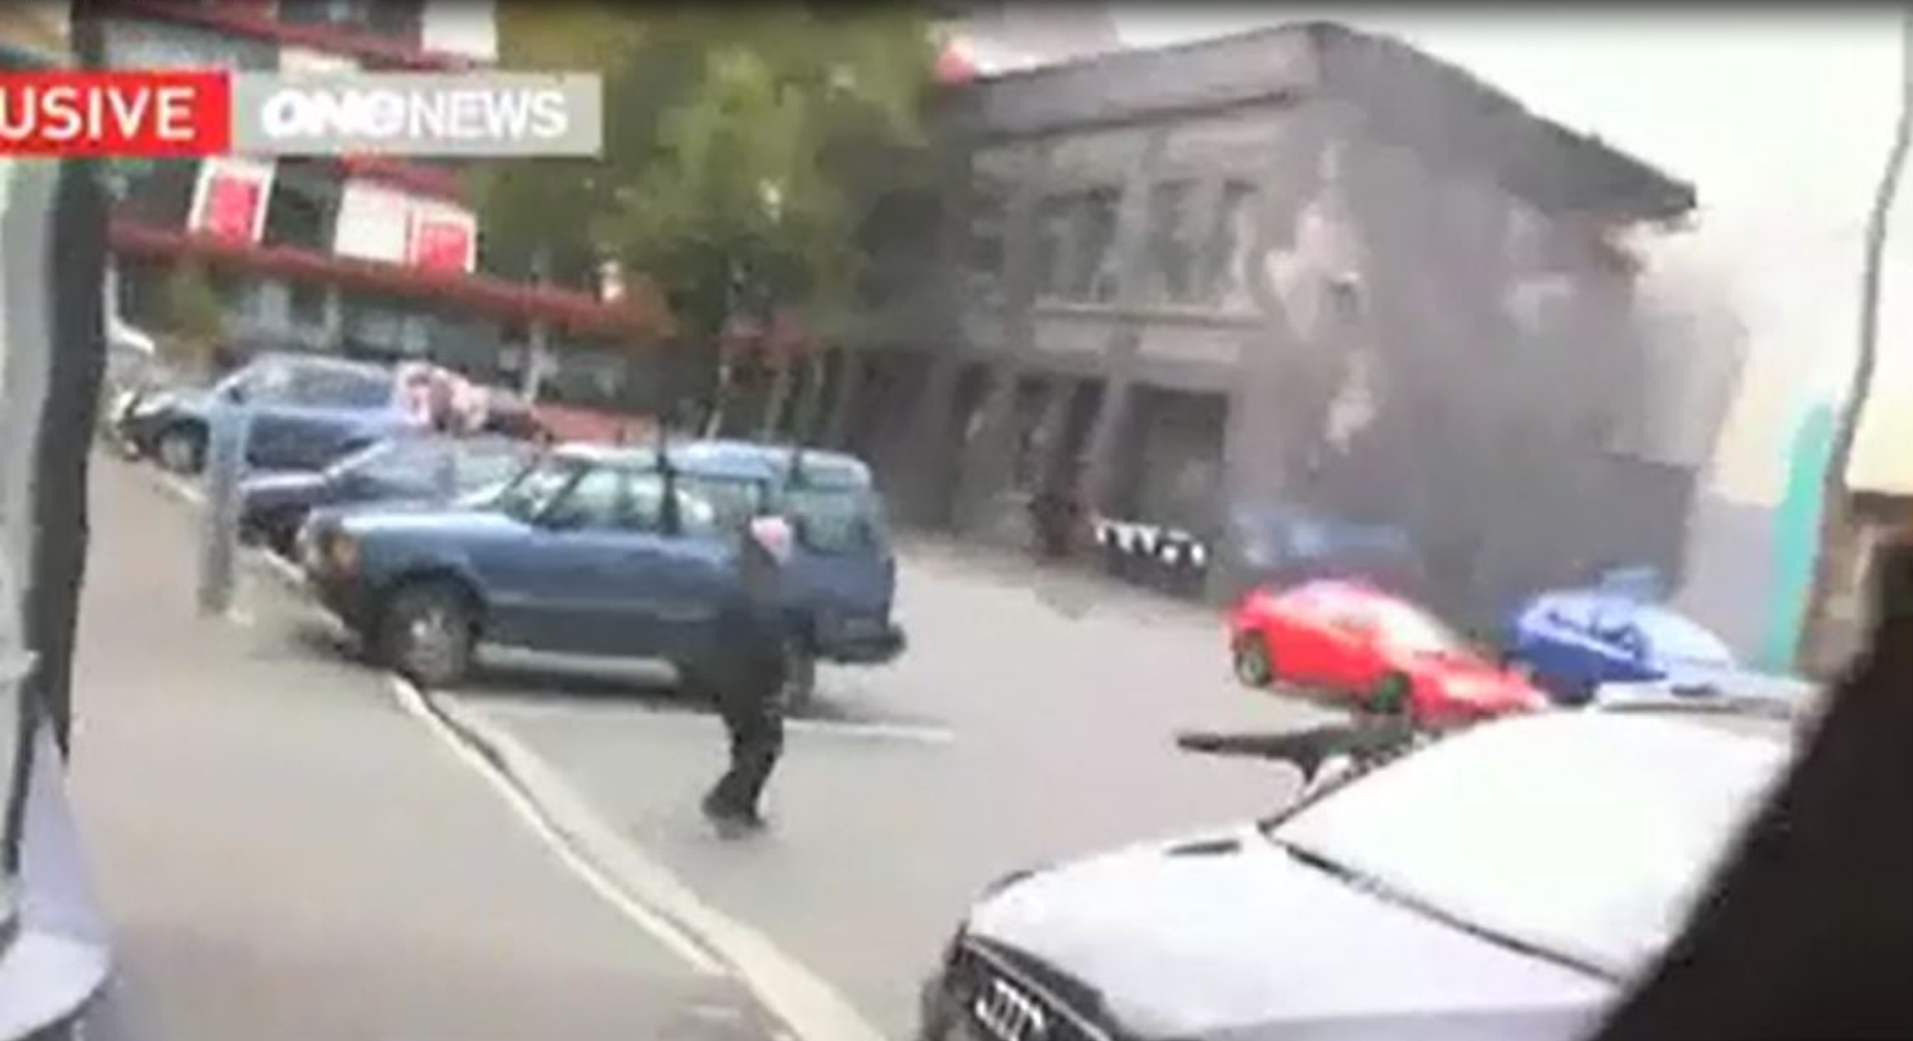
Upper part of right-facing wall has fallen out (above top ceiling joist) and is falling down the side of the building.

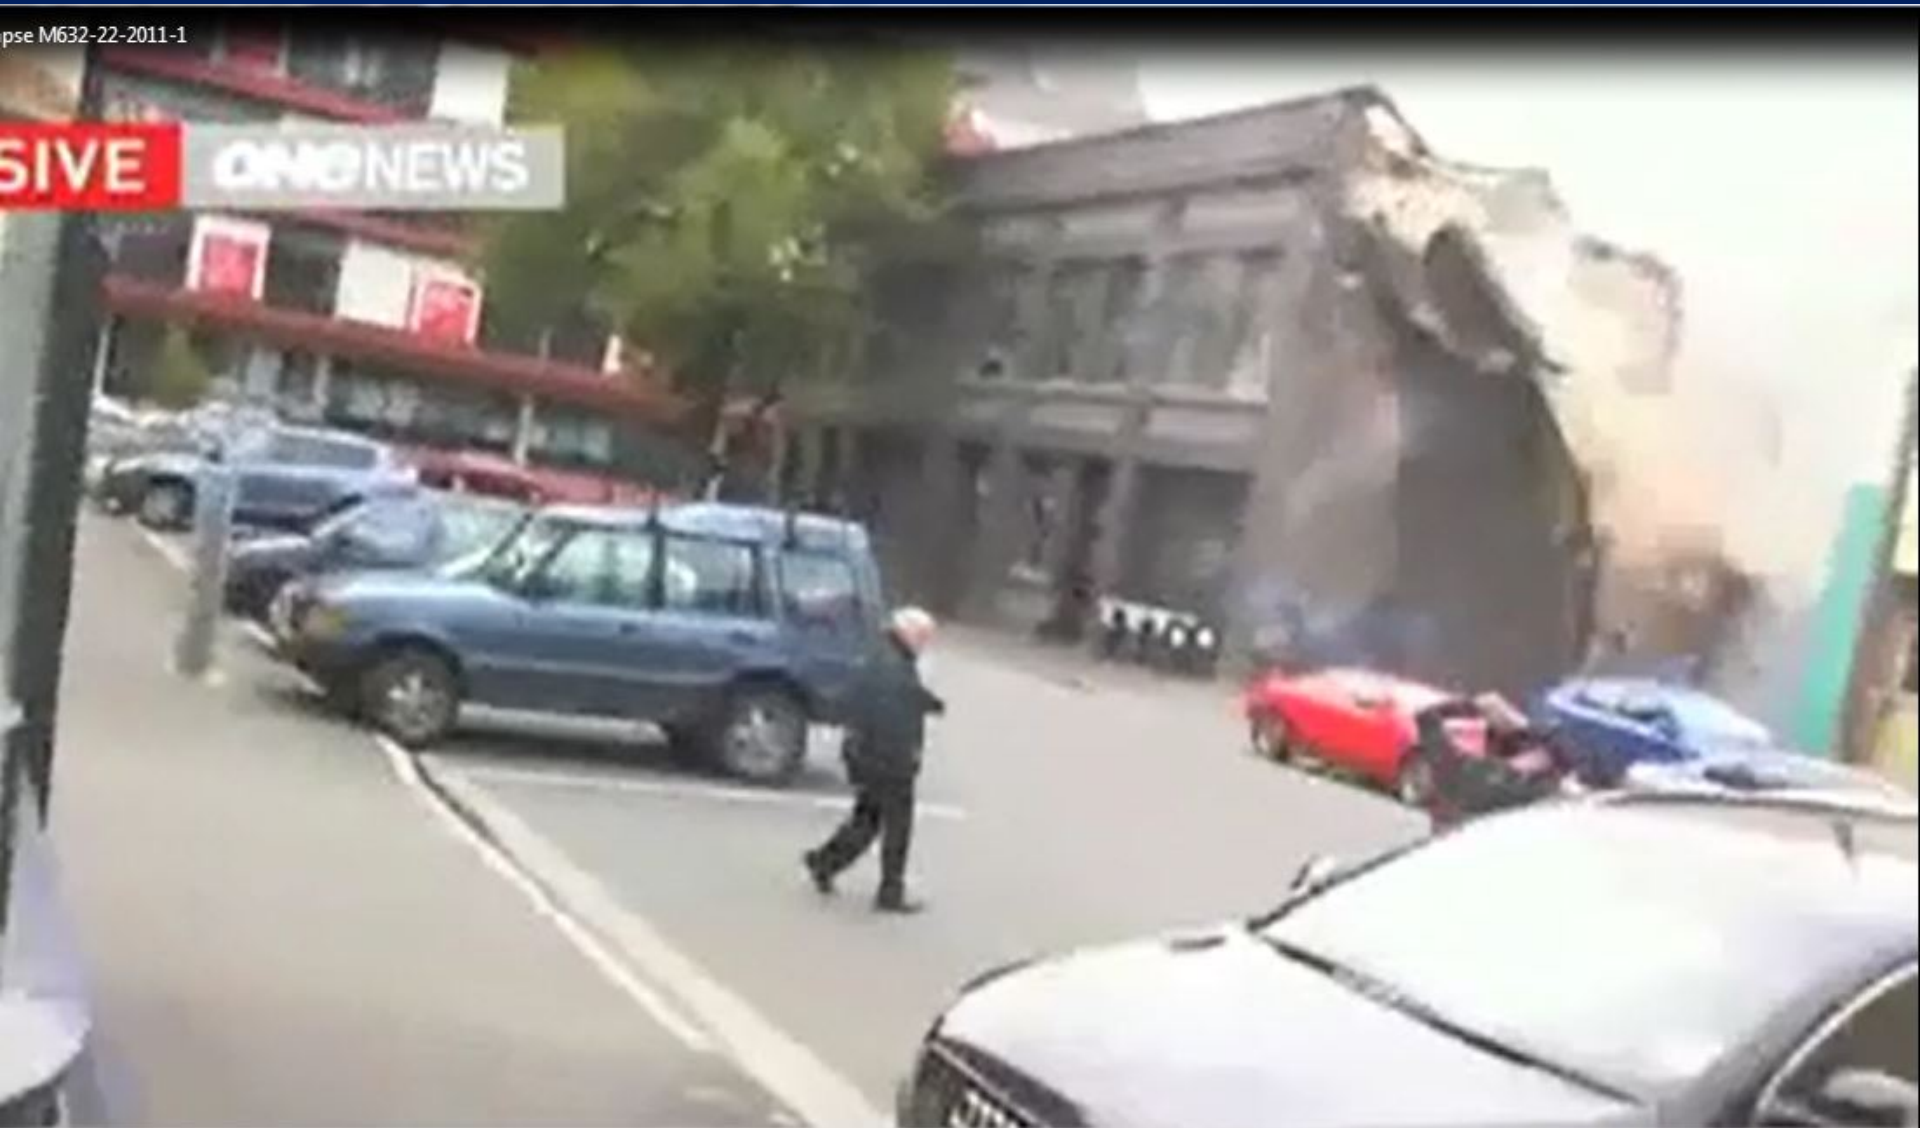
A major portion of the right-facing wall is peeling off and falling next to the building. One man has hands on head in awe.

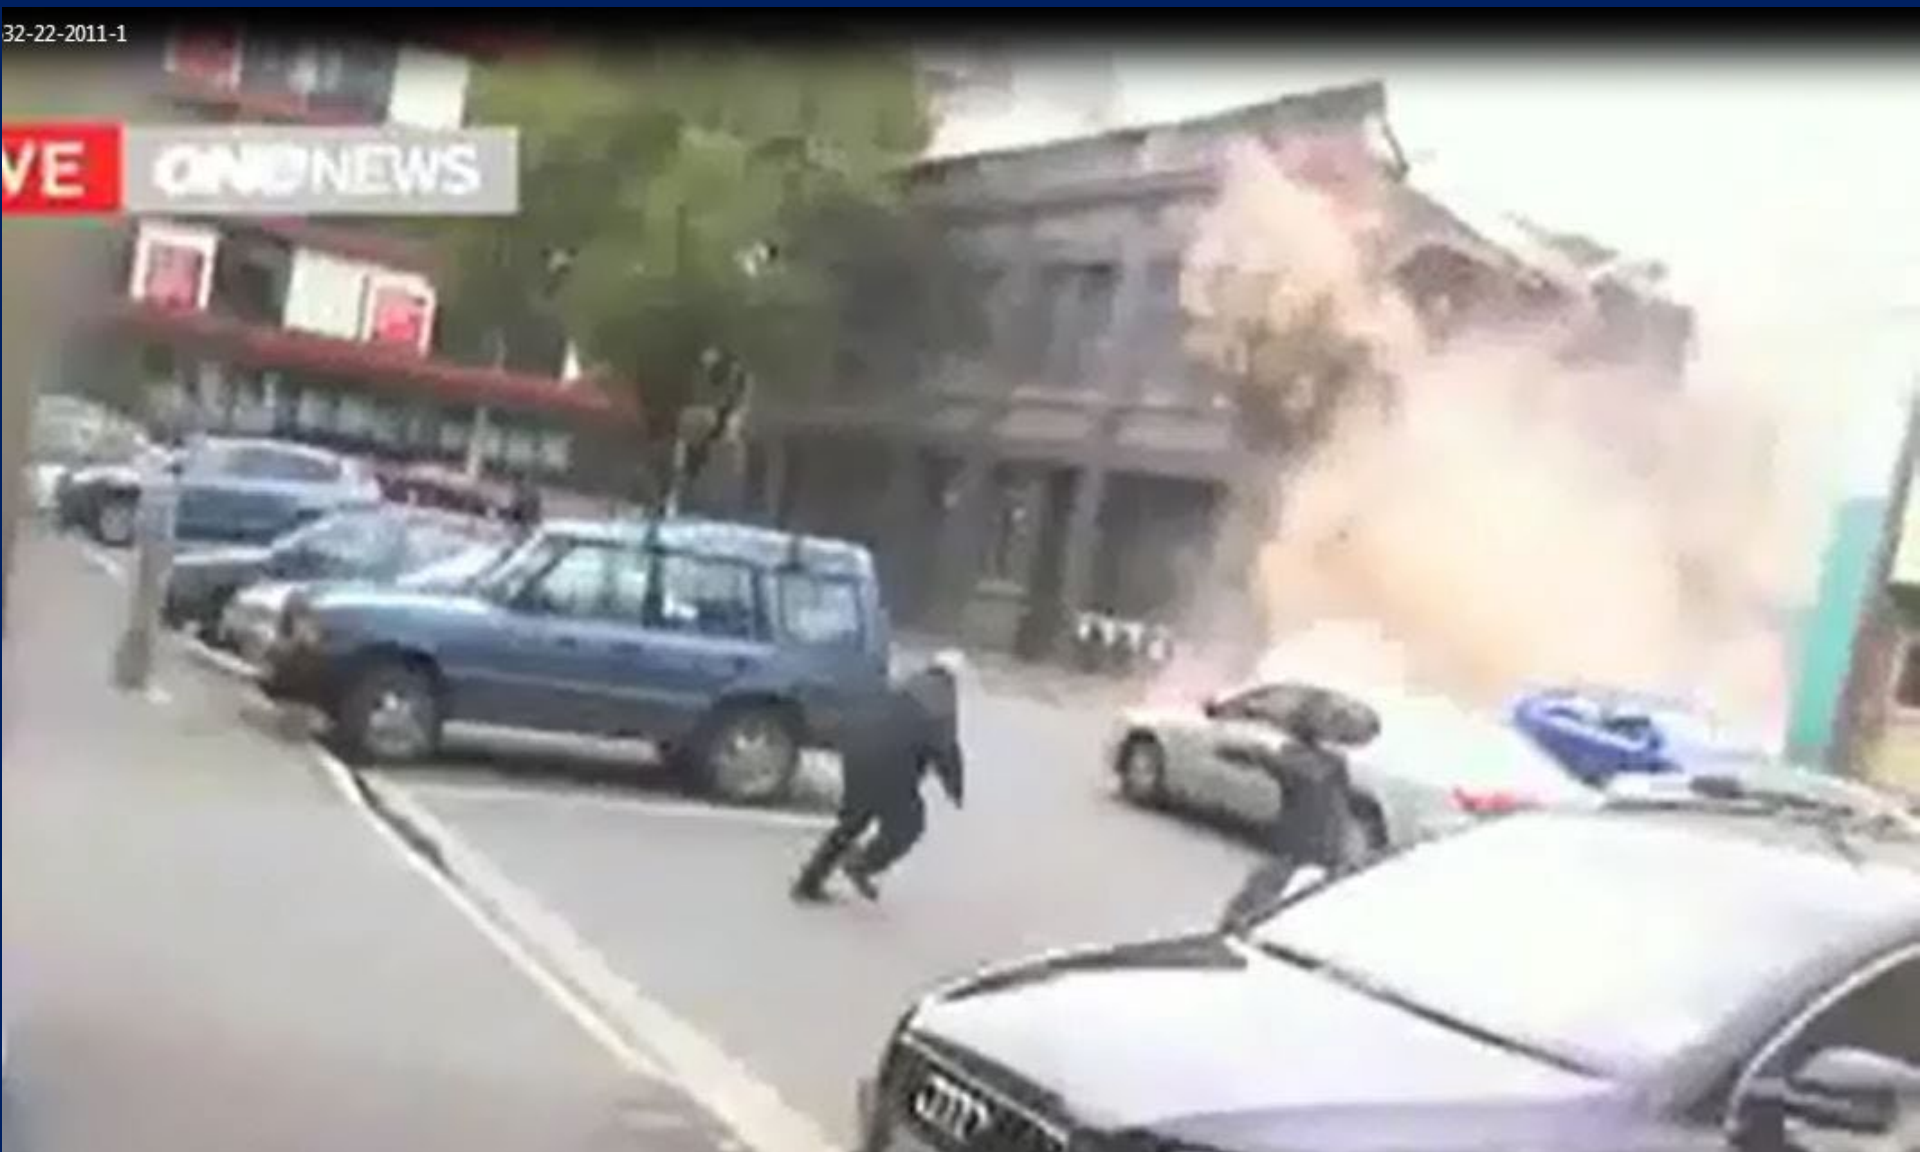
Large portion of the right-facing wall is falling on ground and dismembering. Dust rising from central part of the building indicates failure there.
