Seismic Risk of Unreinforced Masonry Buildings in Nevada

Craig M. dePolo

Nevada Bureau of Mines and Geology

September 10, 2019

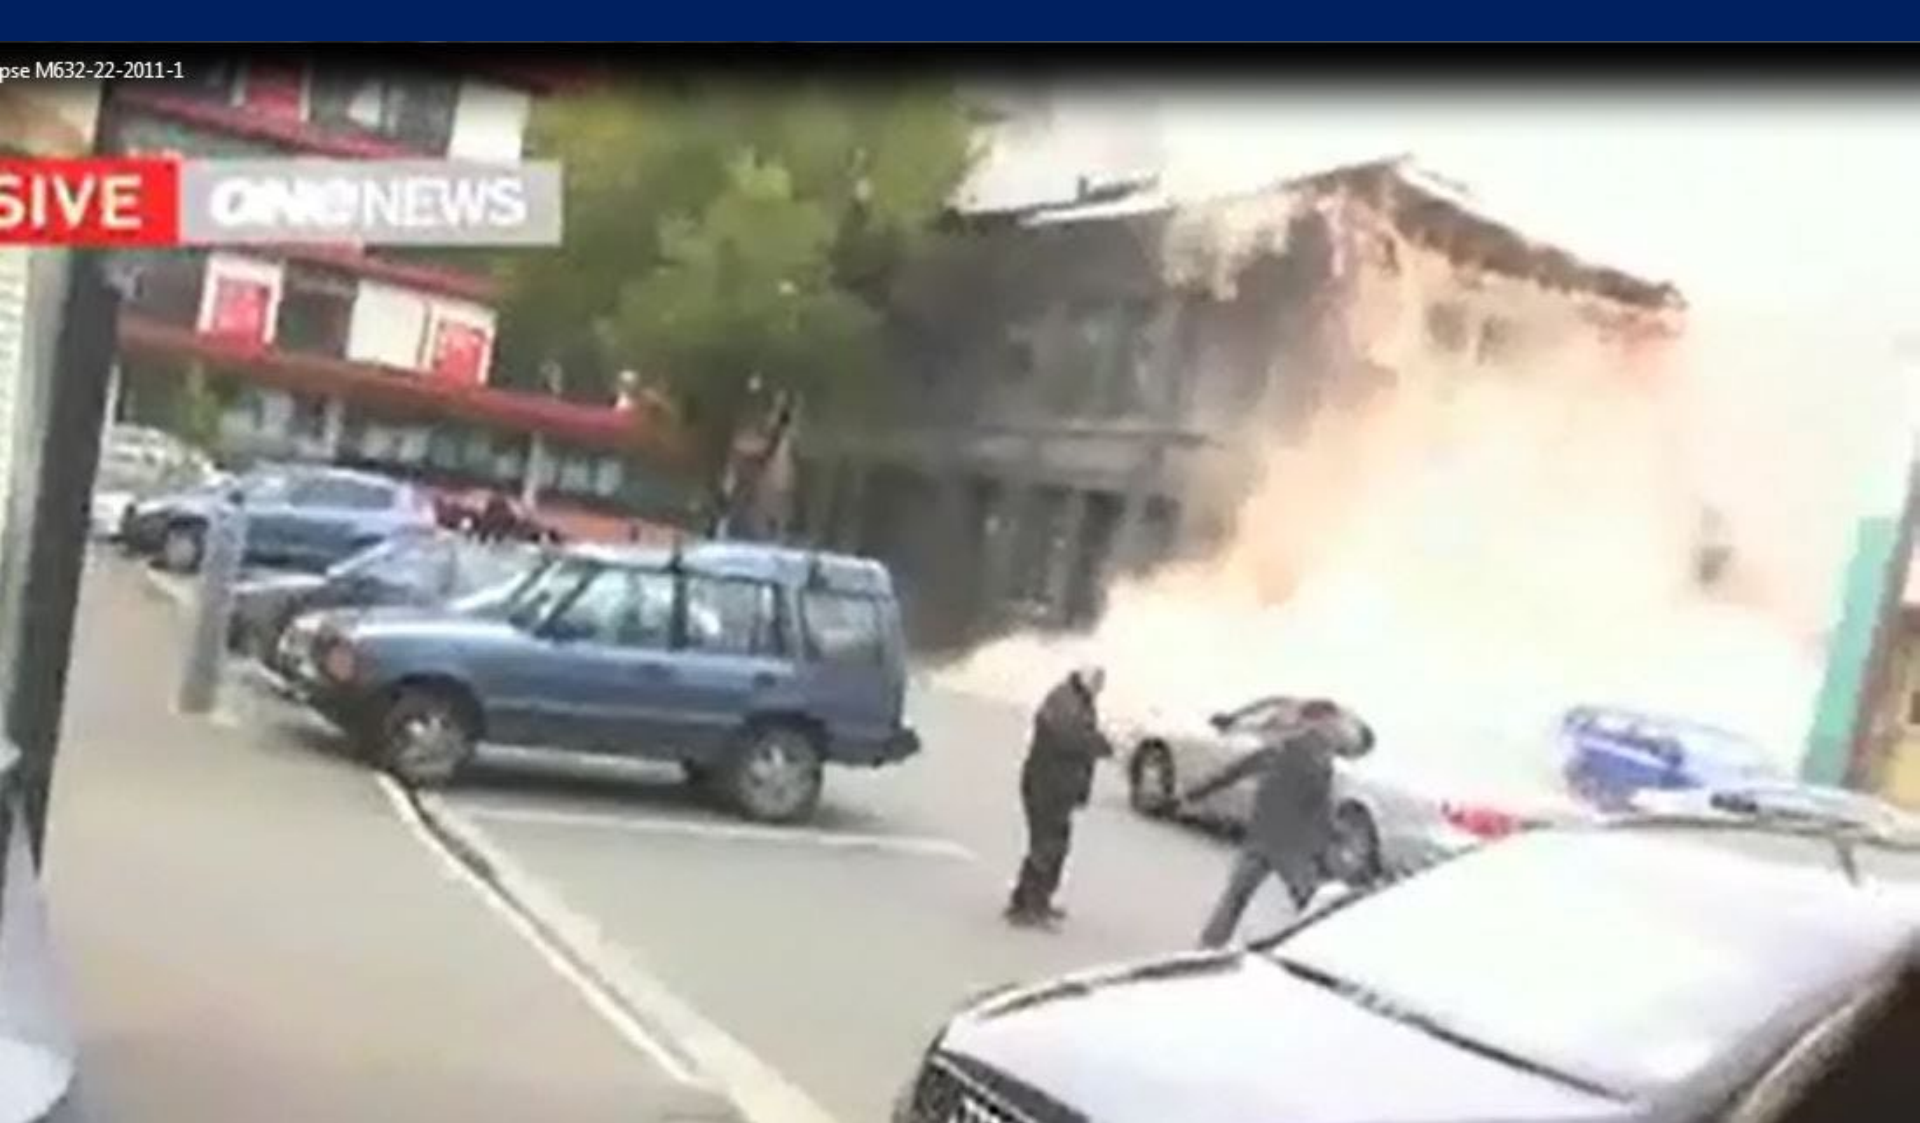
Upper part of left-facing wall is starting for fail and fall.

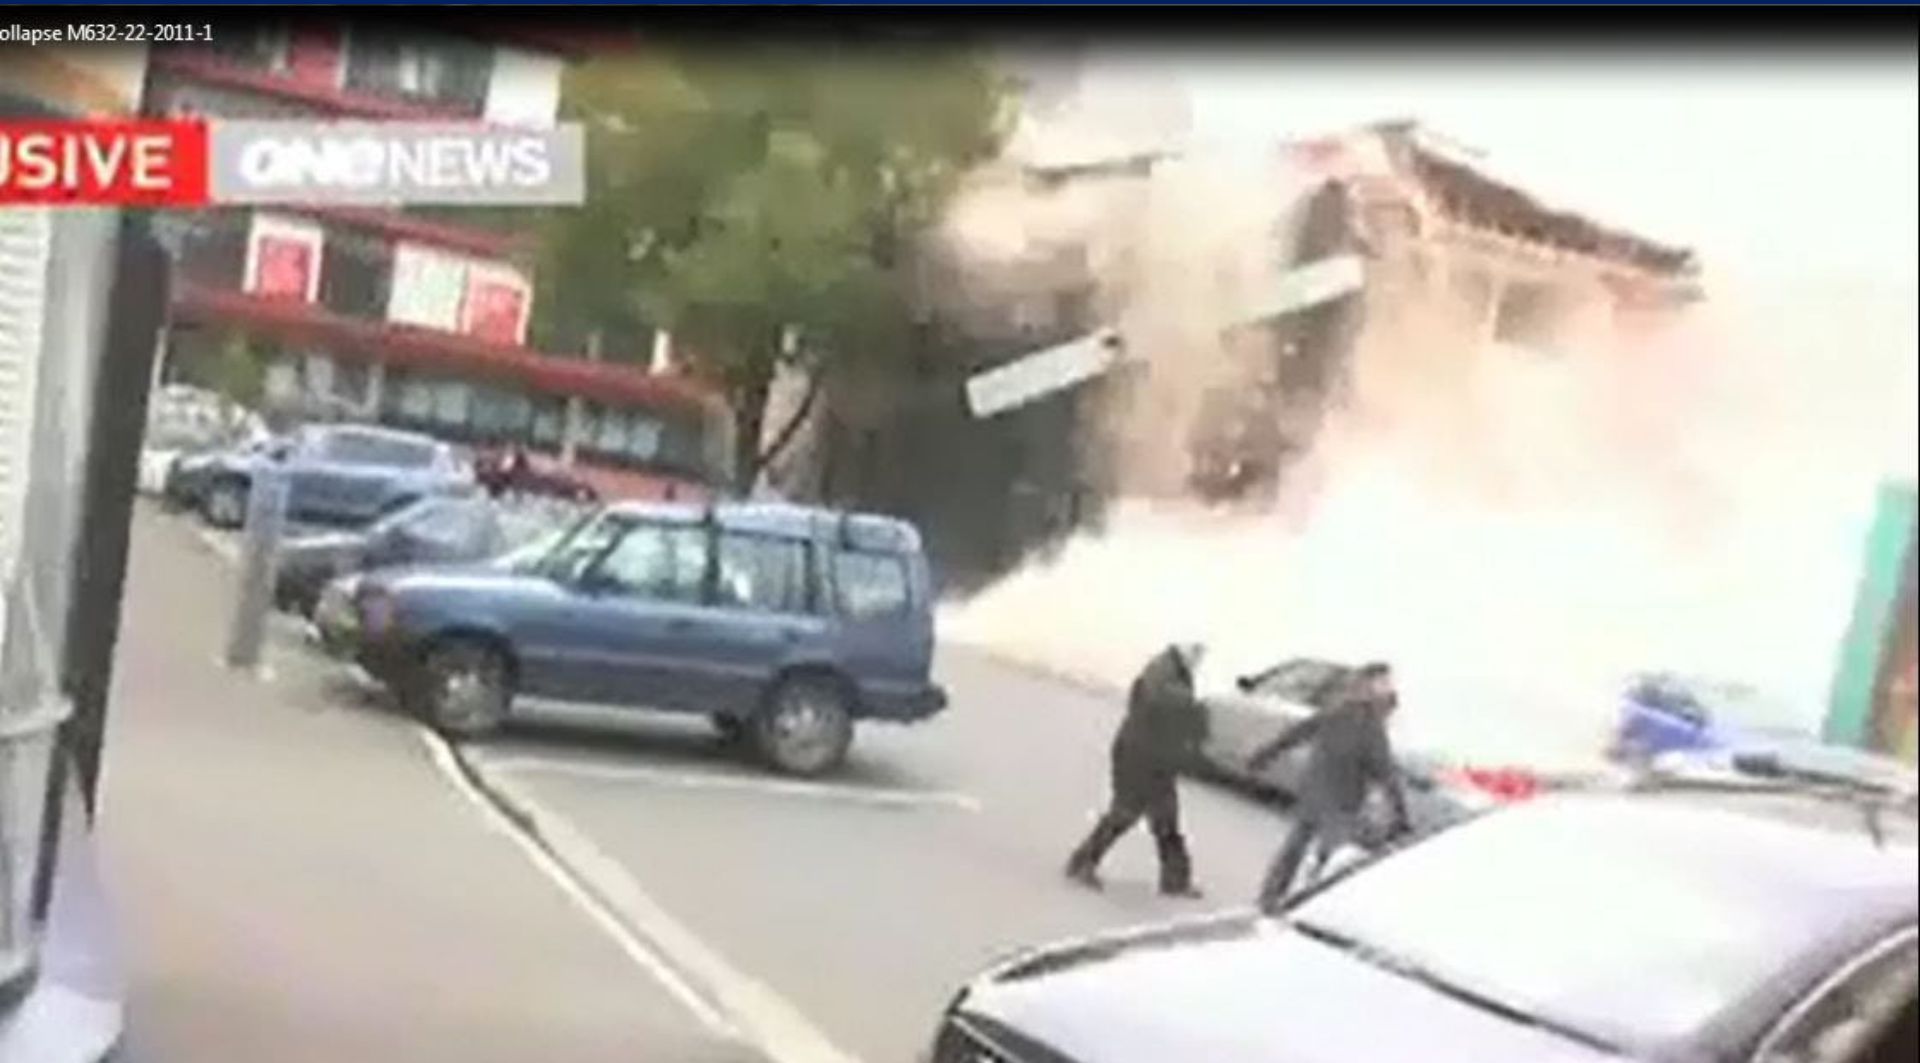
Large part of upper part of wall on the left-facing wall is falling off as more of the upper part of that wall fails.

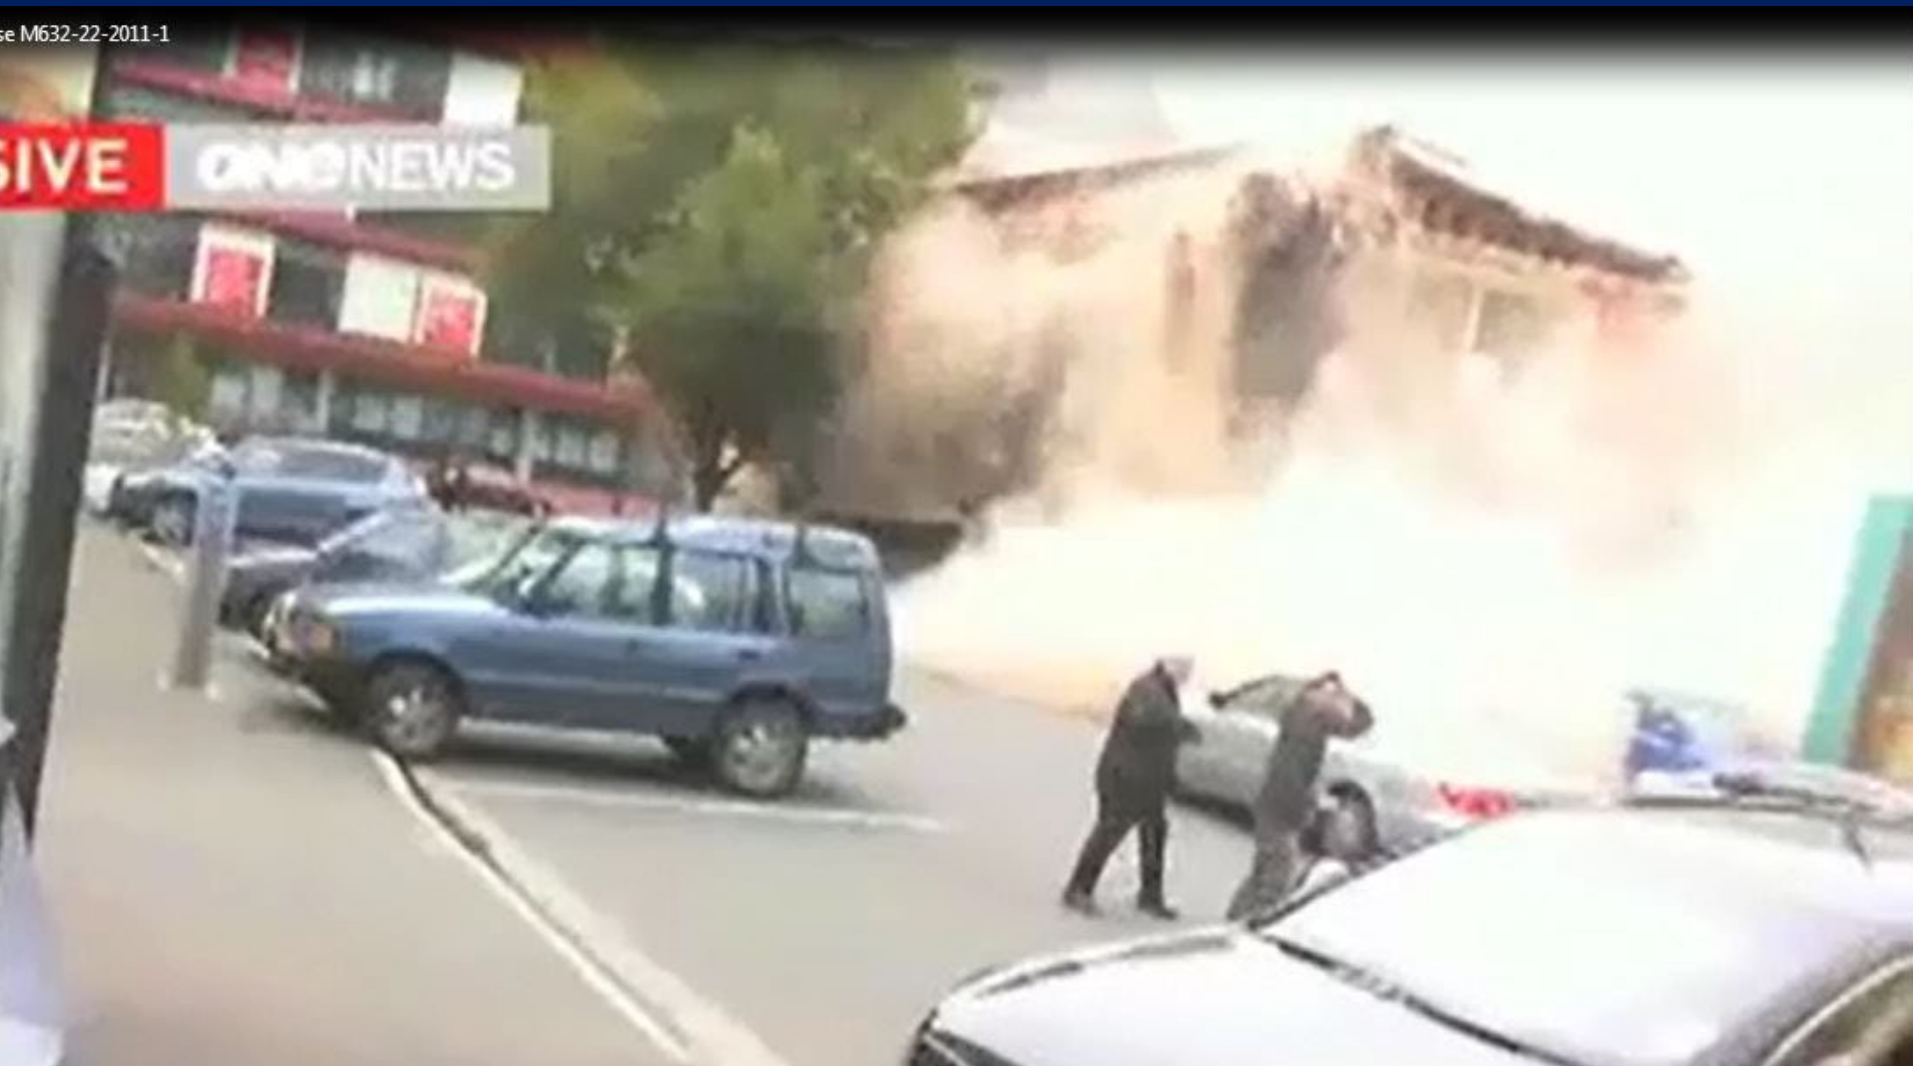
More of the upper part of the left-facing wall is failing in chunks.

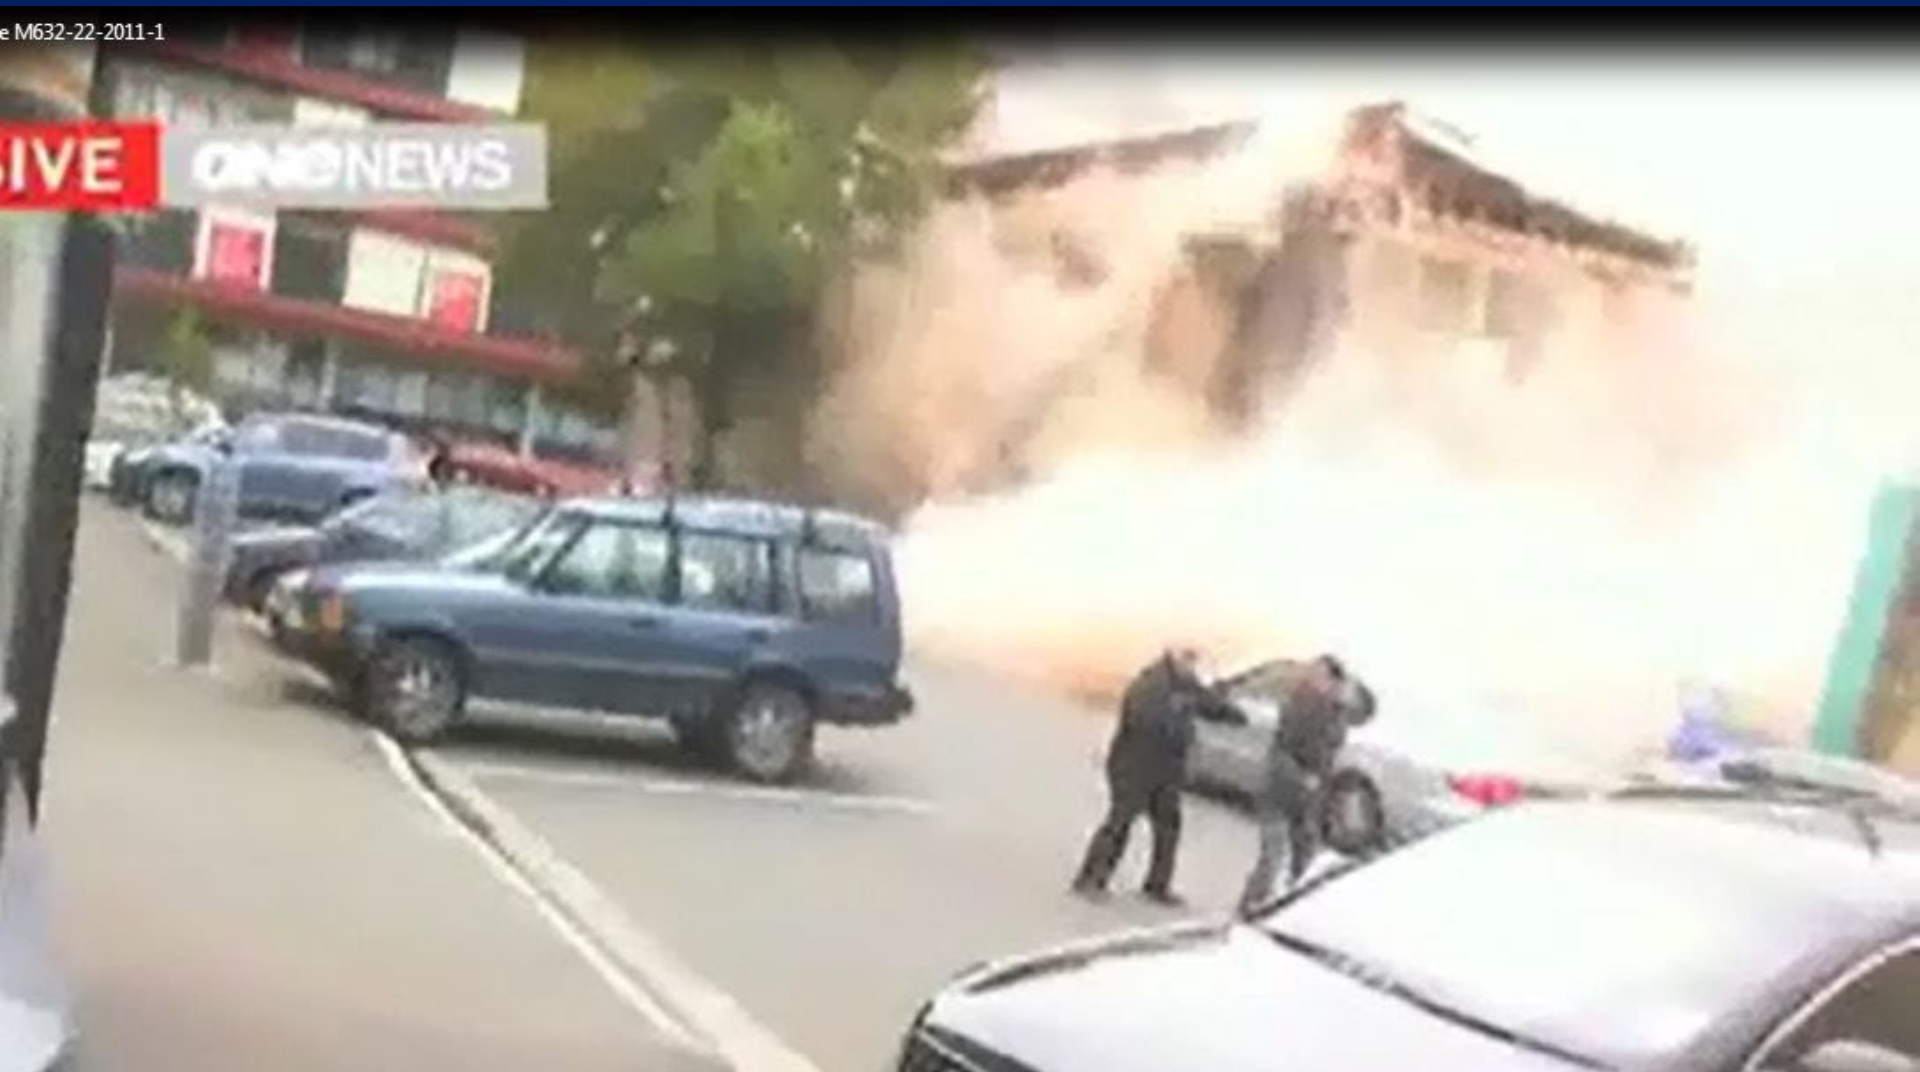
Continued failure of the upper part of the left-facing wall – chunks of Bricks continue to fall.

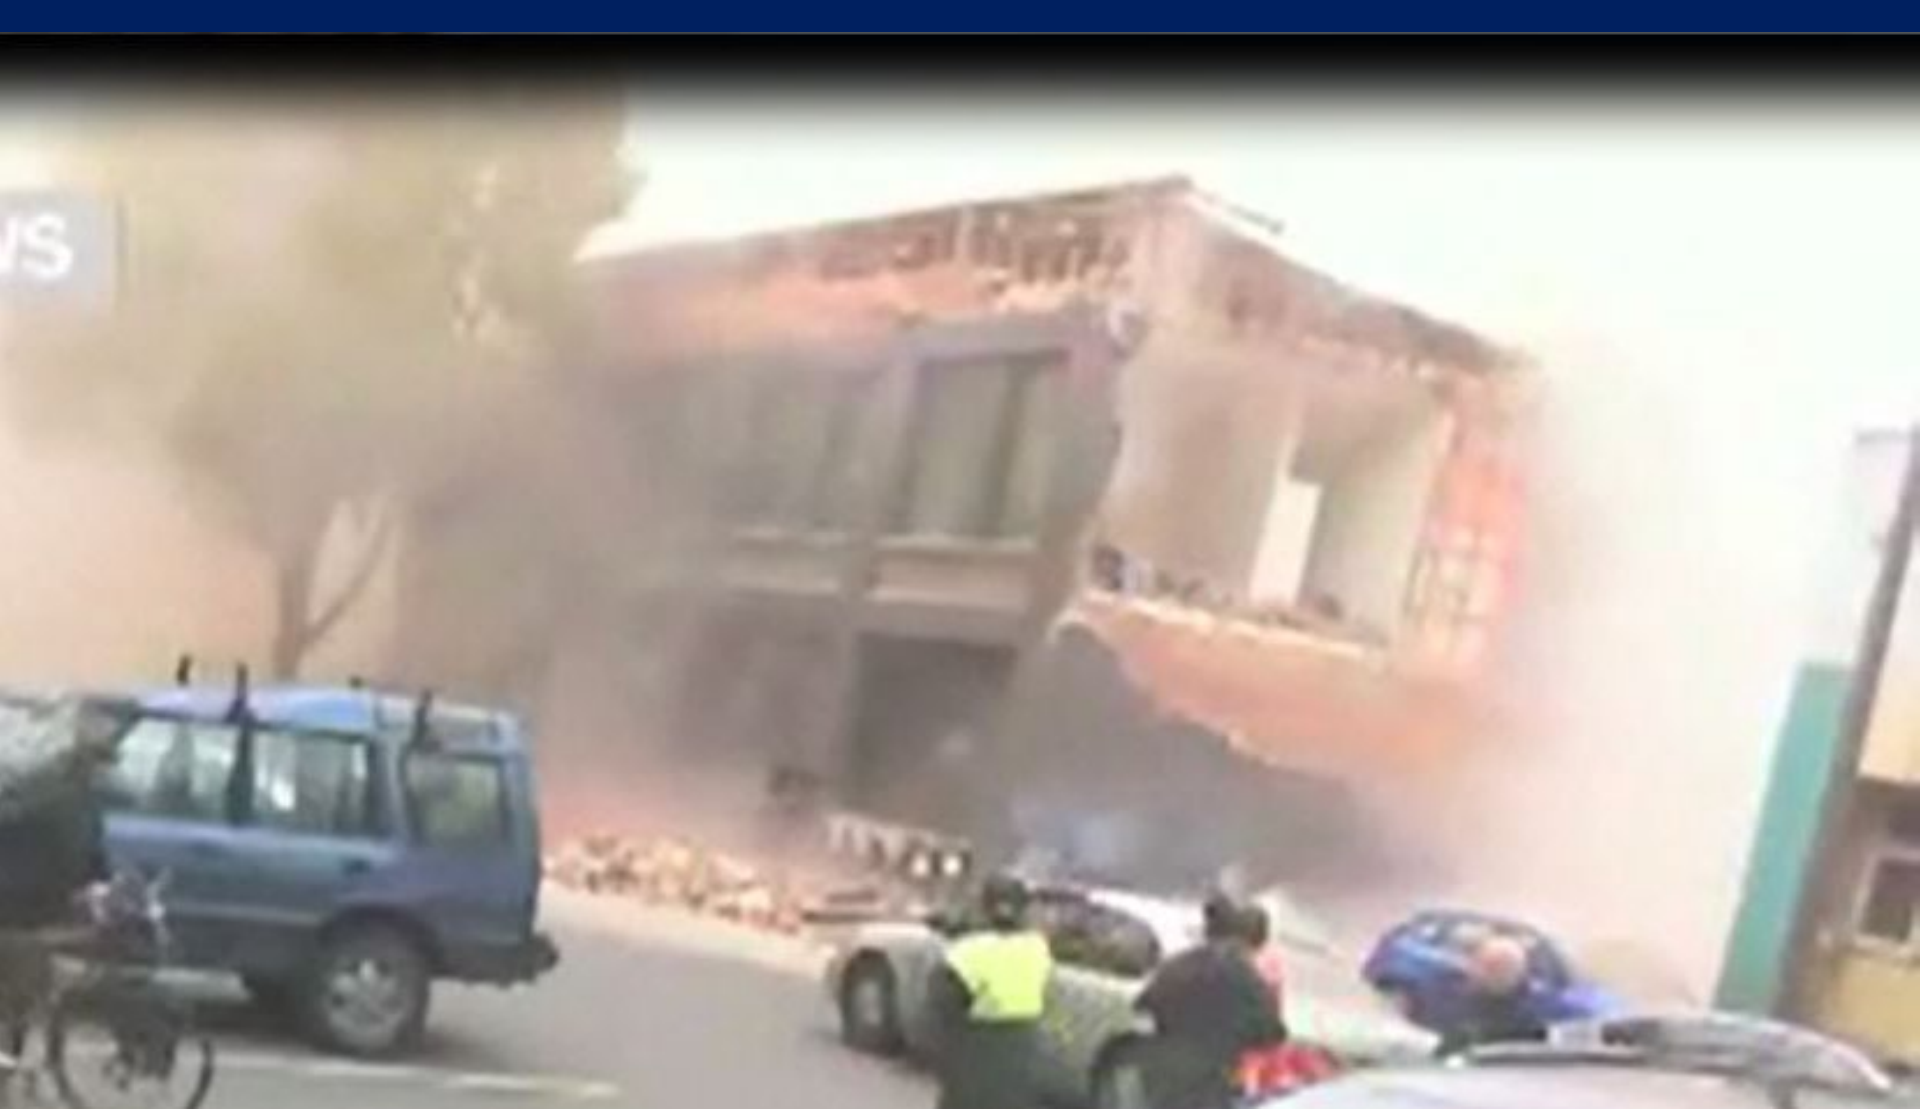
Damaged URMB – major failure of right facing wall exposing rooms and Failure of the upper part of the left facing wall. Debris surrounds building.

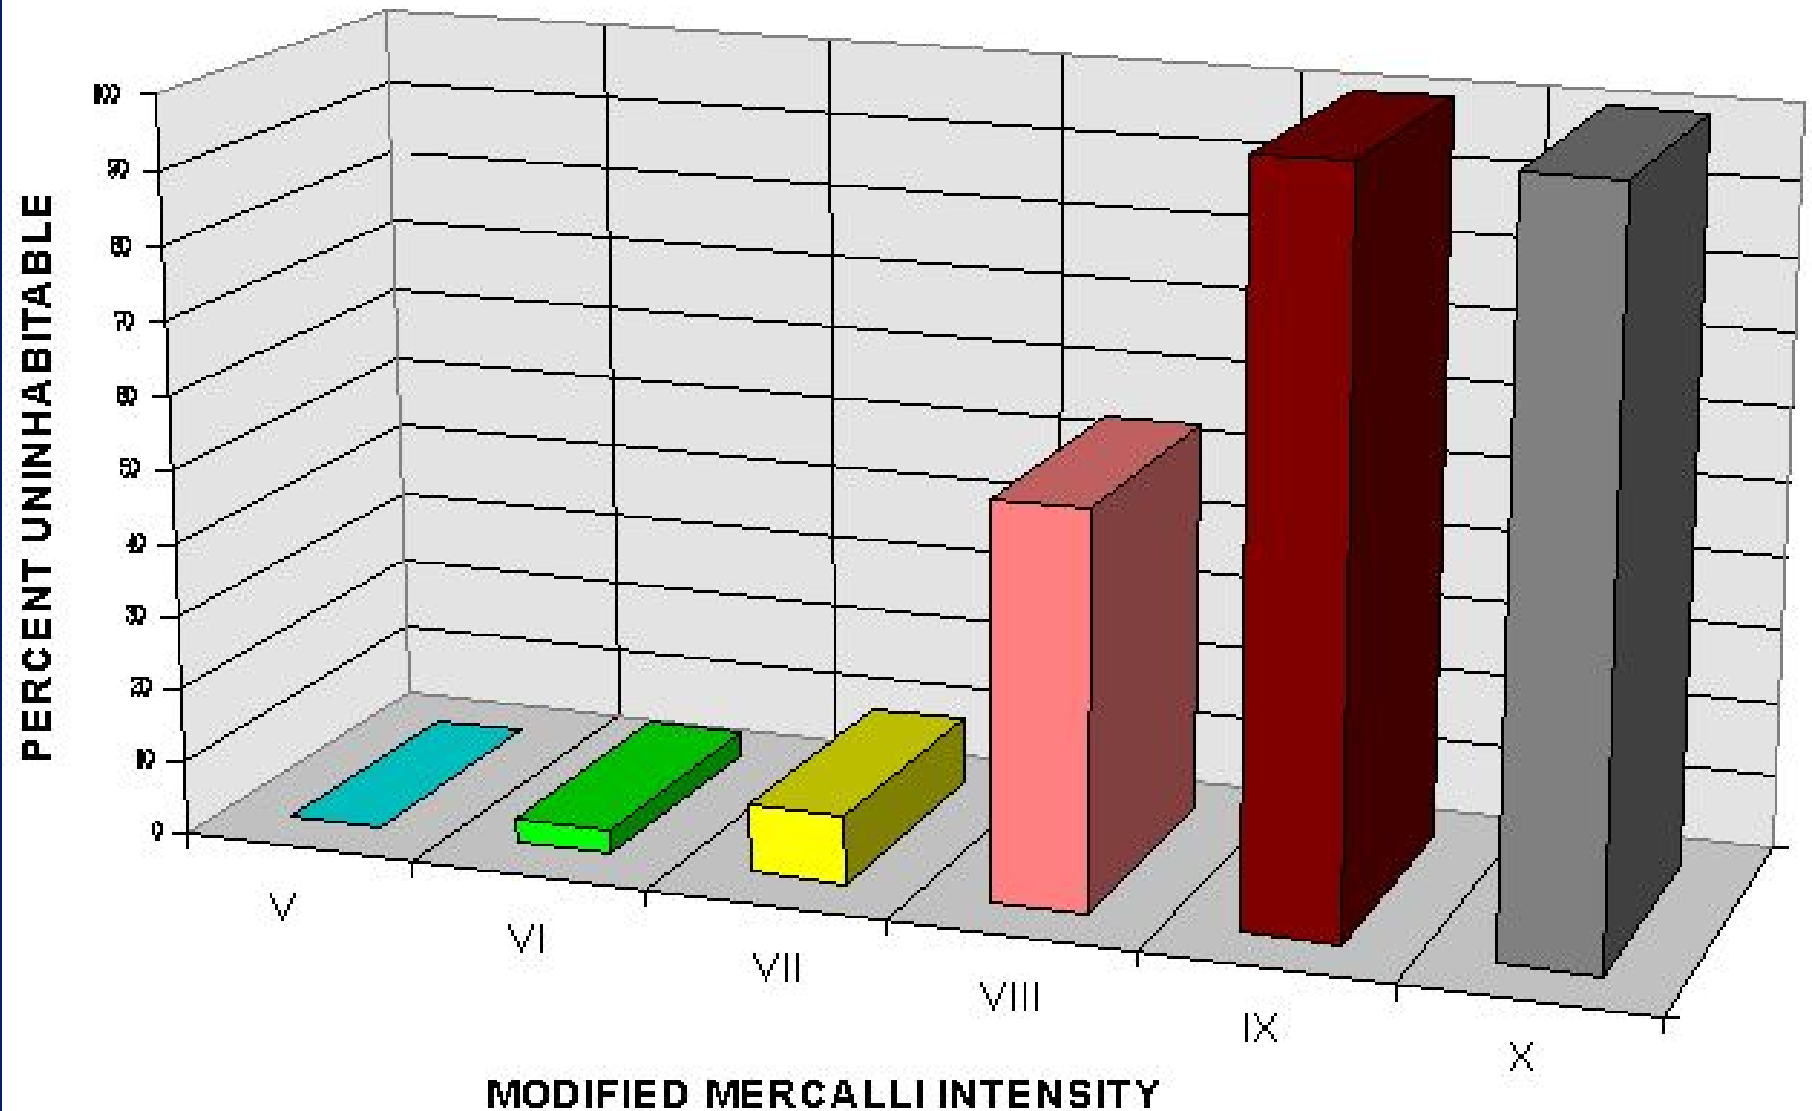
UNREINFORCED MASONRY PERCENT UNINHABITABLE BY MMI INTENSITY LEVEL

On the order of about a third of URMBs are expected to have failures in areas of strong shaking.

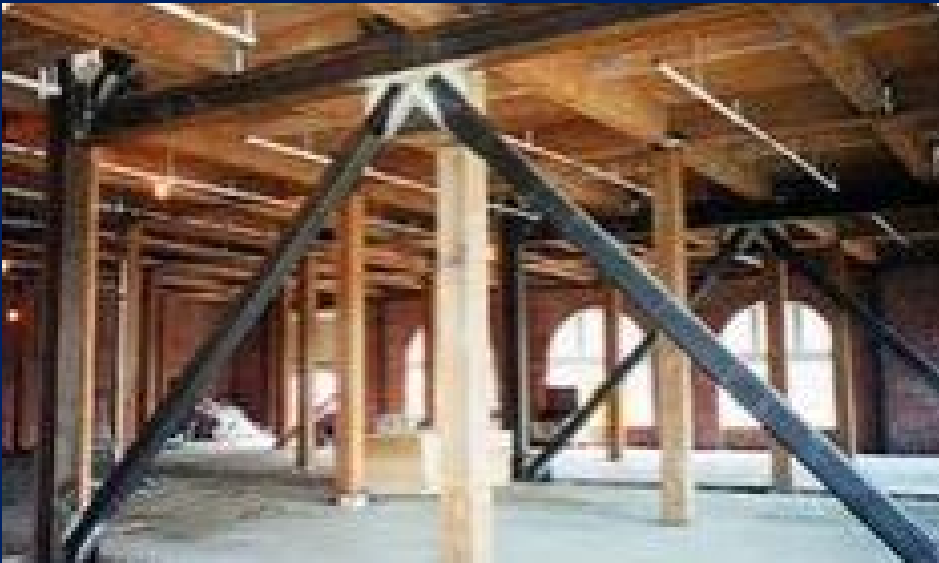
Interior cross bracing helps prevent building collapse

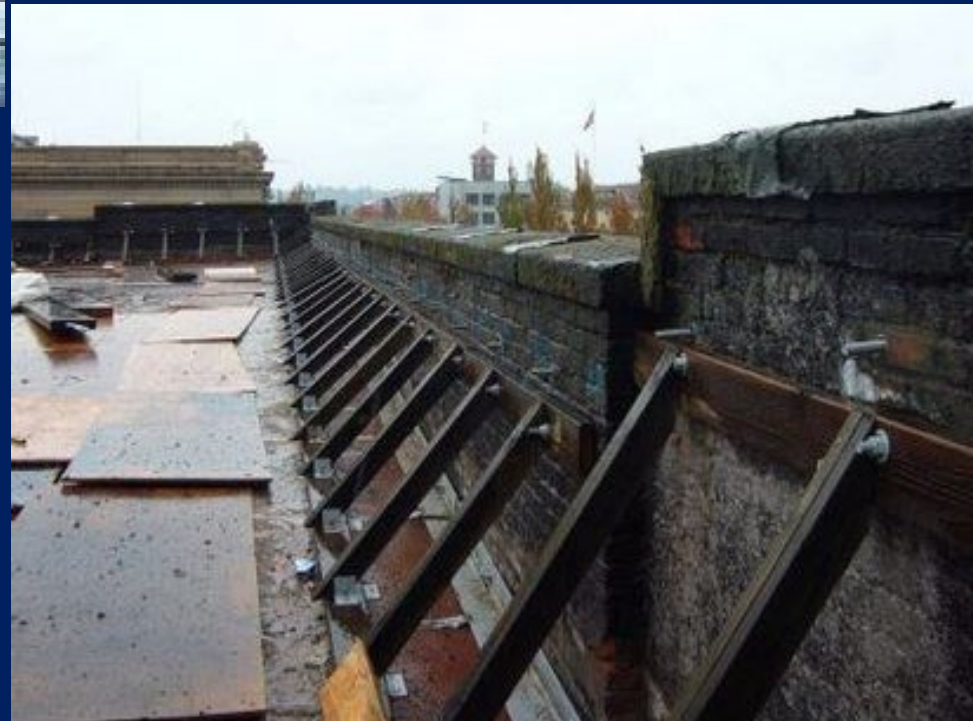
Bracing of URM parapets keeps them from toppling to the sidewalk below

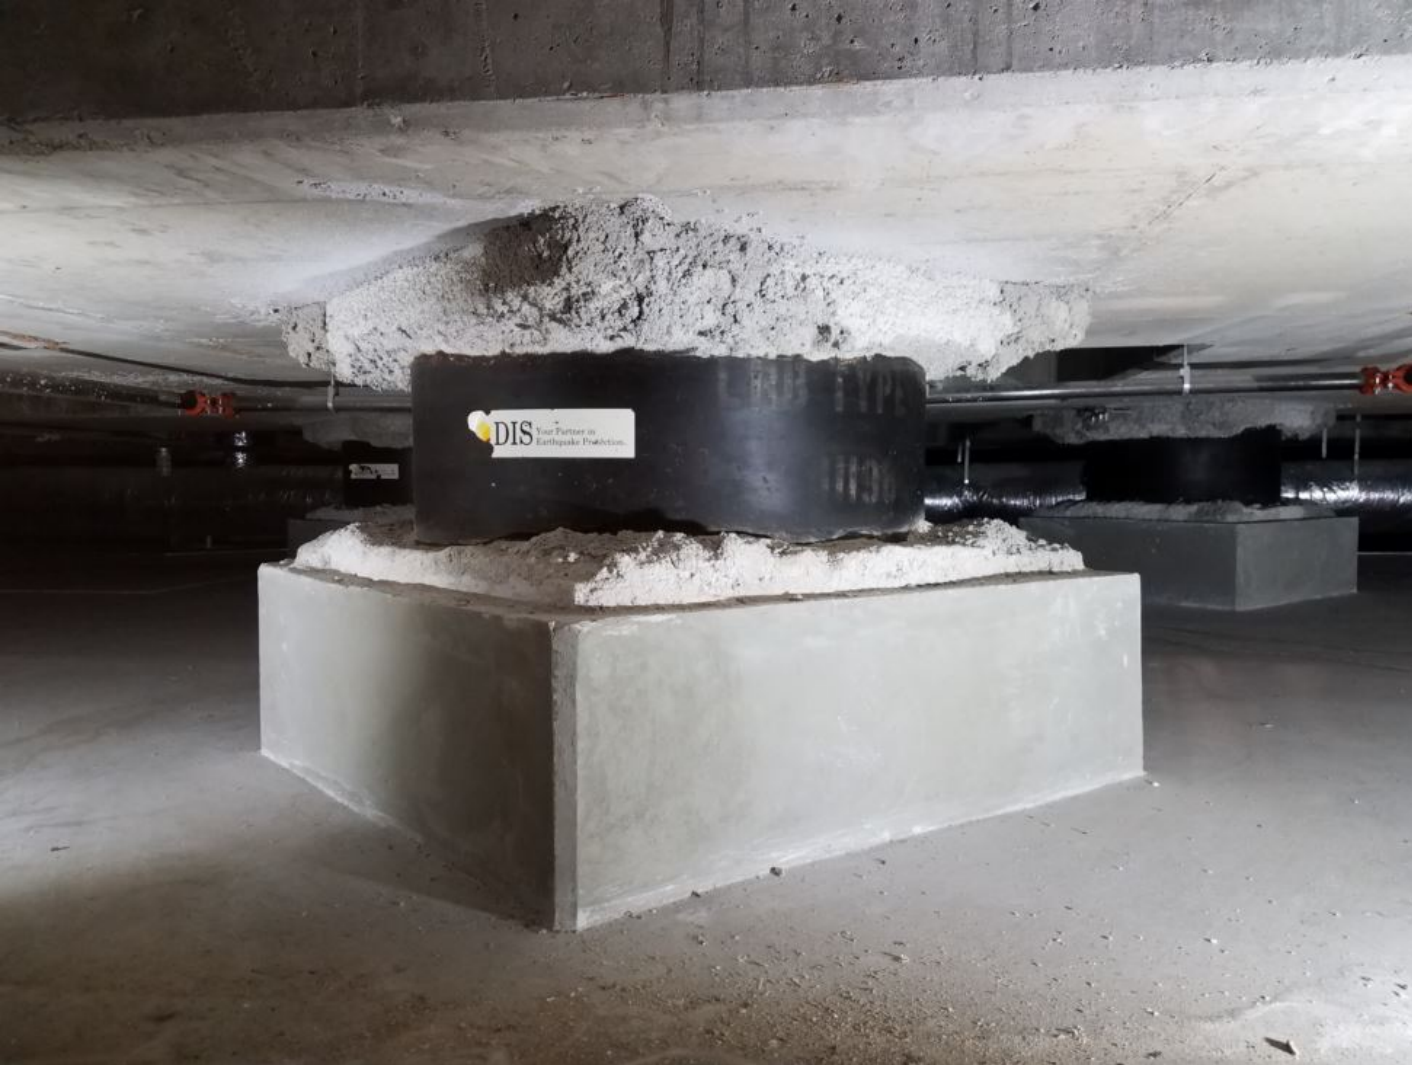
Utah State Capitol – seismic strengthening and base isolation (above)

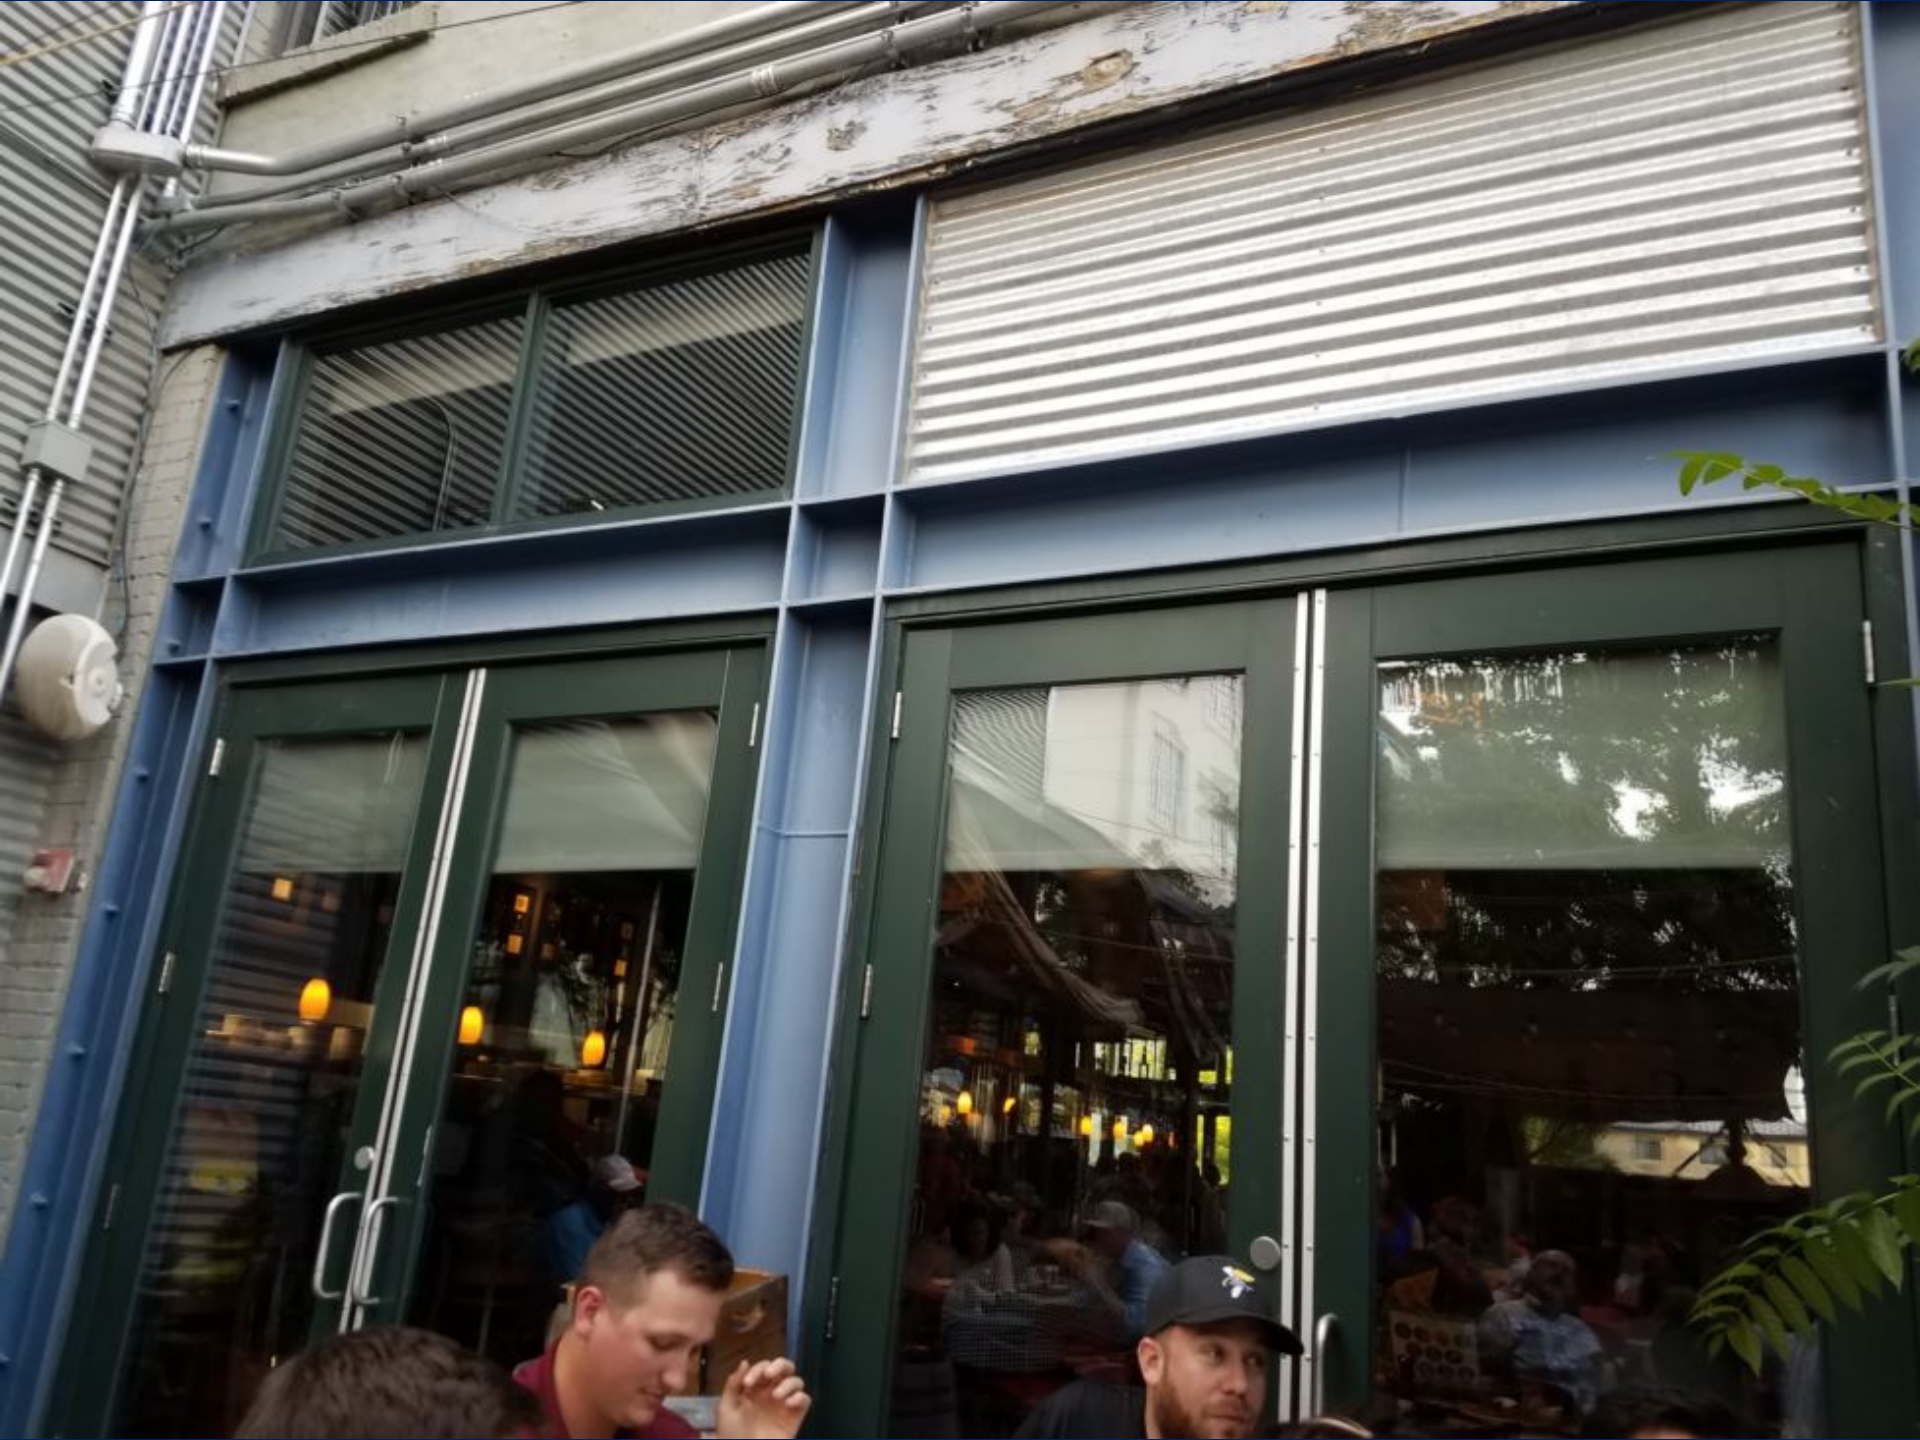
Fiberglass mesh epoxied
to bricks & tied to beam

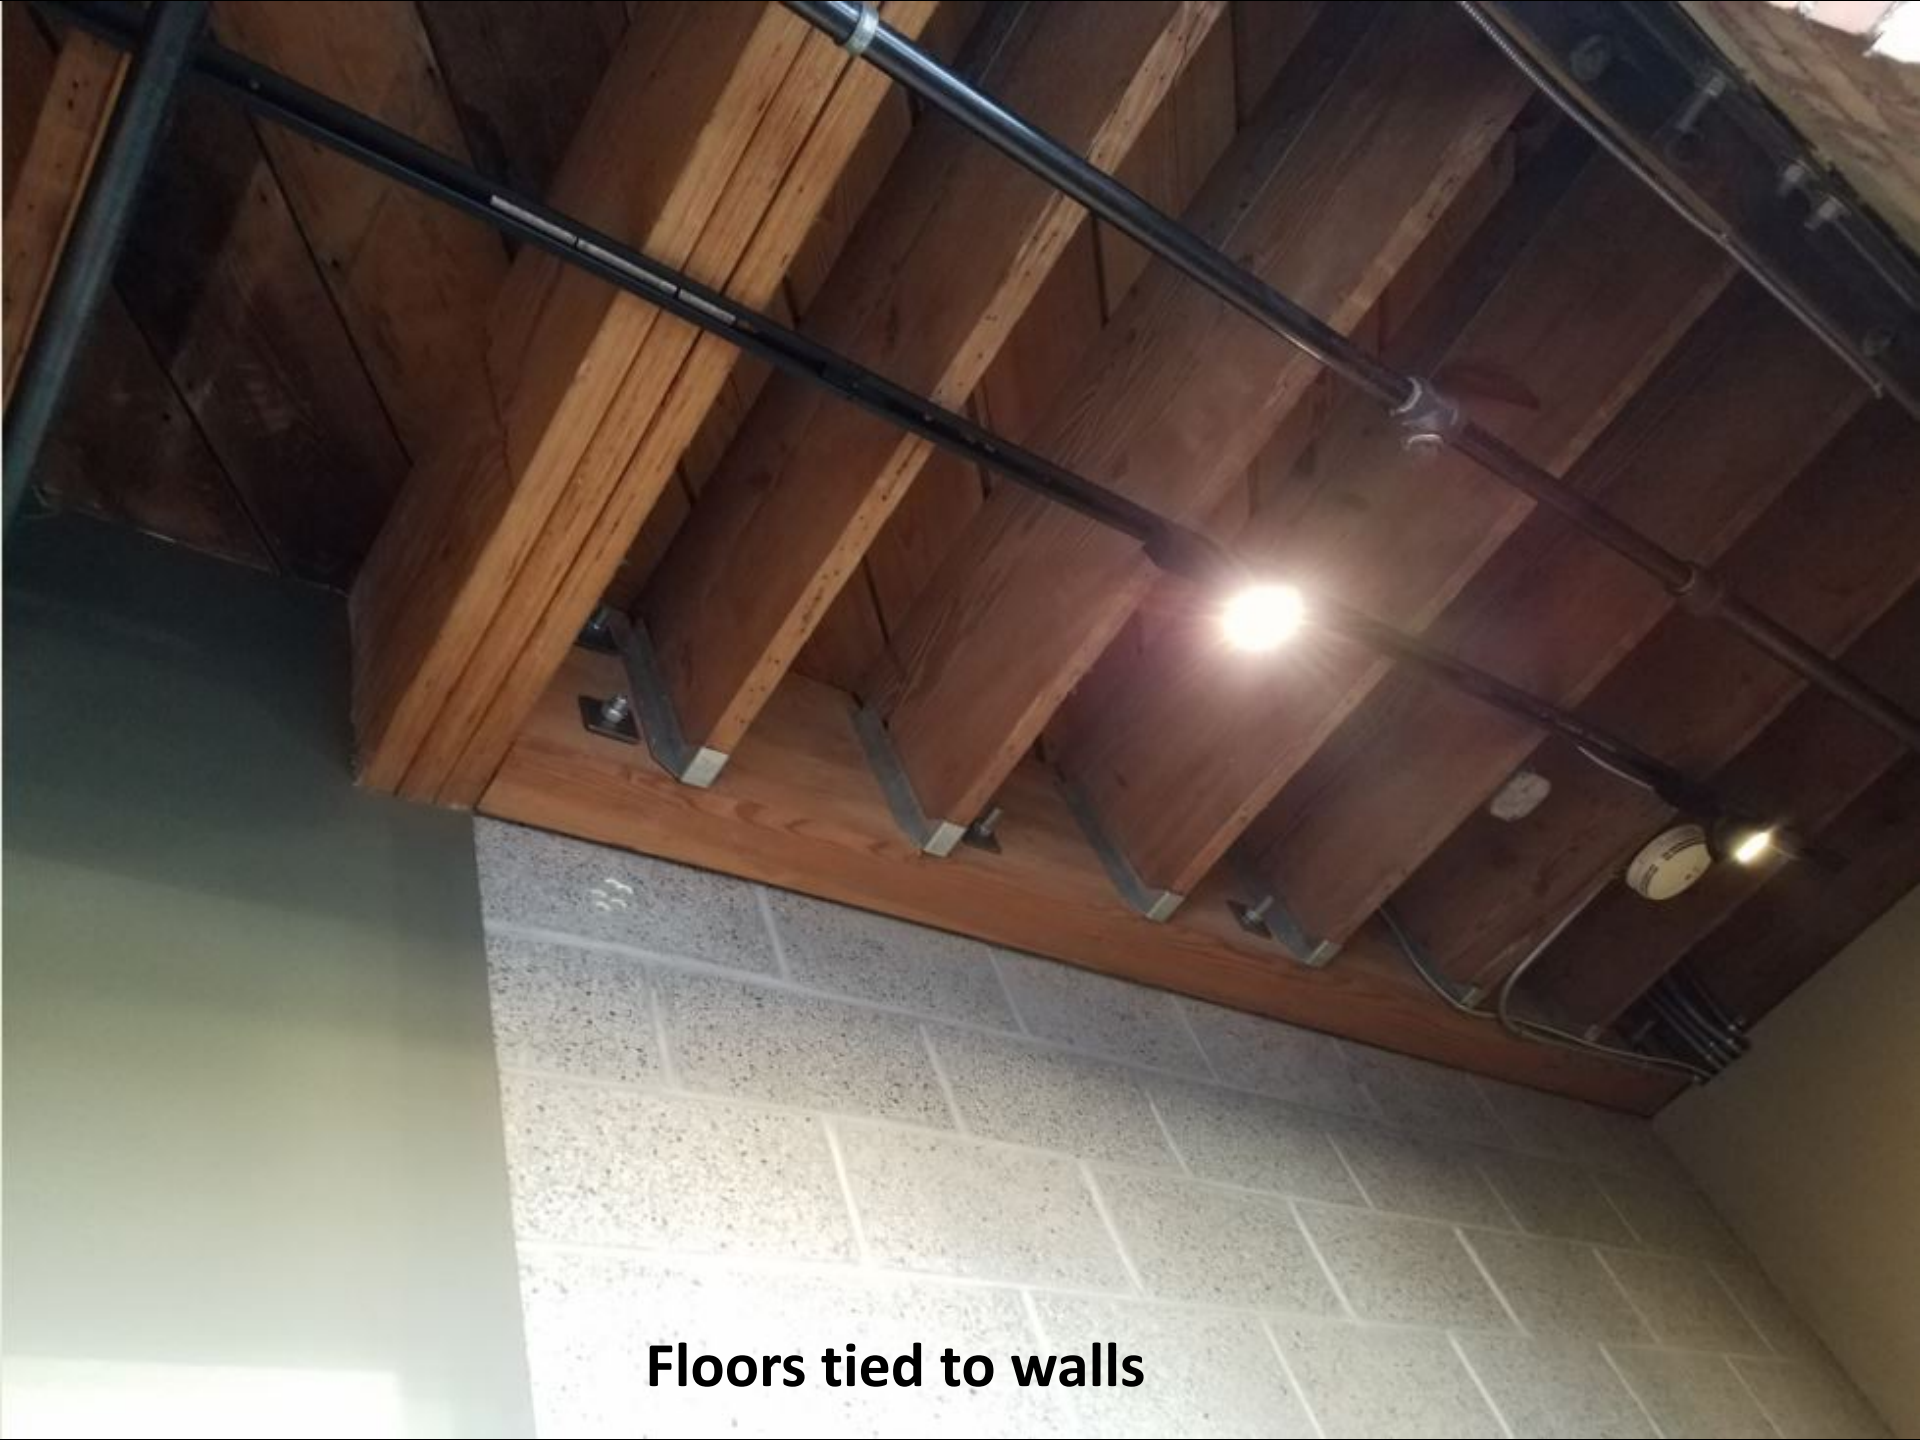
Floors tied to walls
