Nevada Bureau of Mines and Geology Special Publication 36

Wells, Nevada M6.0 Earthquake Impact on the Nevada Department of Transportation

Michael E. Murphy
Nevada Department of Transportation, District III, Elko, NV

2011

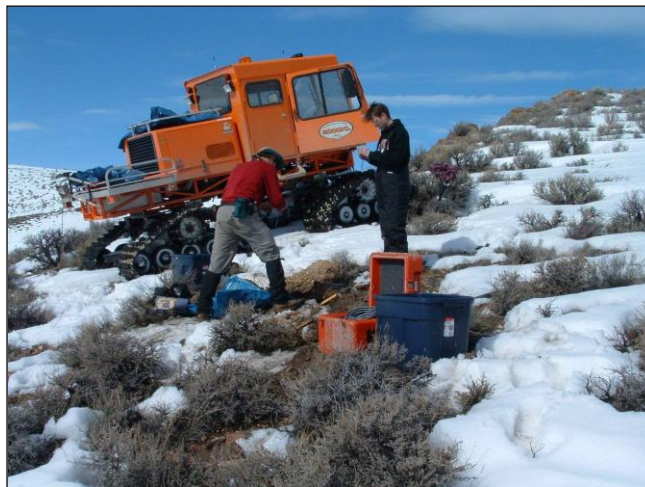
Figure 5. USGS staff installing a seismic instrument after being transported to a location near Turner Hill Station by a state Sno-Cat.

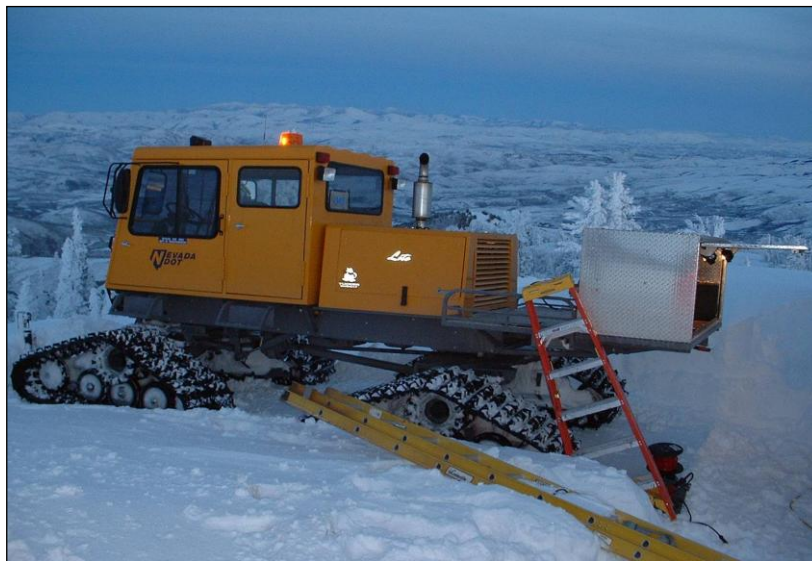
Figure 9. NDOT Sno-Cat at one of mountain-top communication sites.

Only three significant problems were found during the inspections that were believed to be caused by the earthquake:

1. Several small exterior propane leaks were found at the Spruce Mountain communication site.
2. A bolted connection on the steel support structure for the solar panels on the Spruce Mountain site was no longer in normal alignment.
3. The anchor bolts holding a large battery rack at the Turner Hill Station had broken loose and the rack displaced itself on the interior of the building.

Fortunately, none of these problems were serious enough to cause additional damage as they were found and repaired before causing disruption of service.
