Wells High School Analysis and Reconstruction Following the February 21, 2008 Earthquake

Thomas E. Trabert, M.S., P.E.
Trabert Engineering, Reno, NV

2011

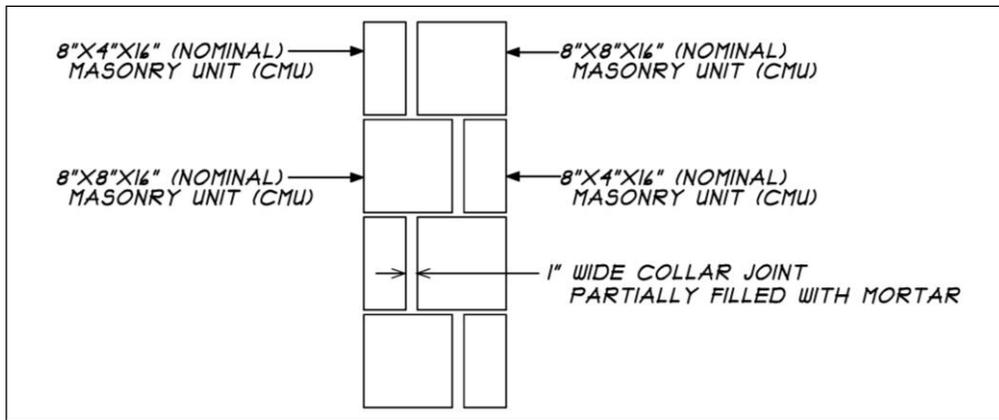
Figure 8. Thirteen-inch-wide CMU wall (not to scale).

However, during the process of installing these supports it was discovered that the portion of the 13-inch-thick double-wythe masonry wall (figure 8) above the concrete tie beam had delaminated. A vertical fracture line occurred along the vertical collar joint and continued through the masonry units causing the two wythes to act independently. Therefore, as two independent wythes or walls, this upper section of wall no longer met the 20-to-1 height-to-width ratio requirement. Now acting as two walls moving independently away from each other a P- Δ moment was created in each wall. The combination of a significant increase in the height-to-width ratio and the P- Δ moment created an extremely unstable condition for this bearing wall. This is the same wall previously noted and shown in figure 3.
