Building Damage from the 2008 Wells, Nevada Earthquake

Craig M. dePolo
Nevada Bureau of Mines and Geology
University of Nevada, Reno

2011

ABSTRACT

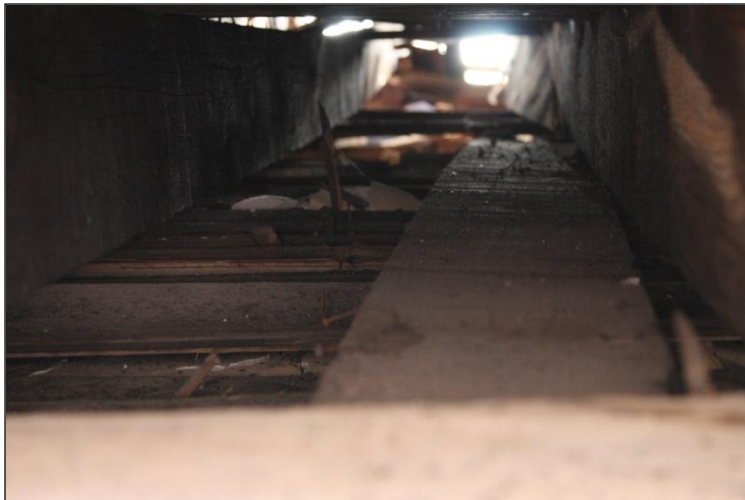
The part of the bottom floor on the side that was not covered by the collapsed roof and second story, was strewn with bricks and debris from the collapsing eastern wall. With the exception of a small room near the back of the building, there was very little survivable space in the collapse (figure 6). The empty lot to the west of the collapsed building, where the western wall fell, was also covered by thousands of bricks, including bricks from the top of the adjacent Goble Market to the west of the lot.

Figure 6. Roof rafters from the San Marin Hotel lying directly on the second story floor. There was very little survival space in this collapse.

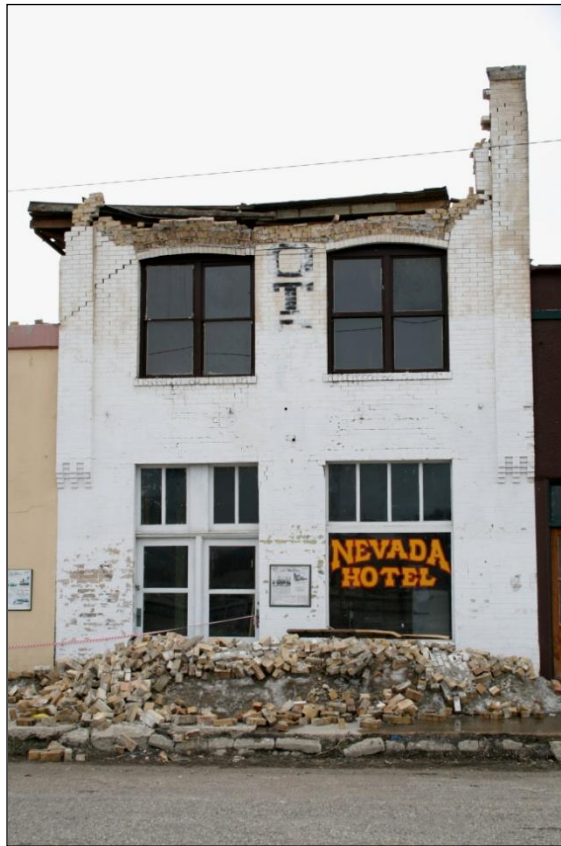
The two-story Nevada Hotel had parapet and upper wall failures (figure 8), and a relatively rigid wood roof that was losing support during the earthquake and collapsed down to the ceiling joists. Most of the bricks fell away from the hotel and the inside appeared to be relatively undamaged. Two brick headers over second story windows and a panel between windows were broken, were out-of-plane, and were threatening to fall.

Figure 8. Earthquake damage to the Nevada Hotel. Fallen bricks from the front parapet and upper part of the wall are visible, as is the displaced roof. On the right (west) side of the Nevada Hotel is Murphy's Bar and on the left side is the Mint Saloon. Note that despite the damage to the hotel, the windows were not broken.

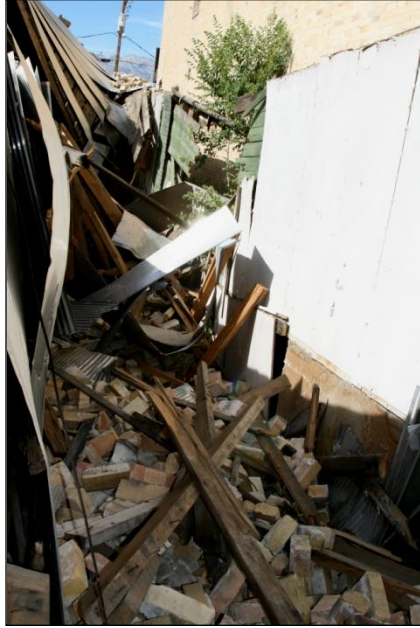
Bricks fell away from the top of the Nevada Hotel and onto the adjacent one-story Mint Saloon and Murphy's Bar. Over 85% of the Mint Saloon's roof was collapsed; bricks fell from the two-story Nevada Hotel onto the western part of the roof. This part of the truss-roof system failed, and it came down as a nearly single tilted unit, remaining attached on its east side and breaking up on its western side. There were a few meters on the western side of the Mint Saloon that were covered with debris, where the roof structure fell to the floor, and part of the wall was broken (figure 9). The part of the Mint Saloon where the roof didn't collapse was pierced by bricks on the western side.

Figure 9. Collapsed western part of the Mint Saloon with bricks from the adjacent Nevada Hotel. The western wall has been broken in the center as well.

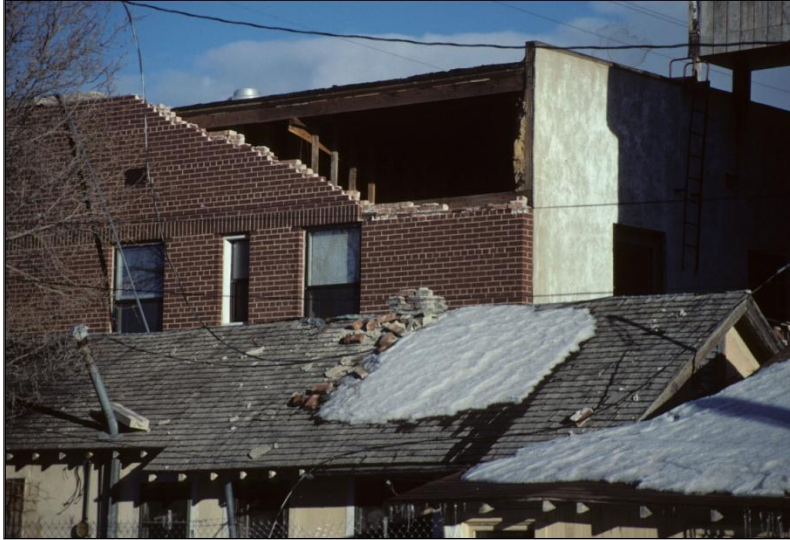
Figure 11. Parapet and wall failure of an unreinforced wall at the back of the El Rancho Hotel. Most of the bricks fell next to the building, but note the one piece of bond beam that fell far enough to clear the crest of the adjacent house; scrapes on the house roof indicate other pieces of brick cleared this crest as well and slid to the ground in front of the house.

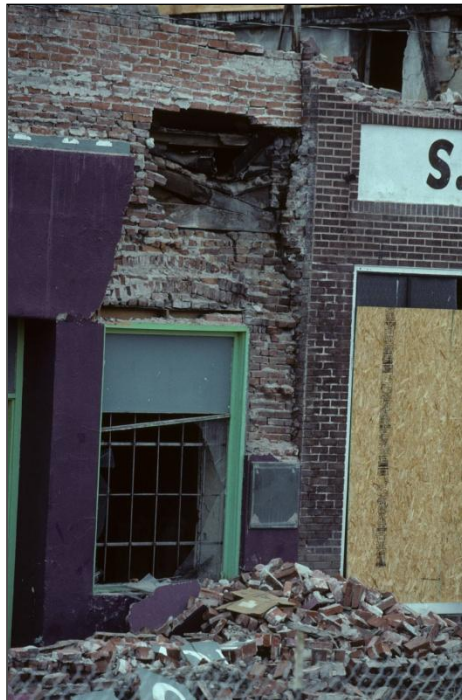
Figure 12. Failure of part of the front wall of the Capitol Club. The hole is in a wall that has three wythes of bricks. Above the hole the two outer wythes of bricks delaminated from the inner wythe, revealing a lack of cross-course bricks tying the upper wall together.

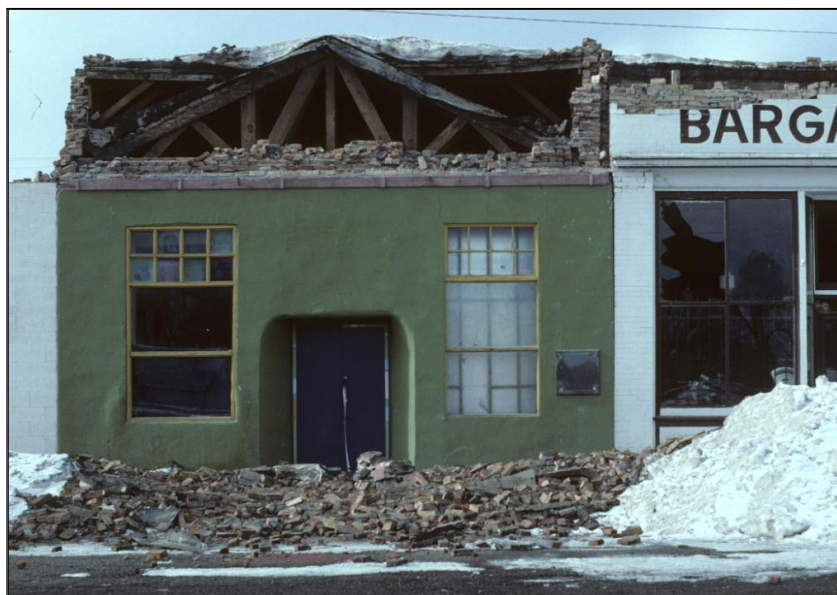
The gable unreinforced masonry ends fell out of the Goble Market (figure 13). These fell out like an unbraced parapet, and were attached only at the bottom to the roof system with a few anchor bolts. Movement of the roof system may have contributed to knocking the gables out.

Figure 13. The gable ends of the Goble Market failed. The hole reveals two roofs on the Goble Market, with an earlier pitched roof on a truss system. Damage stopped near a horizontal wood board attached to the building (this supported a wood-covered sidewalk the past).

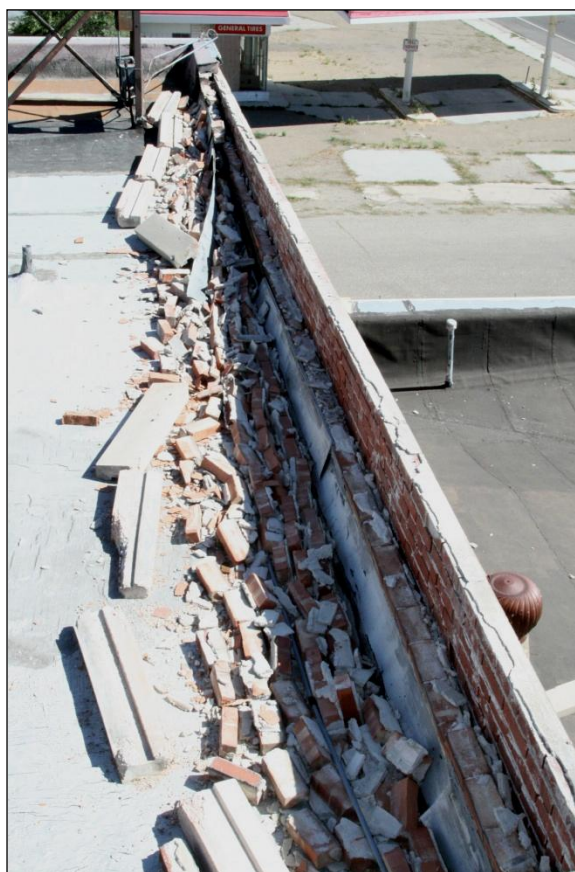
Figure 14. Parapet failure onto the roof of the El Rancho Hotel. The parapet appears to lack cross-tie bricks and the inner wythe of bricks has delaminated and fallen onto the building, along with the crowning concrete bond beam that capped the top of the parapet/wall.

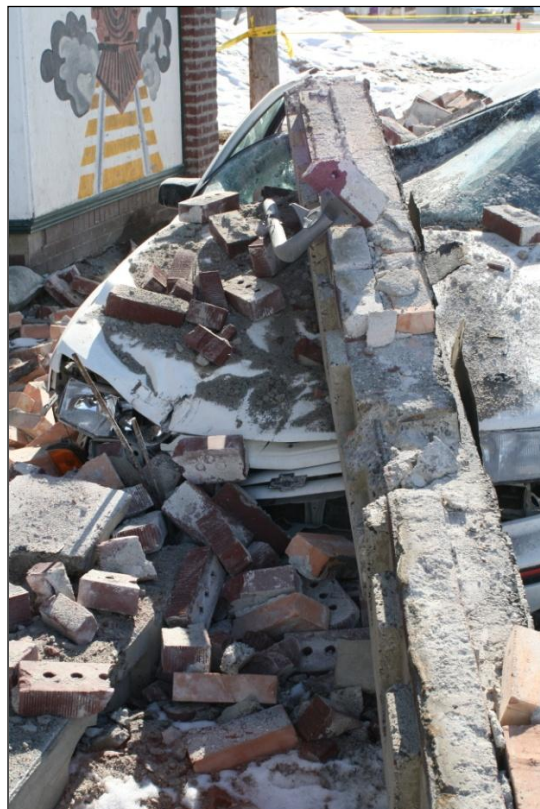
One particularly spectacular type of failure that occurred in several buildings was the toppling of the crowning bond beam from the top of the wall, either inwards onto the building's roof or outwards onto the adjacent building or sidewalk. When these bond beams fell all the way to the sidewalk, commonly with a few bricks stuck to them, they were very damaging (a graphic example of this is the crushed car shown in figure 17). Crowning bond beams in Wells were commonly placed on top of two-wythe-wide unreinforced brick walls that tended to be poorly cross-tied together in their upper parts. This made the upper part of the wall susceptible to delamination failure between the wythes of bricks, making it easier for the crowning beam to destabilize and fall.

Figure 17. Crowning bond beam that fell from two stories and crushed a car. This beam was reinforced with two pieces of iron rebar and fell off in relatively large pieces.

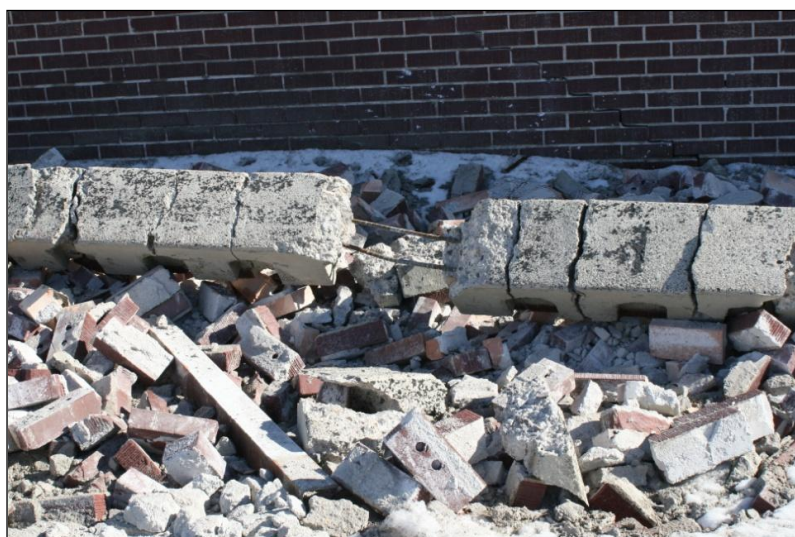
Figure 18. Crowning bond beam section that fell off the Wells Chalet and likely broke up from uneven impact. Rebar in the bond beam can be seen. This is the same bond beam that is shown in figures 17 and 19.

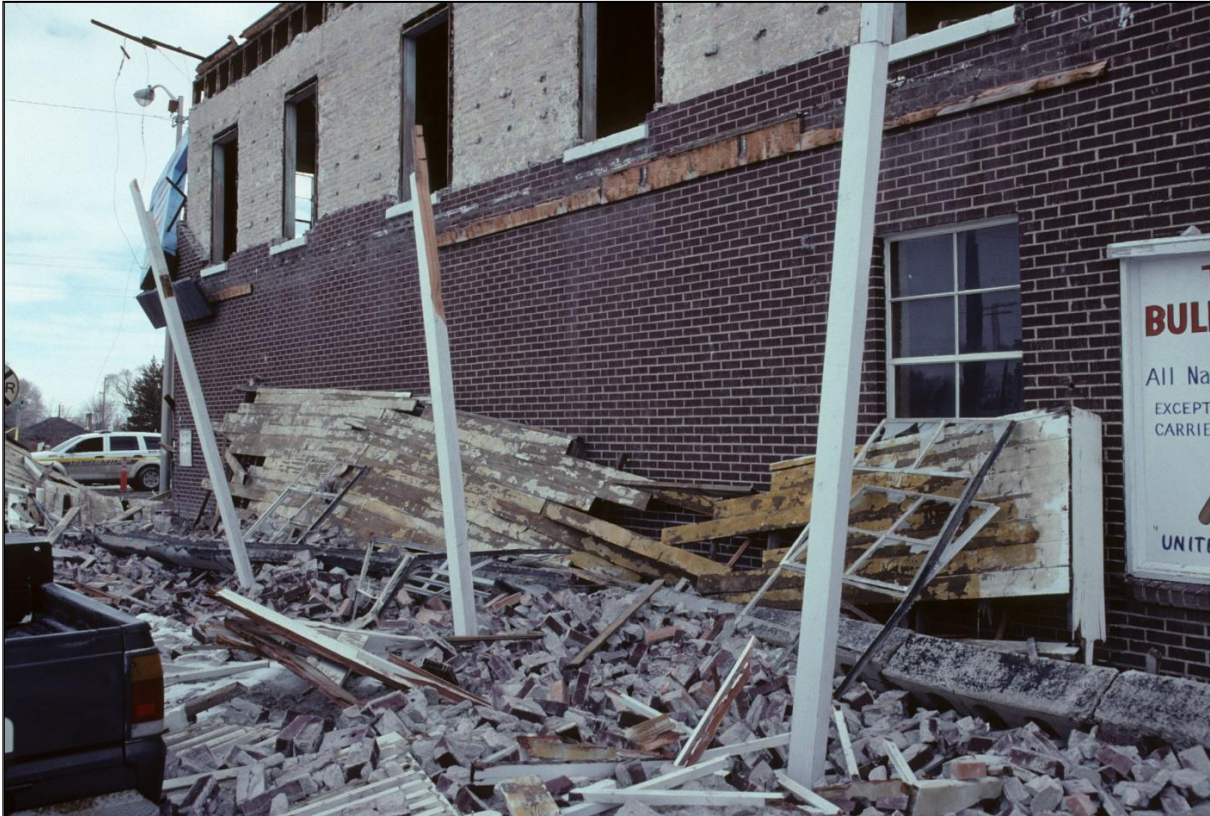
Figure 19. Western side of the Bullshead Bar. The balcony has been smashed to the ground abruptly breaking the column connections and leaving the columns still standing. This likely happened because the balcony was rapidly impacted by the large, nearly intact crowning bond beam that can be seen in the photo. This is the same beam that crushed a car to the right of the area shown here (figure 17).

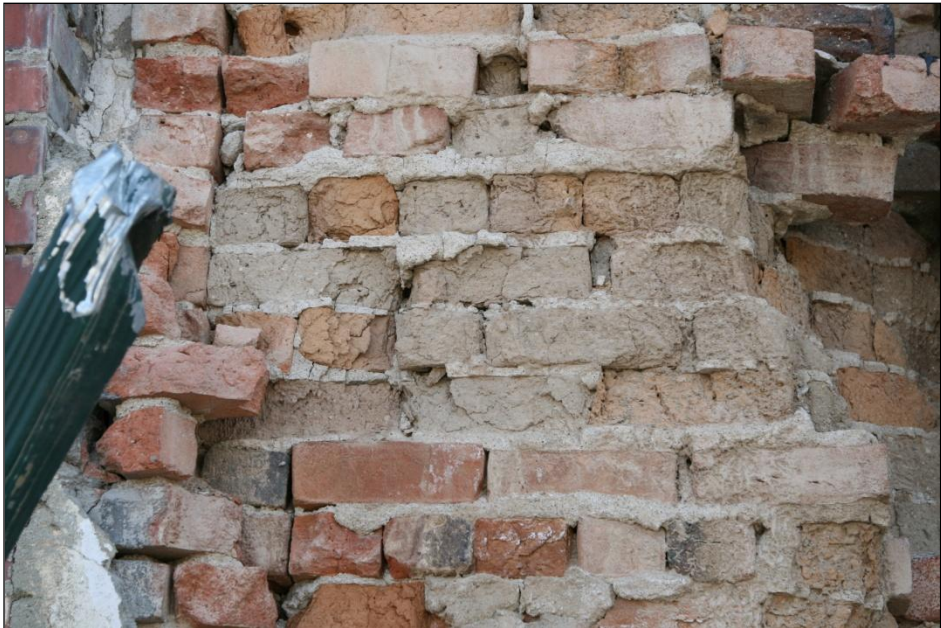
Figure 21. Adobe and unfired bricks in the back wall of the Quillici Market. These were weak elements and were reduced to a pile of dirt when wetted. Notice the course of fired bricks on the far left side of the photo that covered up the unfired bricks.

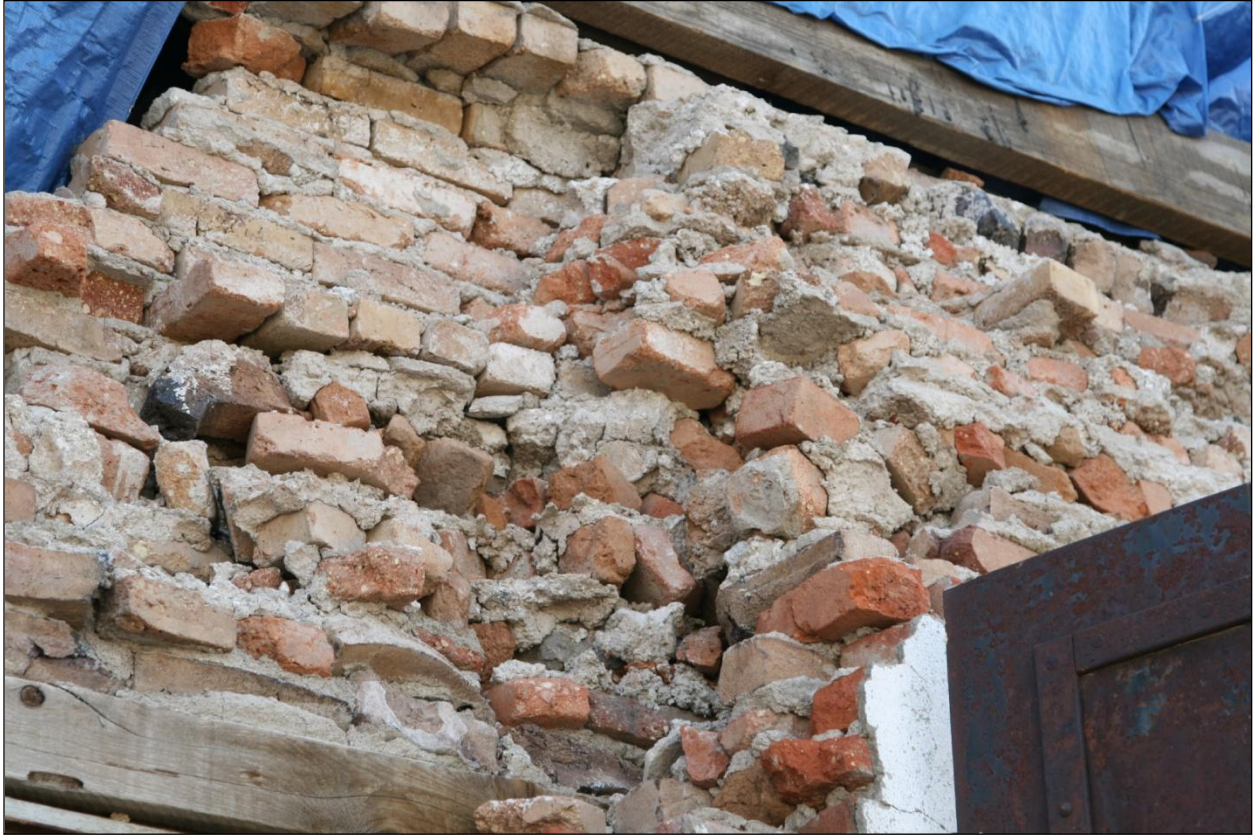
Figure 22. Rubble infill (basically unlaid brick) in the unreinforced masonry wall at the back of the Quilici Market. This was covered by laid bricks and stucco (lower right center).

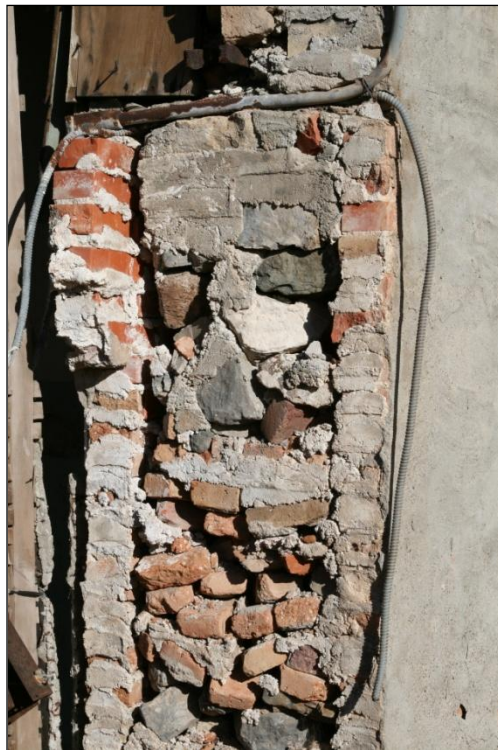
Figure 23. Rubble infill in the unreinforced masonry wall at the back of the San Marin Hotel. There were holes and gaps in this wall large enough to put a man's fist into, and several of the rocks were thrown in with no mortar in between them. The outer courses of laid bricks served as the forms for the rubble infill and hid this kind of construction from outside visual inspections.

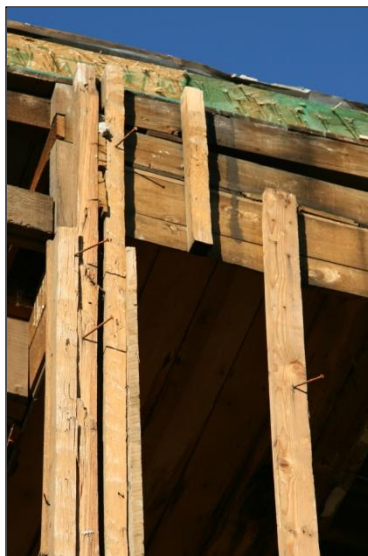
The Bullshead Bar building was veneered with brick in 1945. The bricks used each had three small holes in them that allowed some mortar to ooze in. The ties to the structure for the veneer were one- to three-nail clusters driven into two-by-four vertical wall studs every half-a-meter or so, and sticking out into the mortar joints of the veneer (figure 26). The part of the second story veneer that didn't fall shows several "X-fractures" that break the wall up every 30 to 50 cm (figure 27), apparently because the more flexible wood frame building was moving back-and-forth and breaking up the more rigid veneer. Many of the nails used as ties pulled out of the studs, but others remained. Several nail clusters used on the western wall retained a small amount of mortar when they stayed. This veneer was one wythe wide and served as a wall in half of the second-story northeastern front of the building. It had a fairly heavy concrete bond beam on top, which fell off in its entirety. The veneer on the front failed down to the first story, near where older bricks covered the first floor walls. On the western side of the Bullshead Bar building, the brick veneer also stripped down to the top of the first floor; here the same

Figure 26. Detail of the upper part of the front of the Bullshead Bar showing the wood frame structure and nails that were used to tie the brick veneer to the building. There were more nails; some were pulled out.

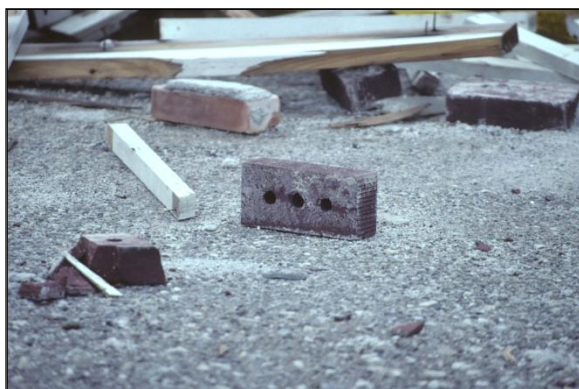
Figure 28. Brick from the upper part of the veneer of the Bullshead Bar showing small holes for the mortar to go into. Cracks seen in figure 25 that cross both types of bricks do not show distinct differences in character when they do so.

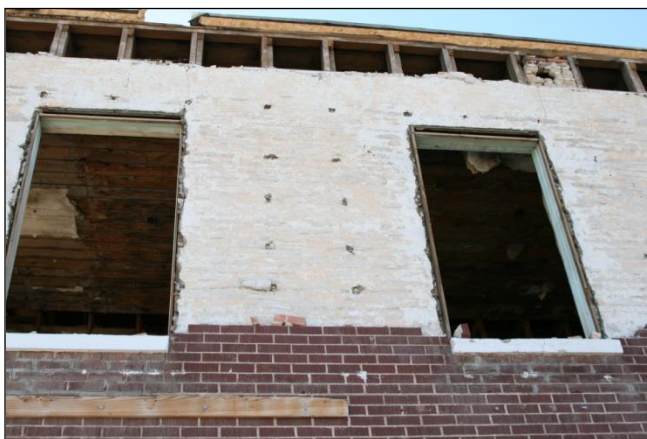
Figure 29. The second story of the western wall of the Bullshead Bar where the unreinforced brick veneer has fallen off. The darker areas on the white wall are where nails, either single or clusters of nails up to three in number, were driven into the wall studs. This was how this one-wythe-wide veneer was attached to the building.

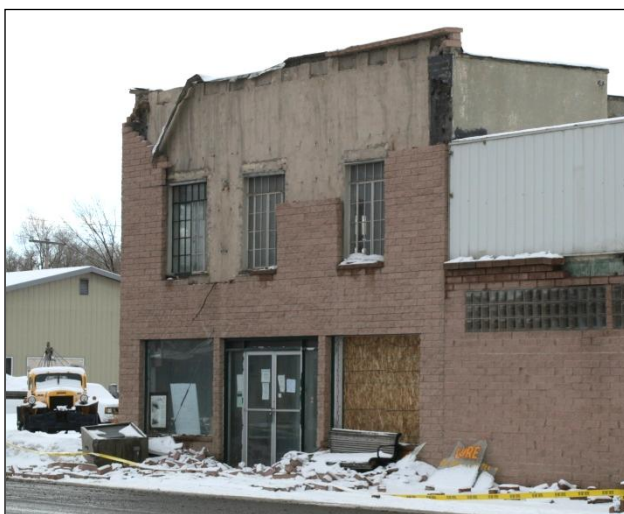
At the Overland Hotel, bricks fell off the front of the building (across the entrance) and off the eastern side (figures 28 and 29). The front pane glass window also shattered over a bench in front of the building, which was unoccupied in the early morning hours of the earthquake. Small metal attachment strips remained on the building, which were tying the veneer to the structure. During the clean-up, the rest of the bricks were taken off the structure and the front was covered with stucco and painted.

Figure 30. Failure of an unreinforced brick veneer on the Overland Hotel.

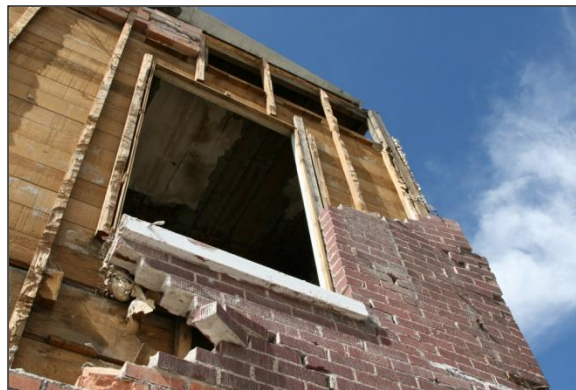
Figure 32. Wood frame of the Bullshead Bar exposed at the northwest corner of the building where the brick cladding has come off. The remaining cladding is damaged and ready to fail, which would also allow the concrete window sill to fall.

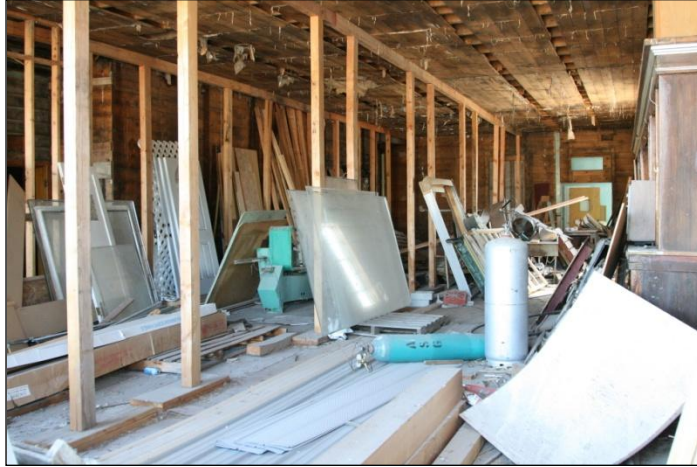
Figure 33. Interior of the Bullshead Bar showing the wood-frame structure. There are new wood braces (pre-earthquake) to help secure the building during construction. Note the leaning glass and other items on the first floor that did not topple or break. The wood reinforcing frame may have helped to keep the building from collapsing during the earthquake.

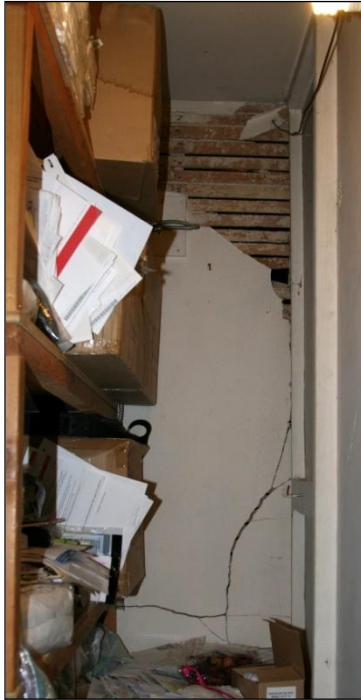
Figure 35. The eastern portion of the building had racked and fallen plaster.

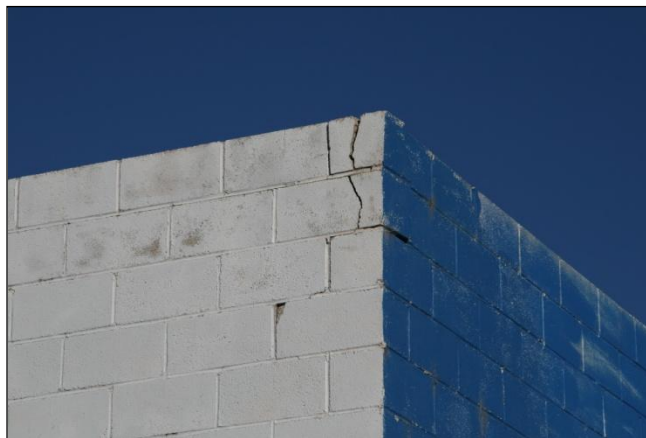
Figure 36. Damaged corner of the concrete block Supp Garage.

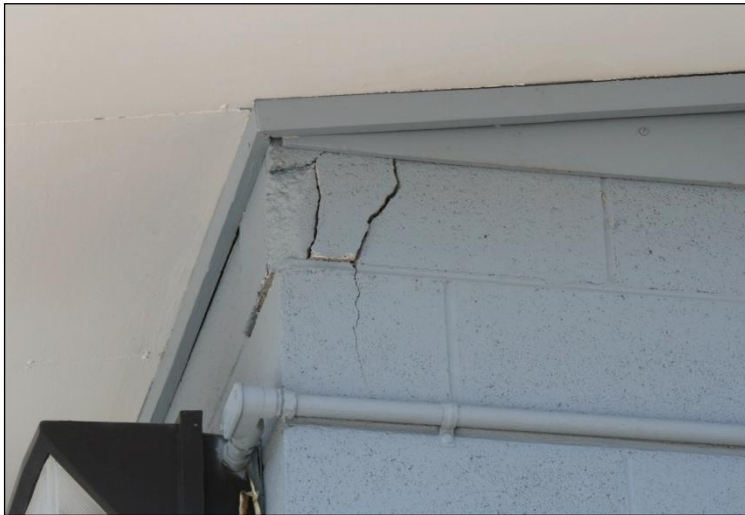
Figure 37. Broken concrete block brick and cracking in the upper corner of a Nevada Department of Transportation garage building in Wells.

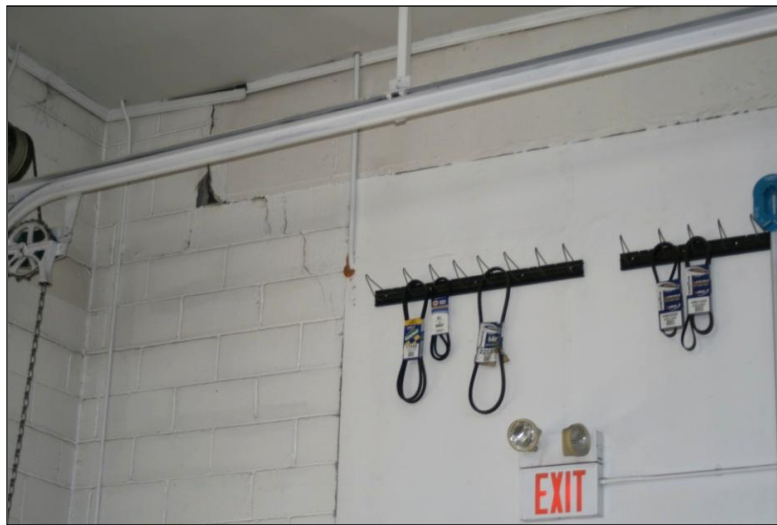
Figure 38a. Cracking in the inside corner of a Nevada Department of Transportation garage.

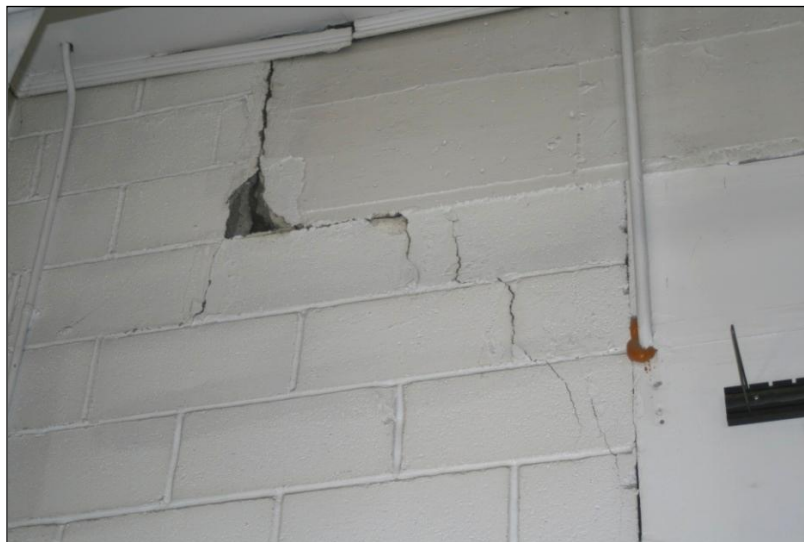
Figure 38b. Close-up view of the cracking shown in figure 38a.

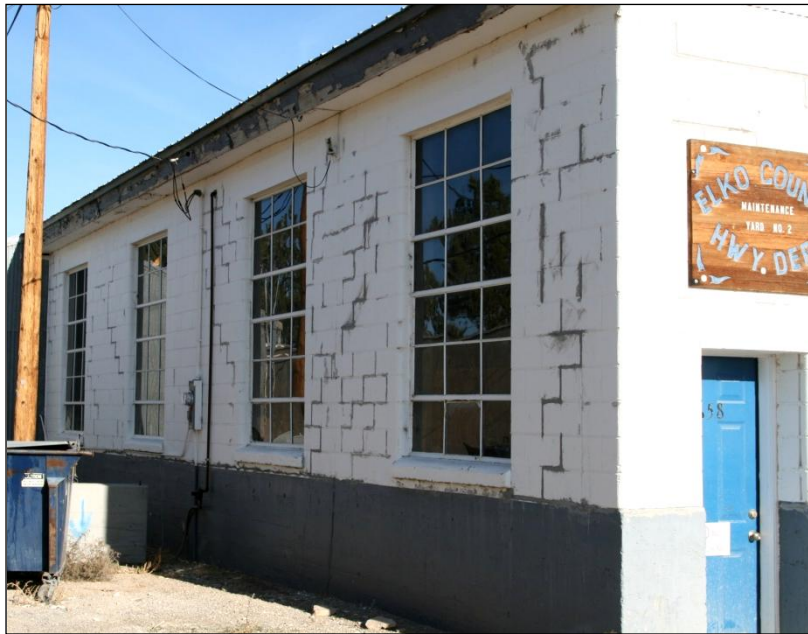
Figure 40. Southern side of the same building shown in figure 39, also showing patched cracks.

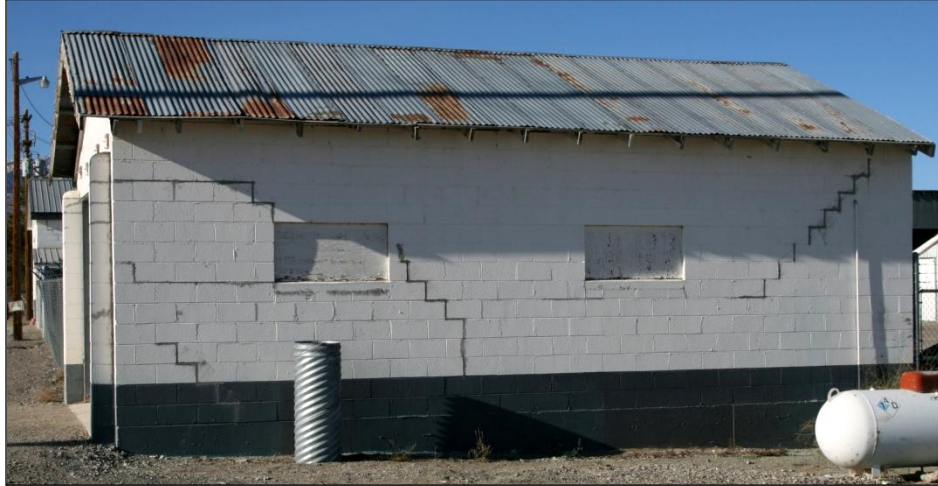
Figure 41. Patched cracks in another concrete block masonry building at the Elko County Highway Department compound; northern wall is shown.

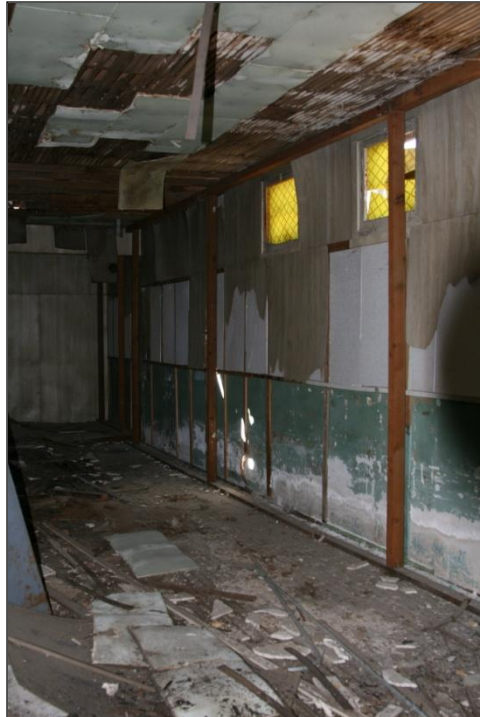
Figure 45. Bracing under the ceiling joist connections and roof. This example is from the Eagle Club.

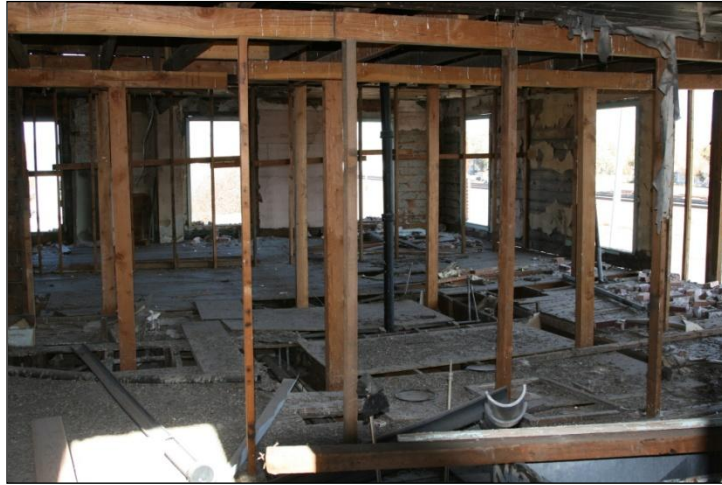
Figure 46. Interior wood bracing in the second story of the Bullshead Bar; the first story had bracing as well (figure 33).

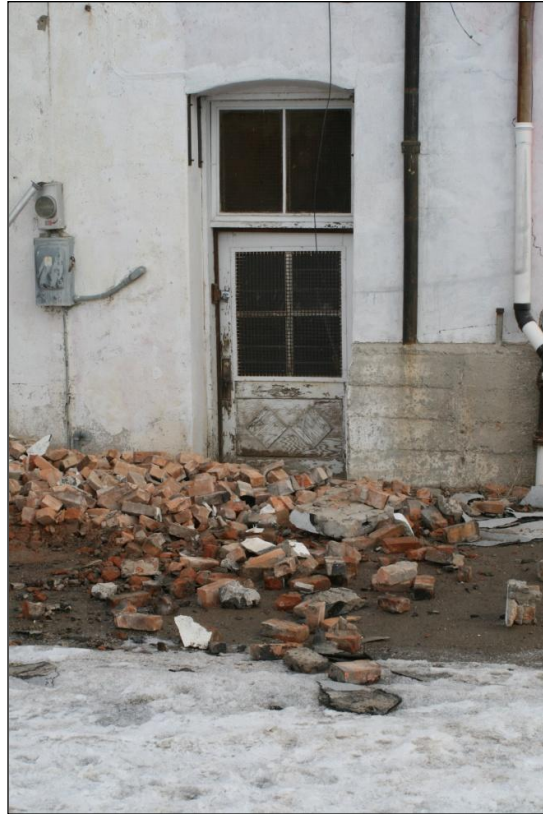
A significant amount of bricks and debris fell at many of the entrances and exits of the damaged buildings in the historical district as a result of the Wells earthquake (figure 49). A quick survey of the exits from 16 damaged URM buildings determined that out of a total of 36 exits, 21 exits (58%) had fallen debris and 15 exits (42%) were clear of debris. Two of the 21 debris-strewn exits had some overhanging protection from falling bricks: in one case it was a balcony and in the other it was the metal roof of an adjacent enclosed garage that served to protect the exits. Only 4 of the 16 damaged URM buildings had exits that were clear. In contrast to this, there was only one URM building that had few survival spaces left after the damage, and that was the collapsed San Marin Hotel. Most of the interiors of these buildings were clear of debris, which tended to fall away from buildings. Thus, in 15 out of 16 of the damaged URM buildings, any occupants would have survived the Wells earthquake by staying inside the buildings.

Figure 49. Bricks that fell across the back entrance of Quilici and Sons Market.

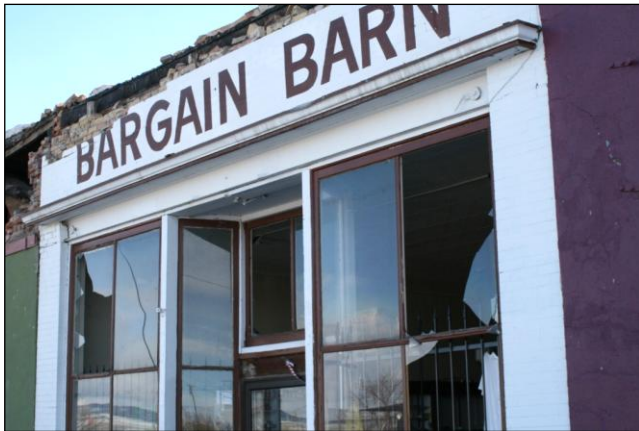
The Bargain Barn (formerly the Elite Saloon) was an operating store in the historical district. A large, sheet metal cornice fell off the top front of the Bargain Barn from just above the name along with several bricks, and a couple of the front windows were broken. Although a minor amount of merchandise thrown off the shelves and onto the floor, most of the merchandise stayed on the shelves along the walls and on the free standing shelves, which was surprising, given the earthquake damage to the historical district and the front of the Bargain Barn itself.

Figure 50. Front of the Bargain Barn store showing a couple of broken windows. The area above the sign is where the decorative cornice fell out. The broken windows on the left side of the store front in the picture are next to a column that was displaced at its top.

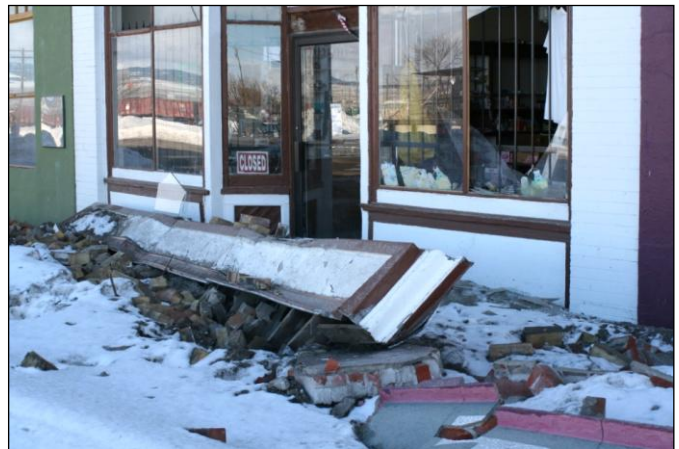
Figure 51. The cornice that fell from the top front of the store lies immediately across the entrance in an upside-down-and-backwards position. The cornice itself is made of metal sheeting, metal and wood, and was mounted into the unreinforced brick front.

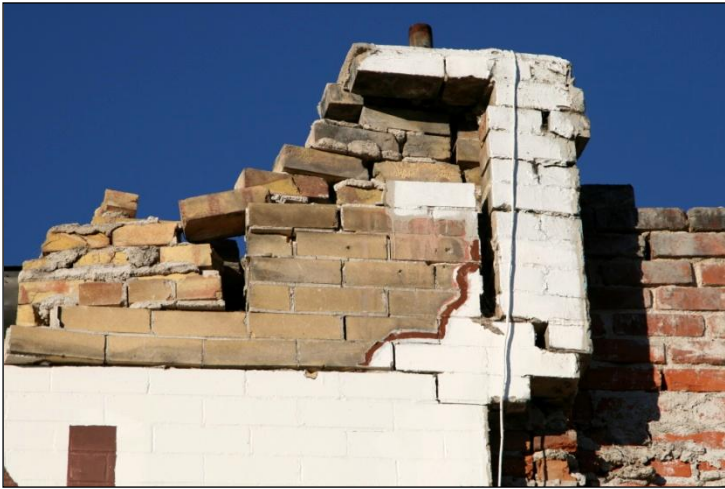
Figure 52. Top of front wall of the Bargain Barn where the cornice pulled out. Note the paint outline. This western side of the parapet didn't fail but was badly damaged.

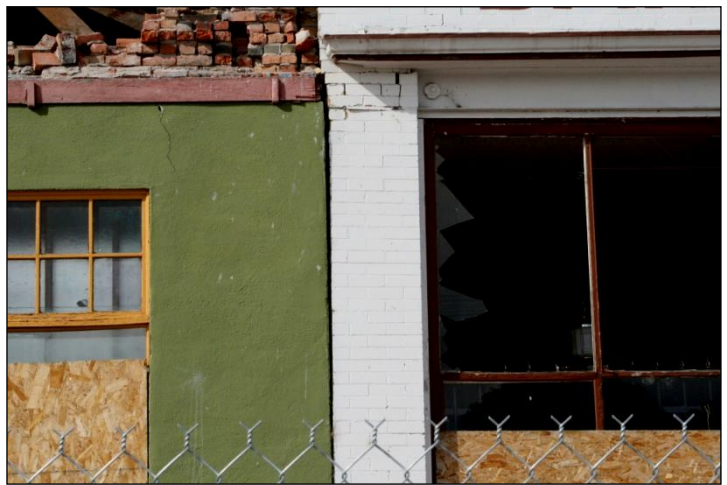
Figures 53. Pounding damage to the eastern wall of the Bargain Barn.

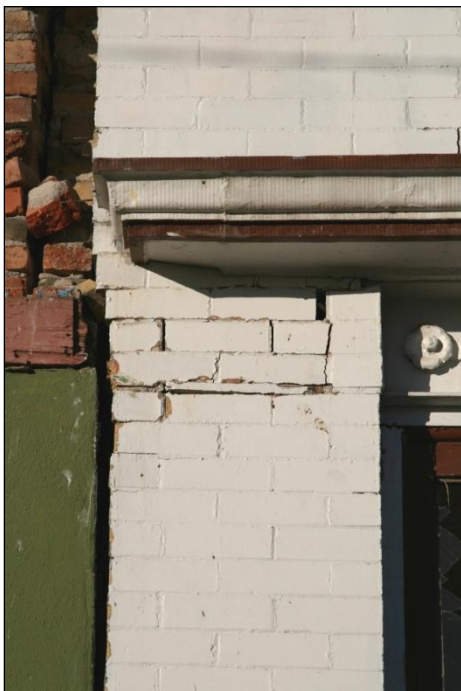
Figure 54. Closer view of the column in figure 53. This front column was pounded and displaced about 4 cm to the west over about four courses of bricks.

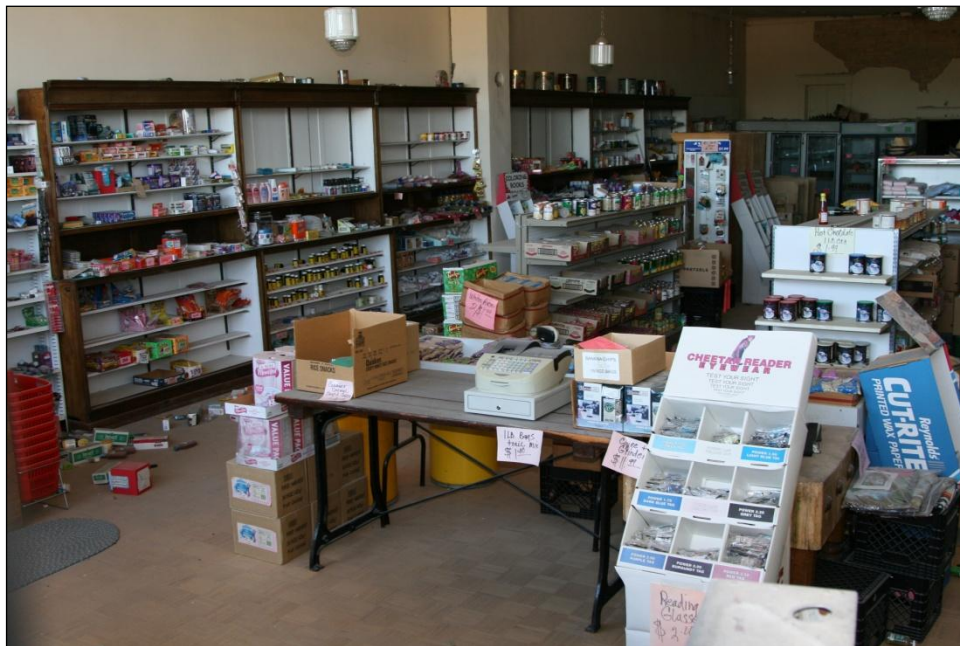
Figure 58. Another view of the interior of the Bargain Barn.

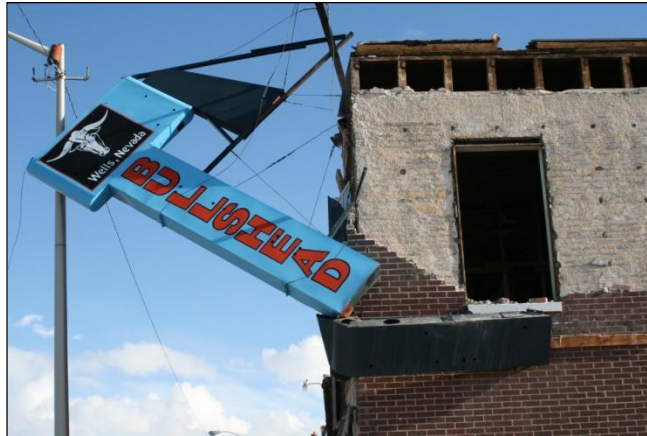
Figure 59. The northeast corner of the earthquake-damaged Bullshead Saloon with its dislodged sign.

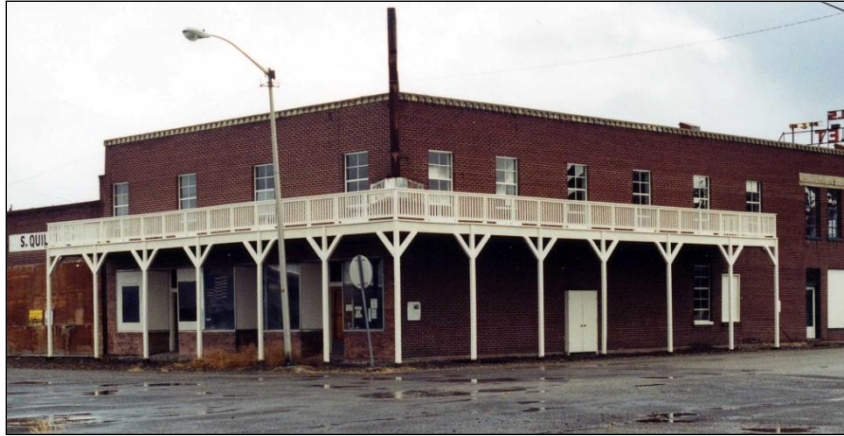
Figure 61. The Bullshead Saloon before the earthquake. The front is on the left side and the western side is on the right. The balcony surrounds the building and the bond beam can be seen on the top of the wall. *Photograph by Sue Chapman.*

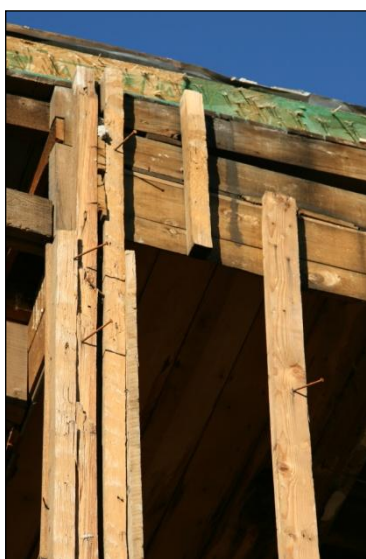
The relatively brittle brick veneer on the second story was put on the outside of the Bullshead Saloon in 1945 and was anchored to the wood studs and columns of the building with long nails stuck out into the veneer mortar (figure 64). The brick veneer was deformed into pieces from the shaking of the more flexible wood-frame structure (figure 65), and fell onto the balcony, the sidewalk, and the street.

Figure 64. Detail of the upper part of the front of the Bullshead Saloon showing the wood-frame structure and nails that were used to tie the brick veneer to the building.

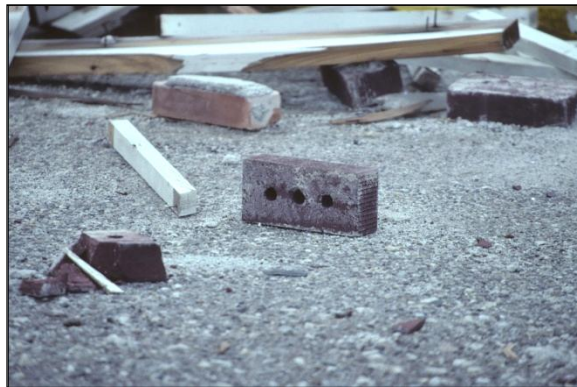
Figure 66. A brick from the upper part of the veneer on the Bullshead Saloon showing small holes for the mortar to stick into them and give the wall some lateral strength. Cracks seen in figure 65 that cross both types of bricks do not show distinct differences in character.

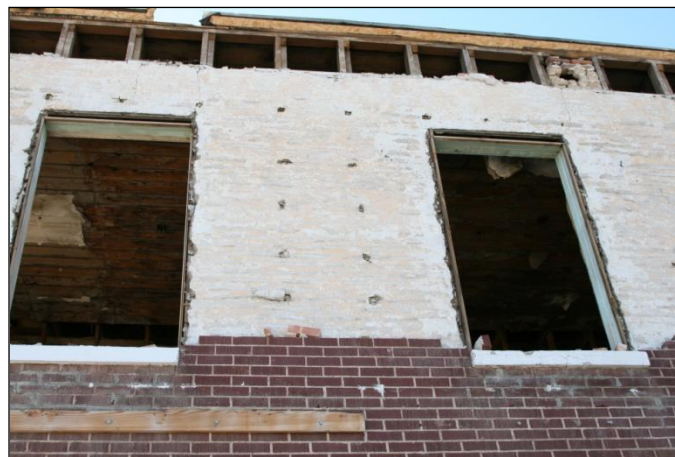
Figure 68. Part of the western wall that shows where the brick veneer has peeled away. The dark areas in the wall are where the nails tied the veneer to the building (many still have the nails in them that weren't pulled out – the veneer probably broke up around them). The window frames and glass fell out with the bricks.

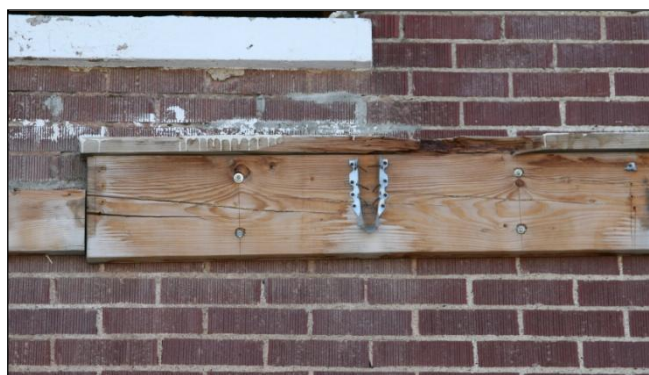
Figure 70. Hanger that held the building side of the balcony up.

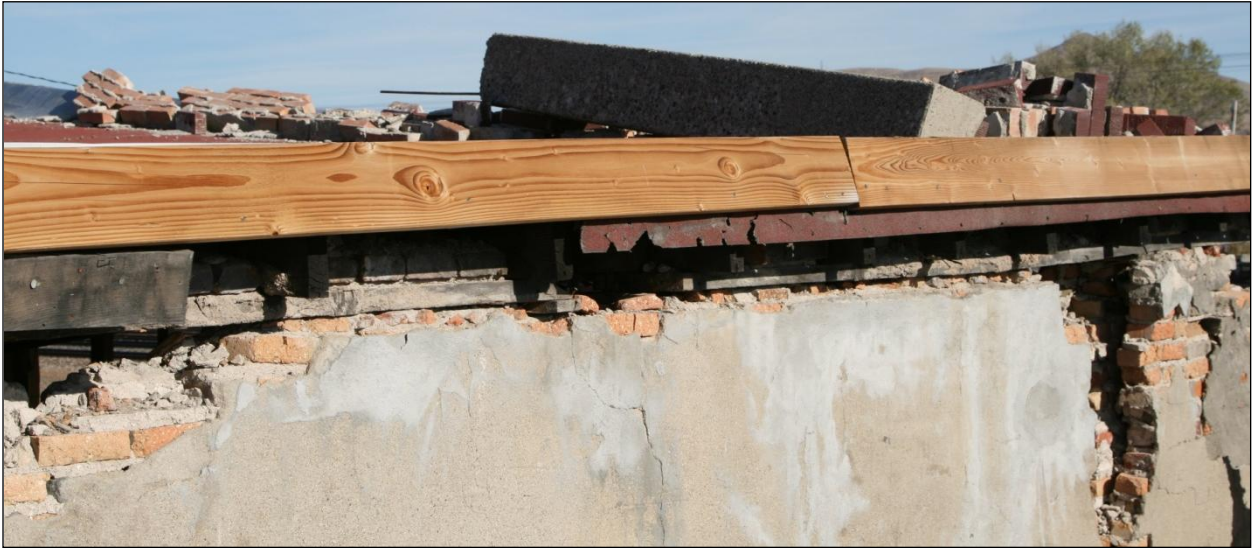
Figure 71. Eastern wall of the Bullshead Saloon. Contact between the roof and the wall. The roof is detached and is carried by the wood frame.

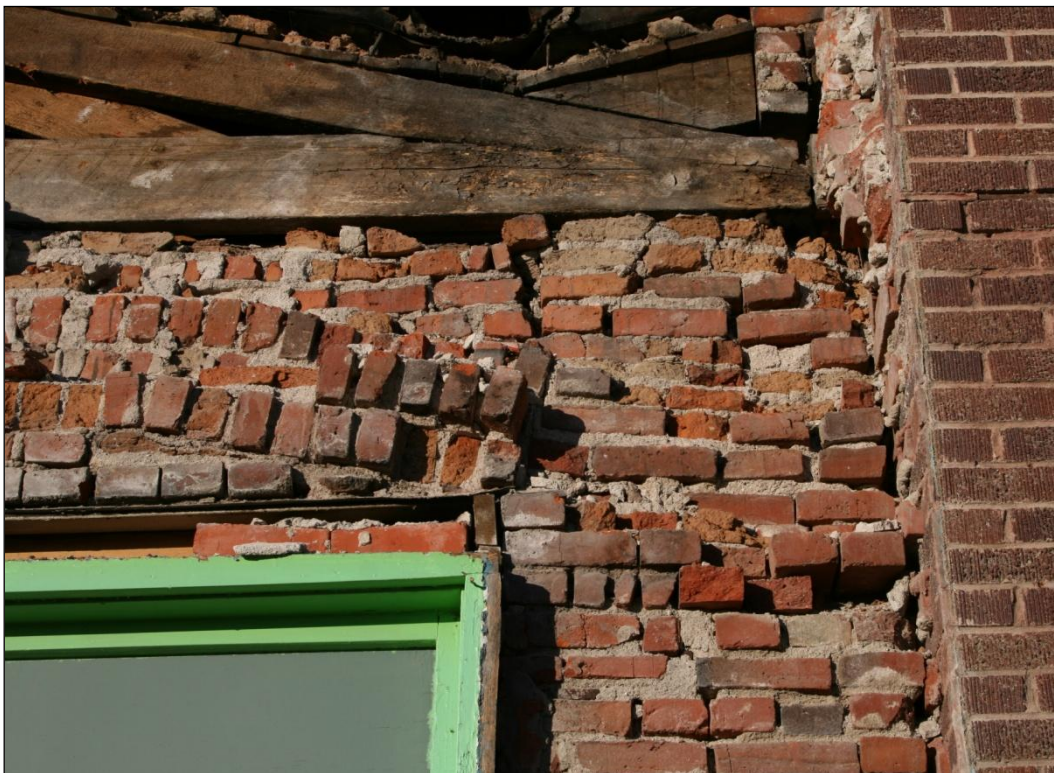
Figure 75. Detail of the front wall. Several of the vertical contacts between bricks lack mortar.

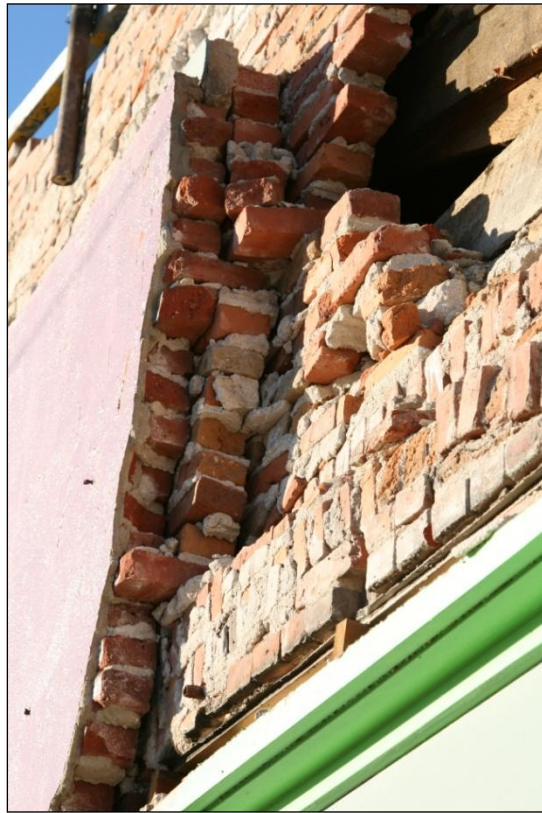
Figure 76. Detail of bricks in the front wall of the Capitol Club. Some widely spaced cross-course bricks can be seen.

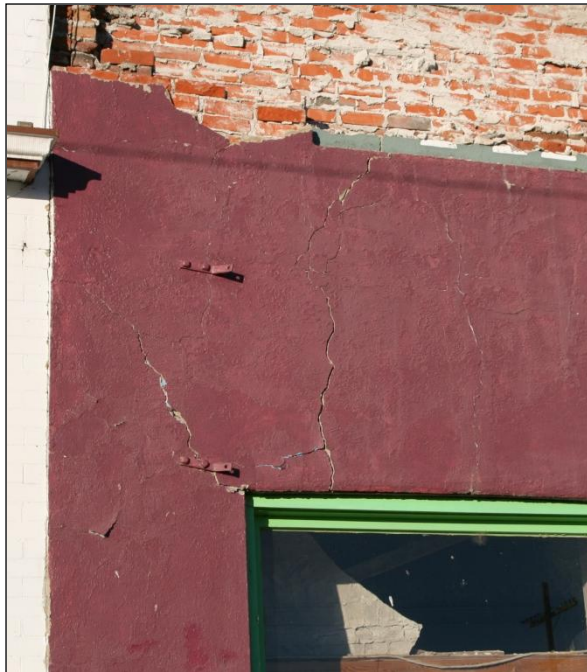
Figure 77. Part of the front wall of the Capitol Club that has not failed but is badly cracked. Note in the window that a part of an interior plaster ceiling has failed.

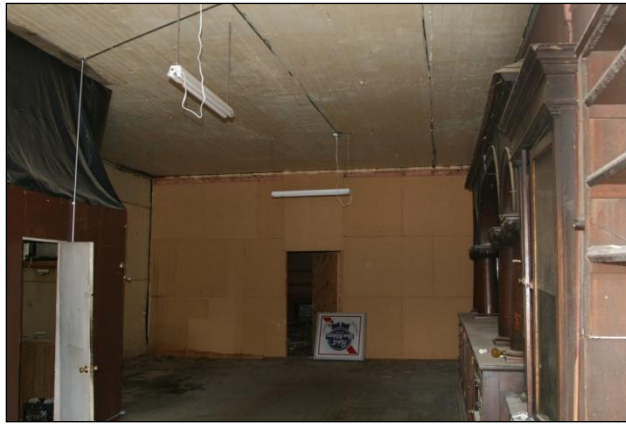
Figure 78. Interior of the Capitol Club showing few effects of the earthquake. The large bar back on the right is assumed to be unanchored to the wall. Note the fluorescent lights still hanging from the ceiling on relatively light-gauge chains.
