Building Damage from the 2008 Wells, Nevada Earthquake

Craig M. dePolo
Nevada Bureau of Mines and Geology
University of Nevada, Reno

2011

ABSTRACT

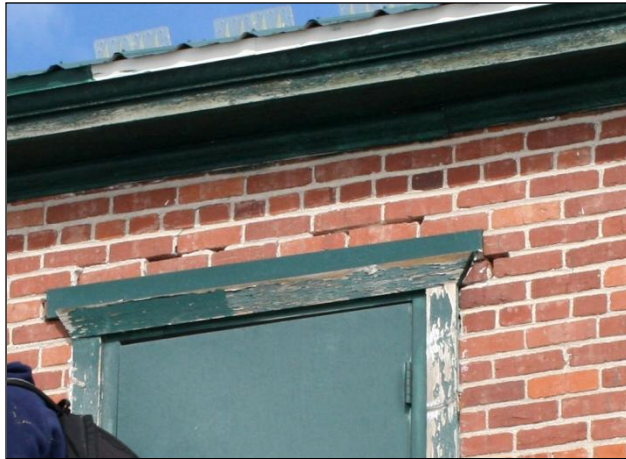
Figure 80. Disrupted bricks above the second-story fire escape of City Hall.

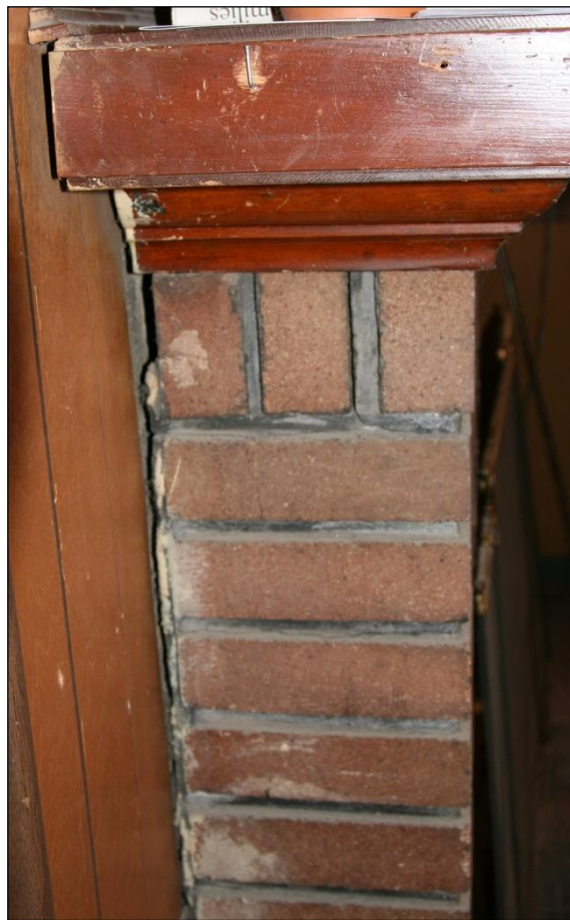
Figure 81. Displaced fireplace in Wells City Hall; this can be seen in the crack between the upper part of the fireplace and the wall.

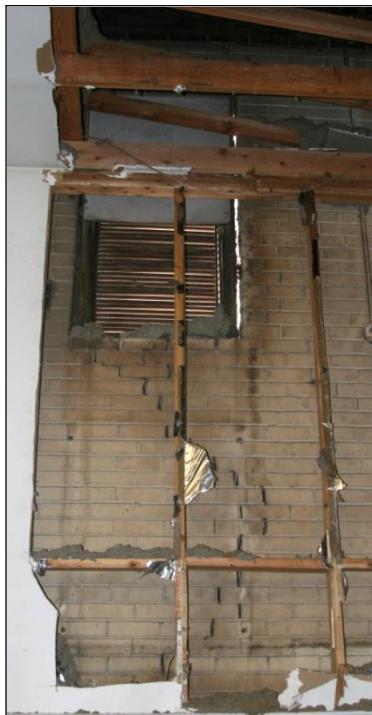
Figure 83. Wall crack shown in Figures 84 and 85 viewed from inside the city shop. There is a wood frame for the interior ceiling and walls.

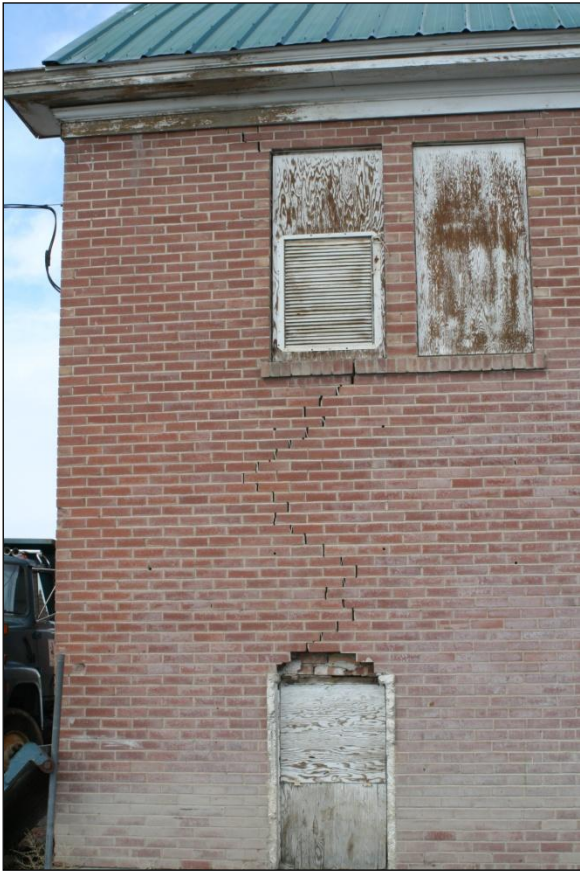
Figure 84a. Cracking of the Wells City Shop.

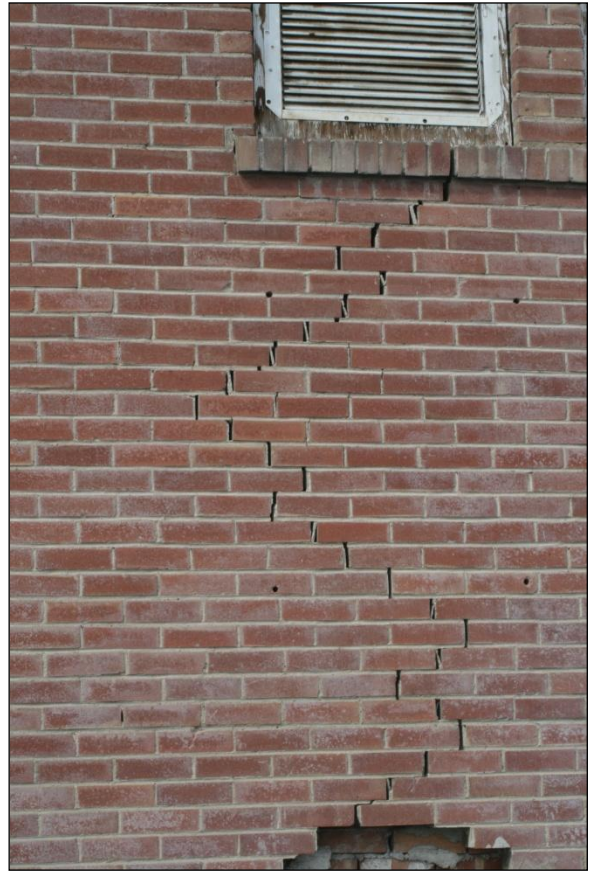
Figure 84b. Close-up view of the crack shown in figure 84a.

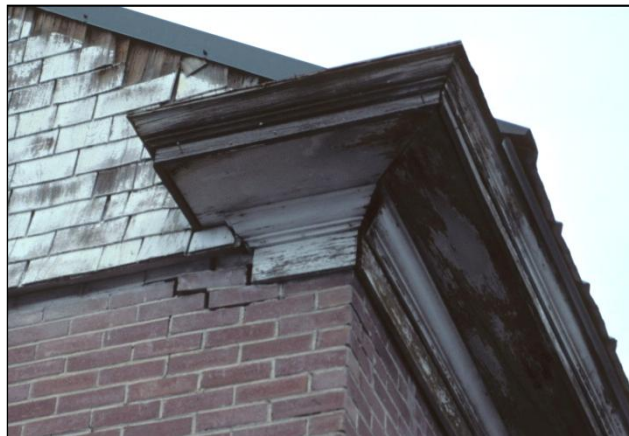
Figure 85. Cracking in the upper corner of the City Shop building, just below a wooden cornice.

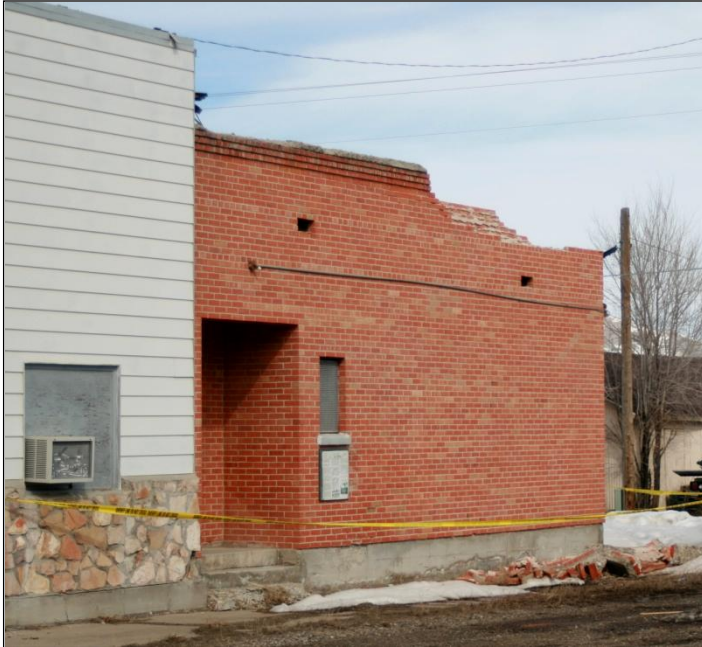
Figure 86. Fallen bricks and crowning bond beam from the parapet on the Constable Powers Building.

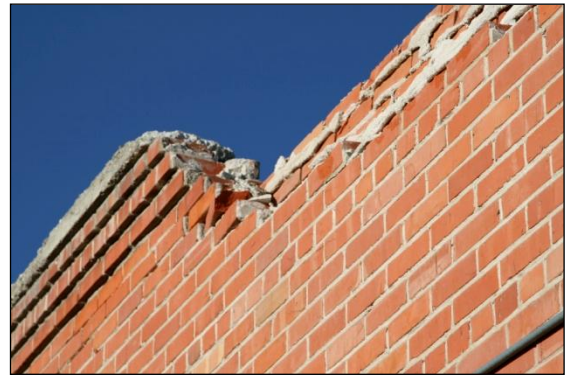
Figure 87. Parapet section that fell out of Constable Powers building.

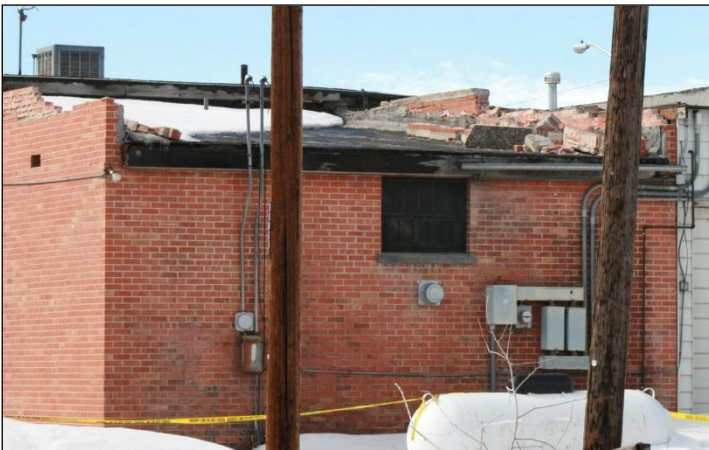
Figure 88. Bricks that fell onto the top of the Constable Powers Building.

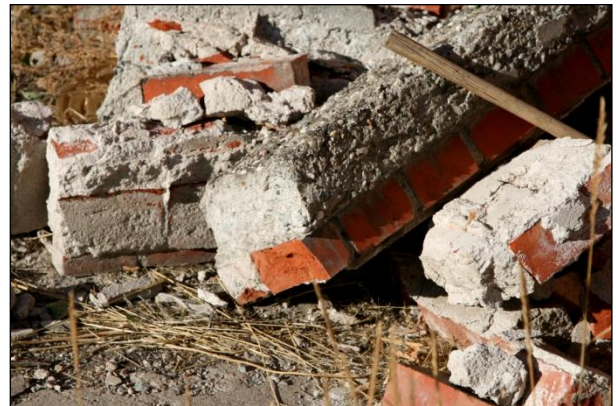
Figure 89. Part of the crowning bond beam that fell from the Constable Powers Building.

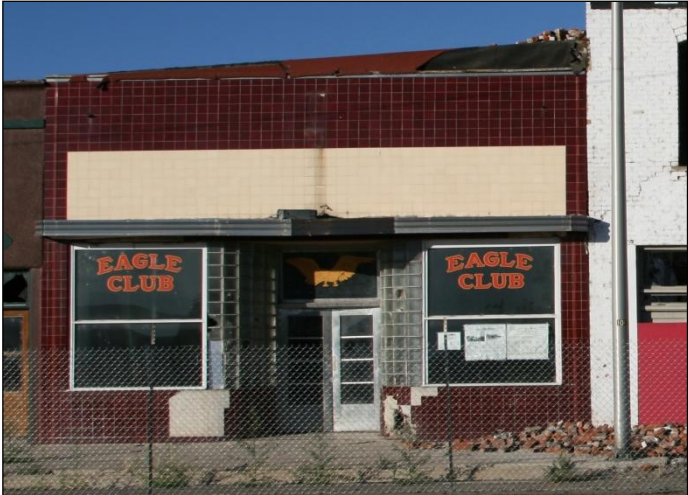
The Eagle Club is a small one-story unreinforced masonry building that was built shortly after the 1901 Wells fire and had been added onto in the back at least twice. The building generally survived the earthquake fairly well, but suffered some roof damage, the loss of bricks and crowning bond beam from parapets in the back portion, and some badly cracked walls. The upper western part of its wall had been extended upwards with a wood frame built against the wall of the San Marin Hotel; this wall failed, exposing the interior of the Eagle Club to the weather. The sign in the front fell onto the front awning, but this reportedly happened prior to the earthquake.

Figure 90. Front of the Eagle Club.

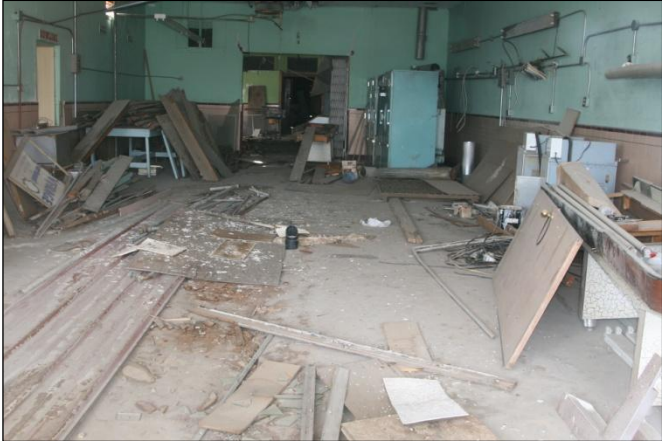
Figure 91. Interior of the Eagle Club showing little earthquake damage and washing machine units in the upper right that did not topple.

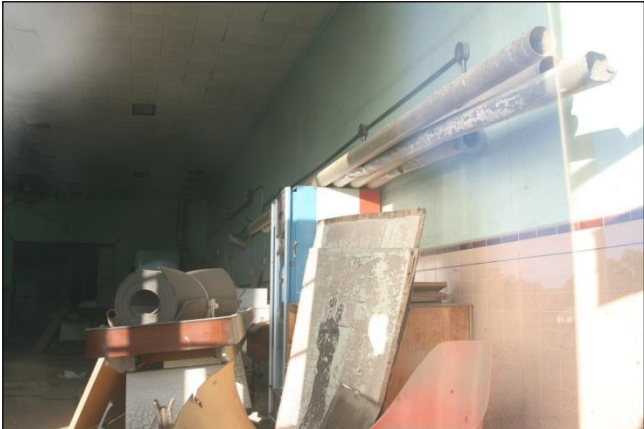
Figure 92. In the photograph to the right showing the inside of the Eagle Club, the pipes on the cabinet surprisingly stayed up during the earthquake even though they were free to roll around.

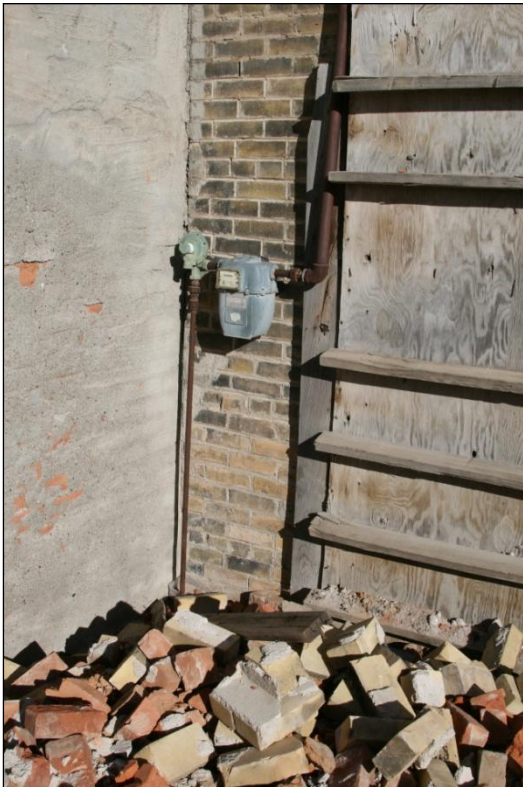
Figure 94. Corner between the back wall of the San Marin Hotel and the Eagle Club. An inactive gas regulator was threatened by falling bricks (shown to the right and below). Active utilities need to be protected from falling bricks around unreinforced brick/masonry buildings, possibly with a protective cage.

Figure 95. Close-up view of the gas regulator shown in figure 94.

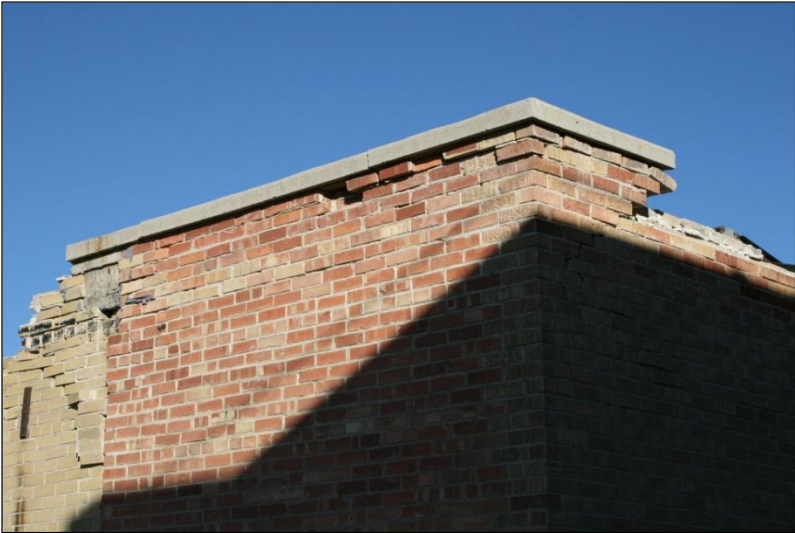
Figure 97. Remaining part of the crowning bond beam and upper wall near the back southwest corner of the Eagle Club.

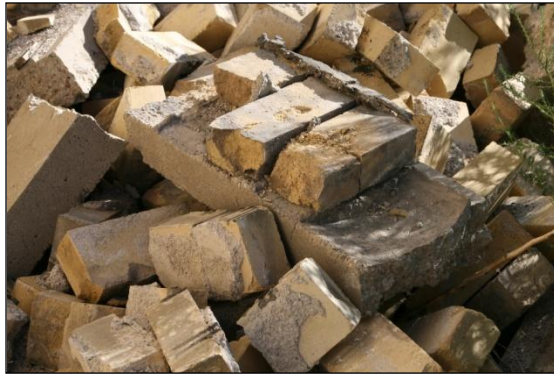
Figure 98. Bricks and a part of the concrete crowning bond beam that fell from the Eagle Club.

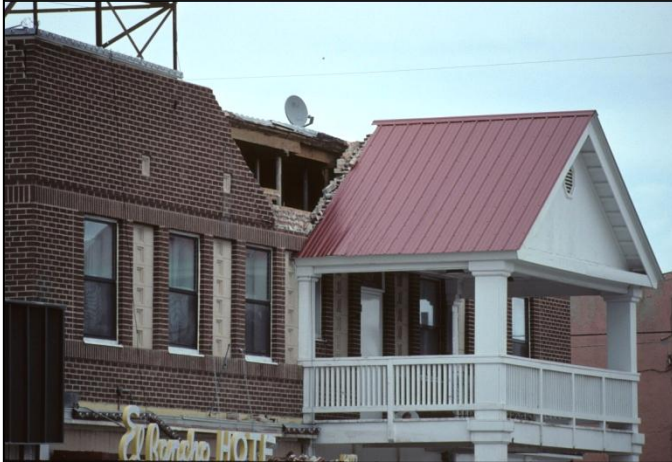
Figure 101. Upper part of the front unreinforced failure brick wall that fell out.

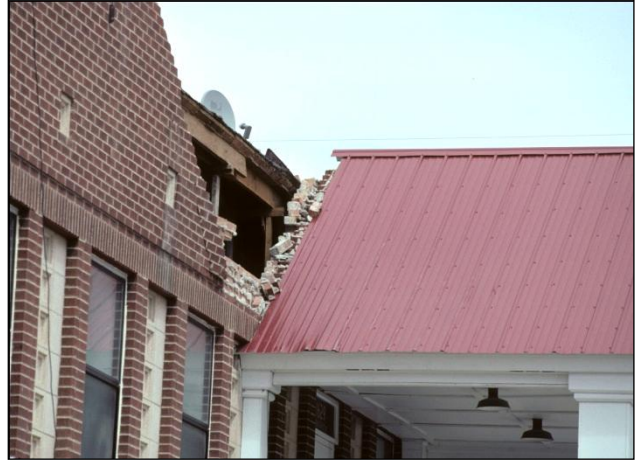
Figure 102. Close-up of upper wall shown in figure 101.

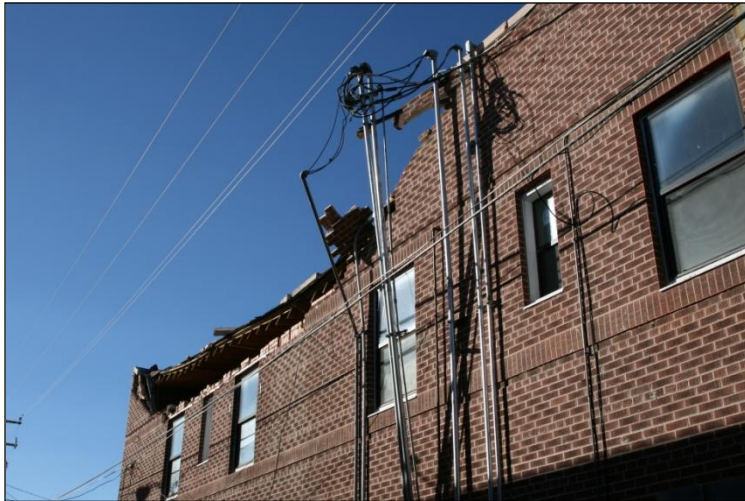
Figure 103. Failure of the upper part of the northern wall. A large section of the wall between the ceiling joists and the roof, including the parapet, fell out and damaged electrical masts to the building.

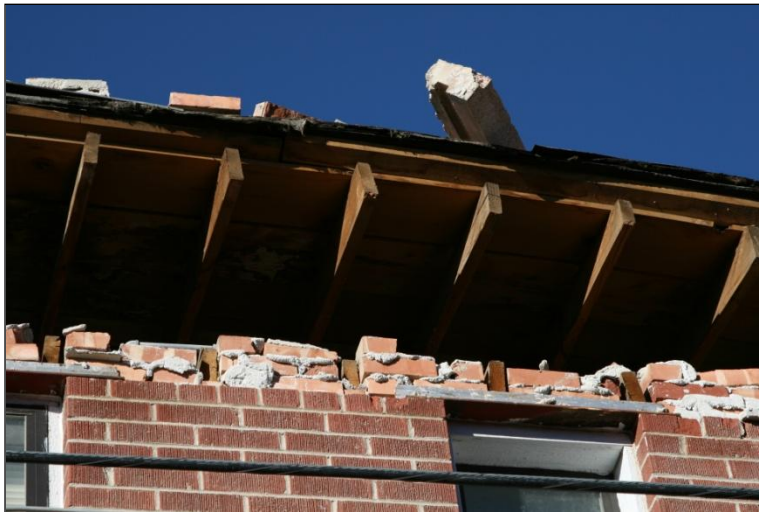
Figure 104. Close-up of the wall failure showing hanging roof joists, a section of bond beam on the roof, and the exposed ceiling joist connections.

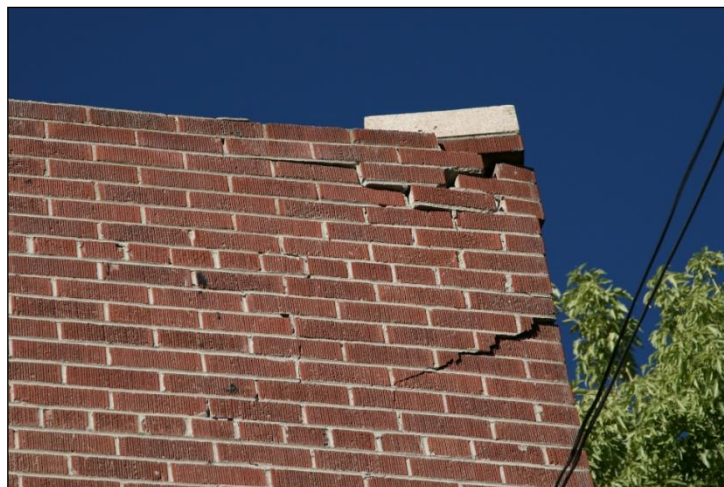
Figure 105. Brick damage to the northwest corner of the El Rancho Hotel.

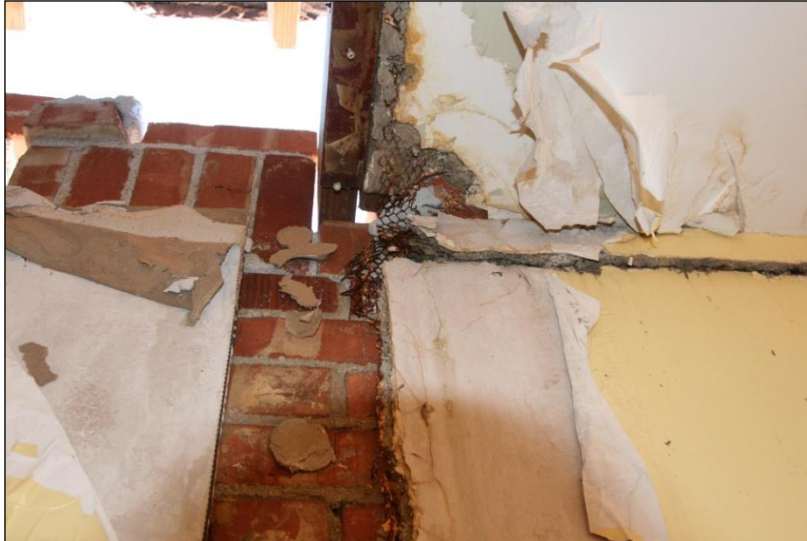
Figure 106. Ceiling joist connection exposed by water damage. The joist is unattached to the wall, but was found to have shifted only a few millimeters in this case, once the shaking had stopped.

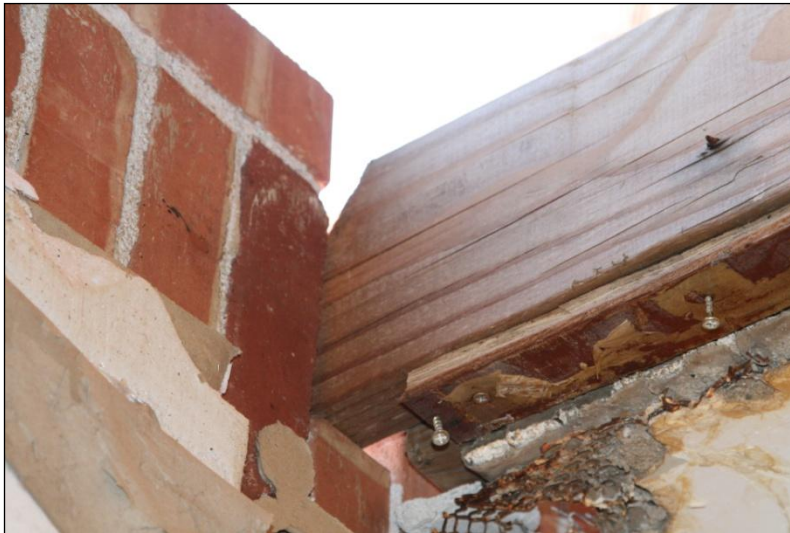
Figure 107. The diagonal cut is a “fire cut” made so the cut would burn faster if there was a fire and drop the interior of the building without damaging the walls. With a longer duration of shaking, these connections might have started to fail.

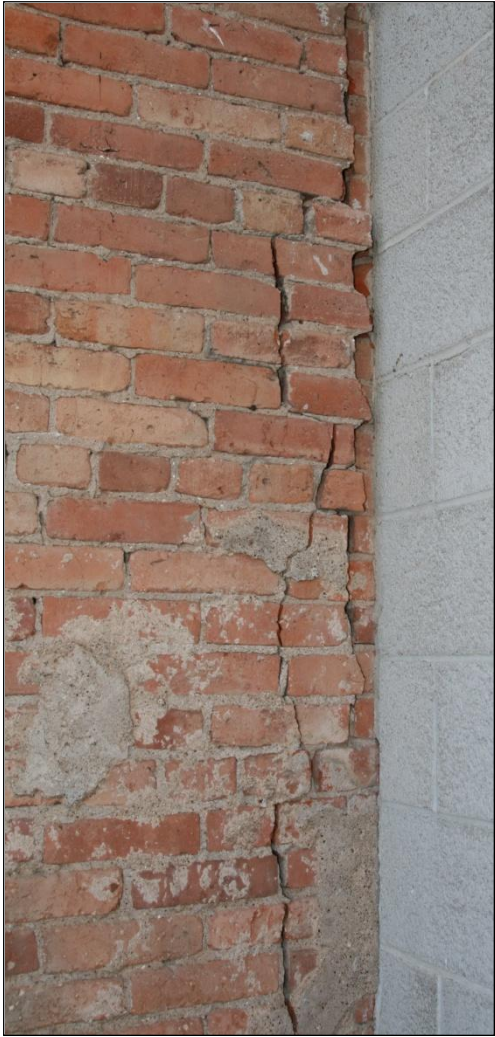
Figure 119. Cracked interface between the undamaged concrete block flag wall and the Goble Market, showing cracking.

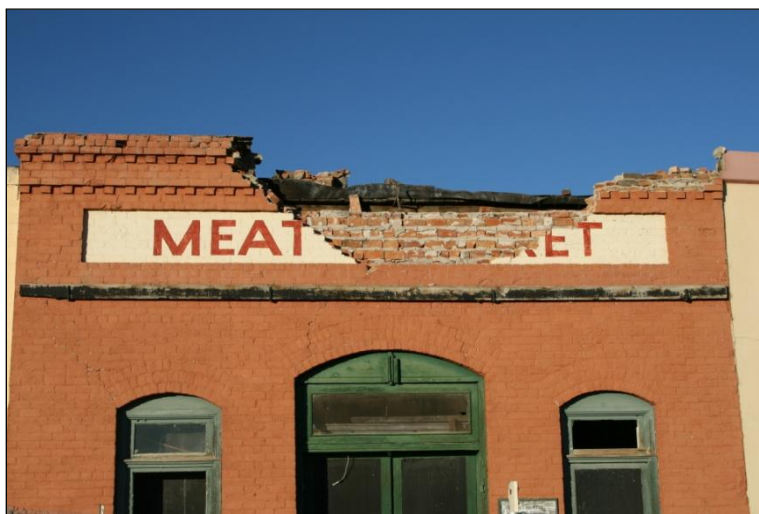
The Meat Market is a small unreinforced building built in 1902 that was cracked and had a small amount of parapet failure and failure of the upper part of the front wall. Bricks were shed onto the sidewalk and across the front entrance. Examination of the bricks remaining in the failure indicates that mortar was applied only to the horizontal surfaces and not the vertical ones, adding a weakness to this part of the wall. Out-of-plane tilting of part of the remaining upper wall indicates that it is close to falling out. There are also several moderate-sized cracks in the remaining brick front. An old wood hanger attached to the front for a covered sidewalk may have helped to stabilize the front wall during shaking.

Figure 122. Area of fallen bricks from the upper wall and parapet of the Meat Market.

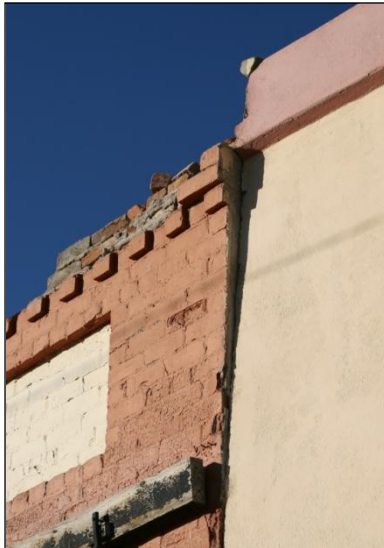
Figure 123. Leaning top of the wall of the Meat Market.

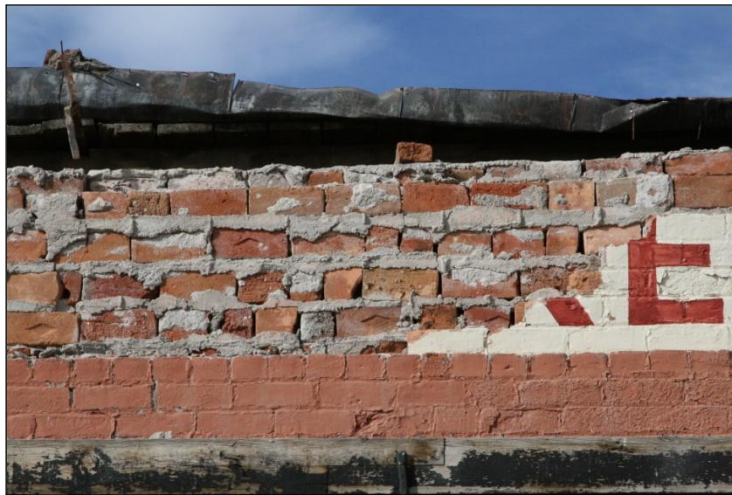
Figure 124. Detail of brickwork from the failed part of the wall. Note mortar is used on the horizontal contacts between bricks, but is missing from most of the vertical contacts between bricks.

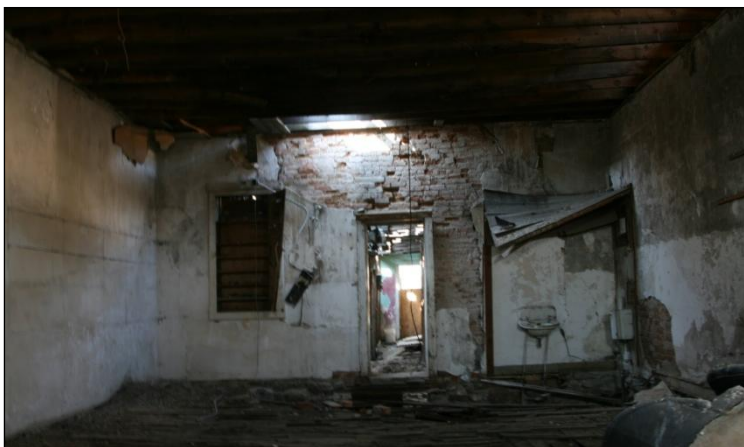
Figure 125. Inside of the Meat Market (an unused building) shows little damage, including ceiling to roof connections.

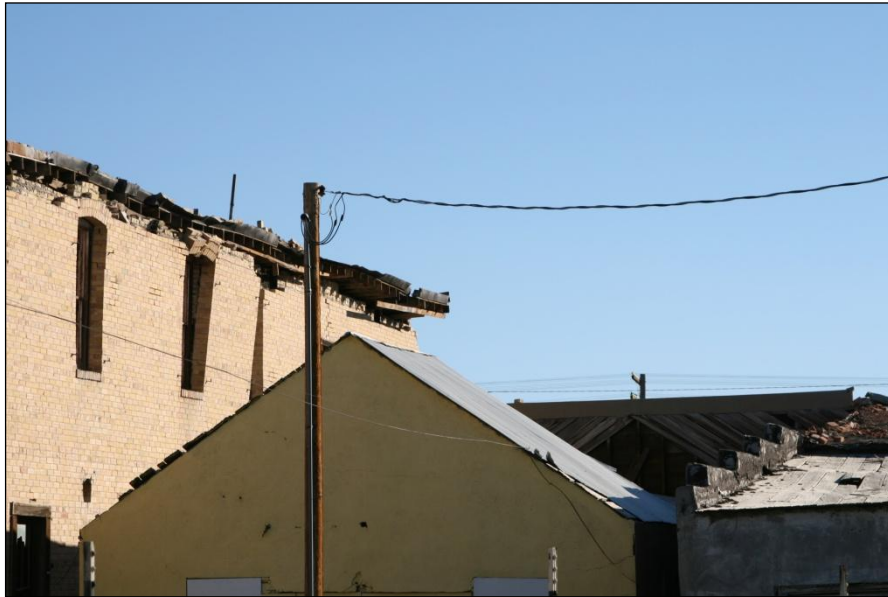
The Mint Saloon was a small wood-frame building with a square false front built in 1902 and remodeled in the 1930s. The building had a pitched roof behind the façade supported by a truss-roof system, and corrugated metal roofing. The building appeared to survive the shaking intact, but bricks from the Nevada Hotel fell two stories, penetrating parts of the Mint Saloon's roof and contributed to the collapse of the roof on its western side. Large parts of the roof system rotated down to the west as a unit, but the westernmost part of the uncollapsed portion was also crushed. About 40% of the inside of the Mint Saloon was survivable without collapsed parts.

Figure 126. Back of the Mint Saloon showing the remaining part of the roof. A large gap can be seen between this remnant and the front where the roof has collapsed. Bricks from the Nevada Hotel, on the left, collapsed the roof.

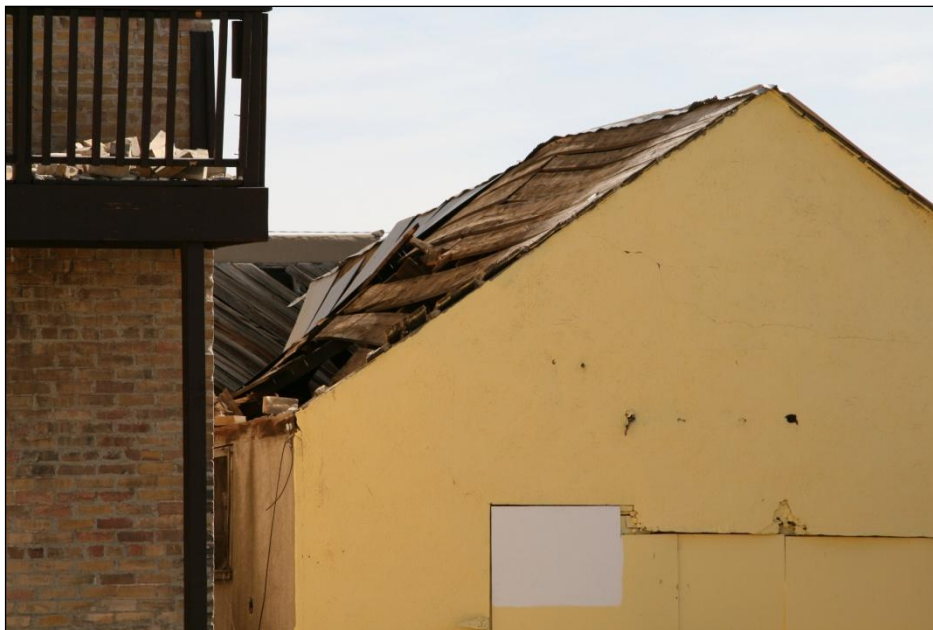
Figure 127. Back of the Mint Saloon. Holes can be seen in the roof where bricks have fallen through. The adjacent balcony that can be seen of the Nevada Hotel caught all the bricks that fell on that side.

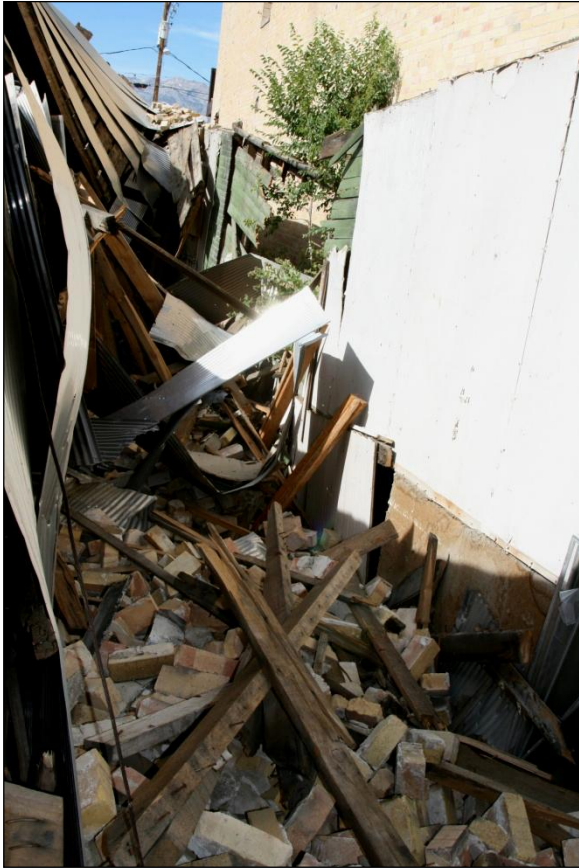
Figure 128. Collapsed western portion of the Mint Saloon, exposing the western wall; part of the wall collapsed.

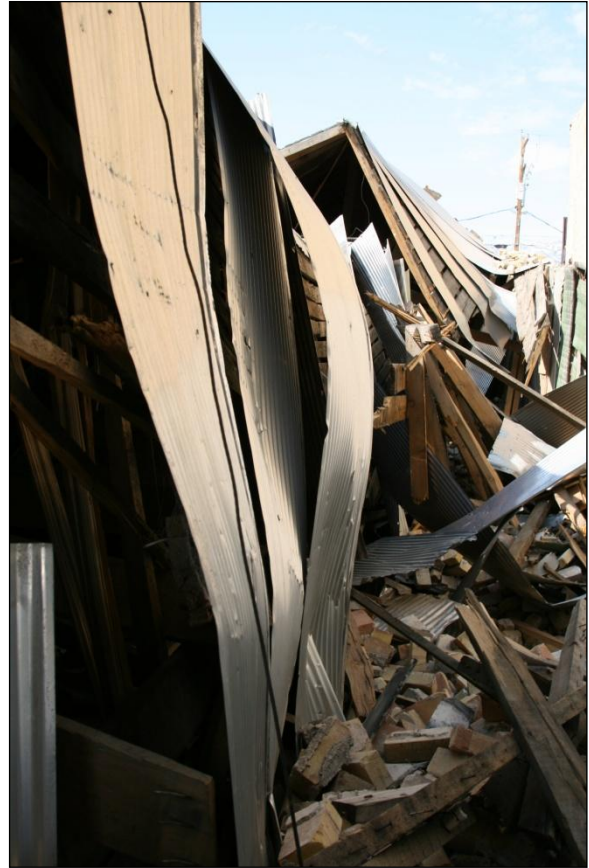
Figure 129. Collapsed portion of the Mint Saloon roof.

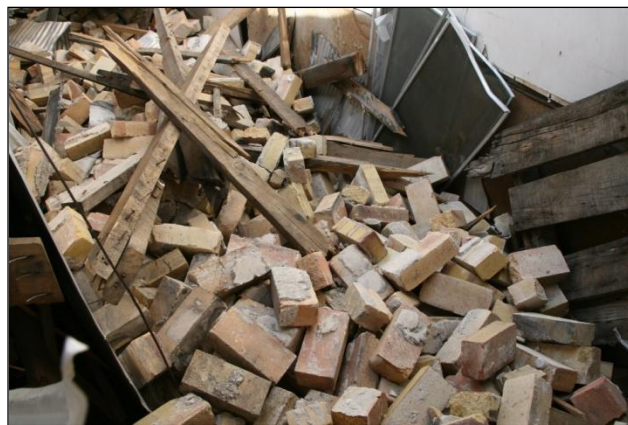
Figure 130. Bricks from the Nevada Hotel on the Mint Saloon floor.

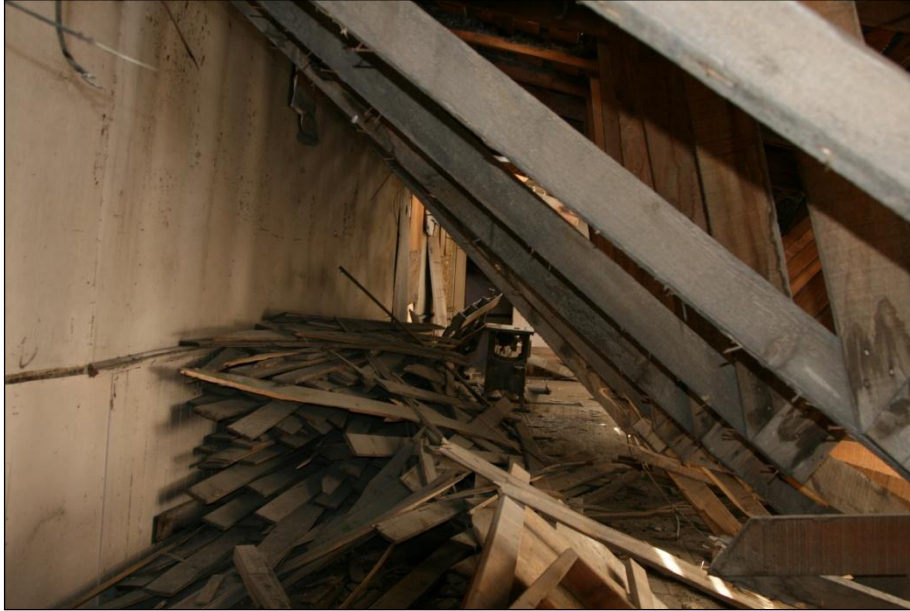
Figure 131. Eastern portion of the Mint Saloon. This area was survivable. The collapsed roof system is in the upper right.

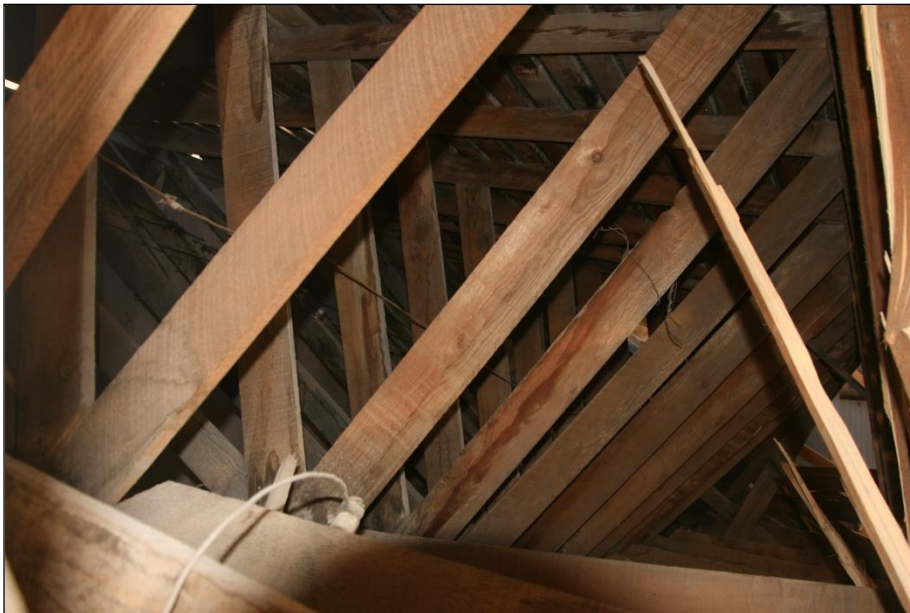
Figure 132. Tilted truss roof system showing it mostly collapsed as a unit.

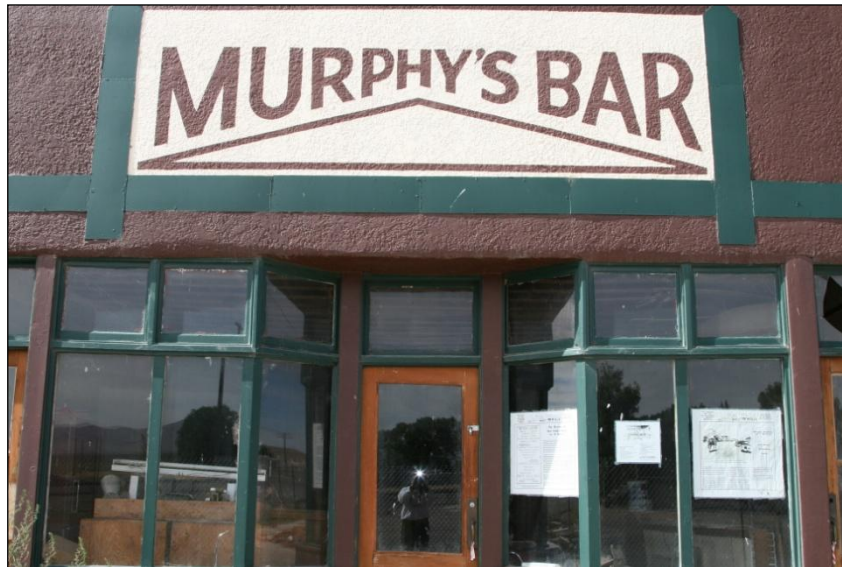
Figure 133. Front of Murphy's Bar. Only a couple of windows were cracked or broken.

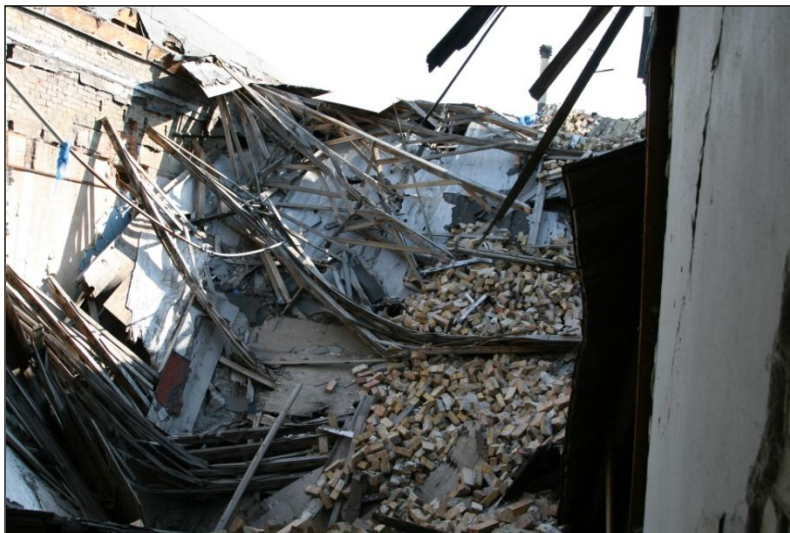
Figure 134. Bricks from the Nevada Hotel fell onto the roof of Murphy's Bar which had previously collapsed from snow. Bricks can be seen around the stove pipe on the uncollapsed part of the roof indicating that the roof was able to handle the weight of the bricks.

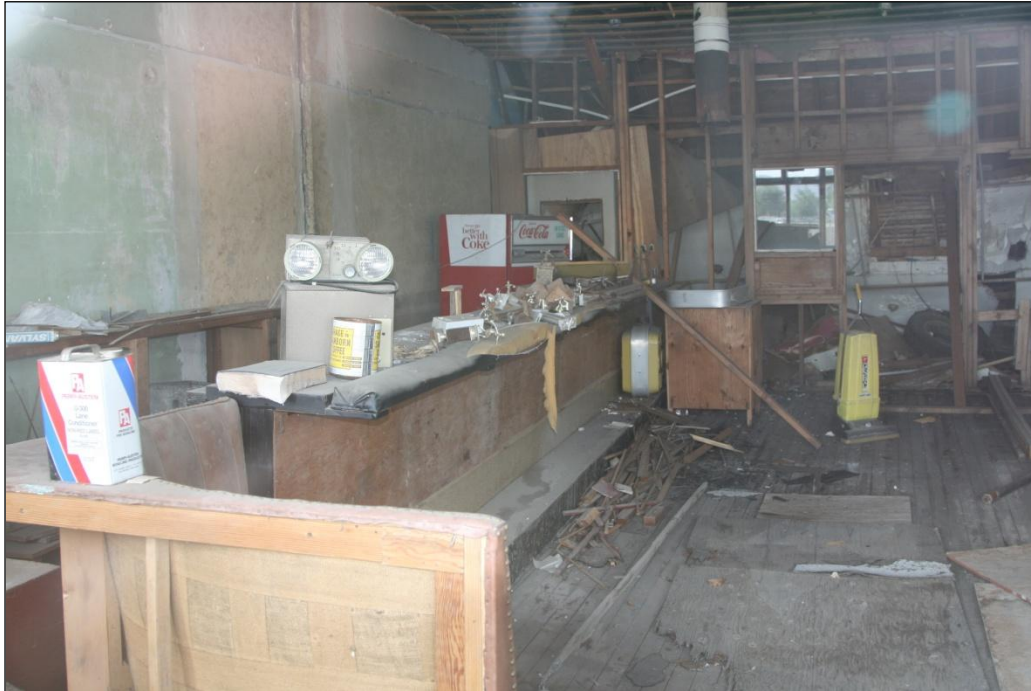
Figure 135. Inside the front of Murphy's Bar. Note the stovepipe hanging down just to the right of center near the top. This is the same stove pipe visible at the roof in figure 134 that is surrounded with bricks. No bricks penetrated and there was relatively little seismic disturbance to the interior.

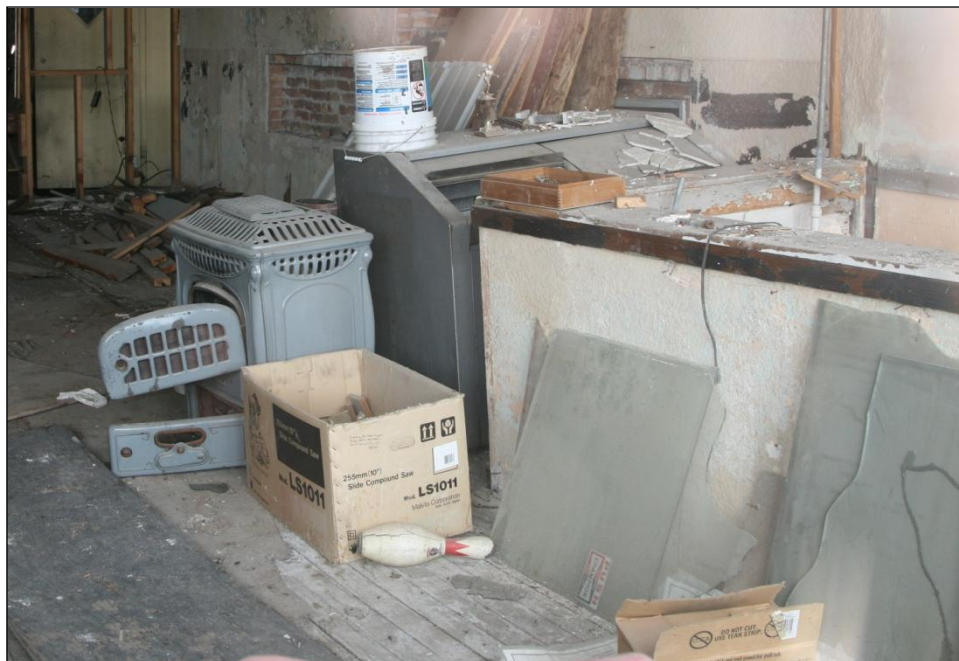
Figure 136. Interior of Murphy's Bar showing sheets of leaning glass that are unbroken by the earthquake. A cut in the wall in the background shows the unreinforced brick construction.

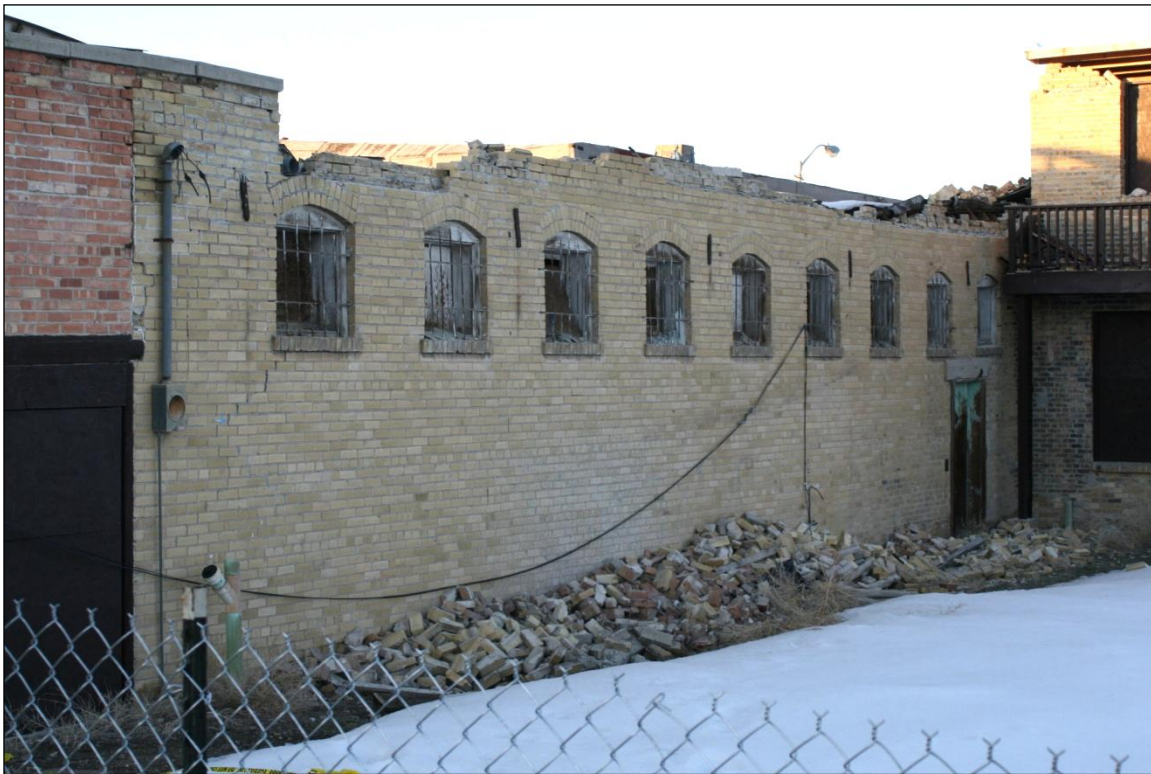
Figure 138. Fallen parapet at the back of the Murphy's Bar.

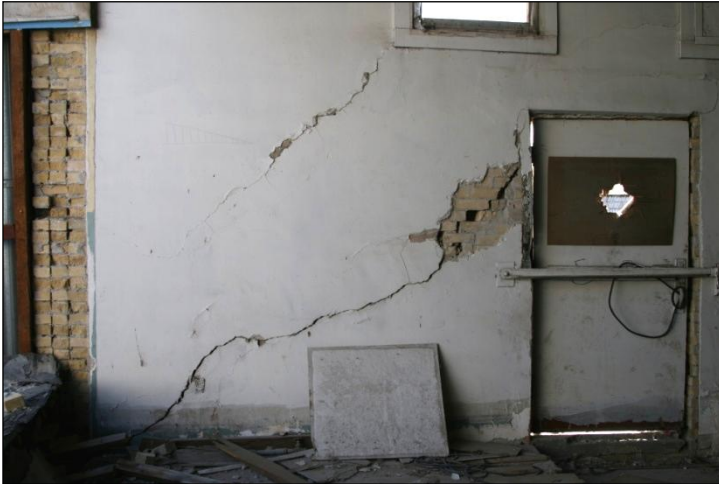
Figure 139a. Large crack inside the back door of Murphy's Bar.

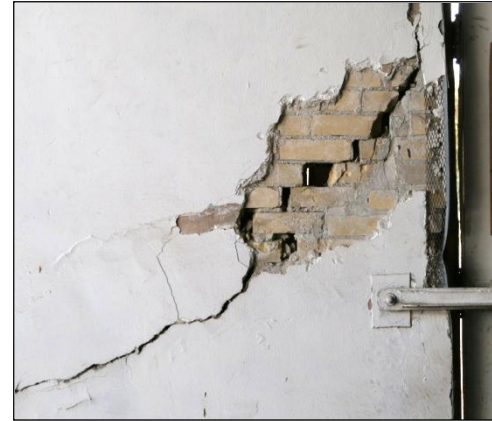
Figure 139b. Close-up view of the large crack inside the back door of Murphy's Bar.

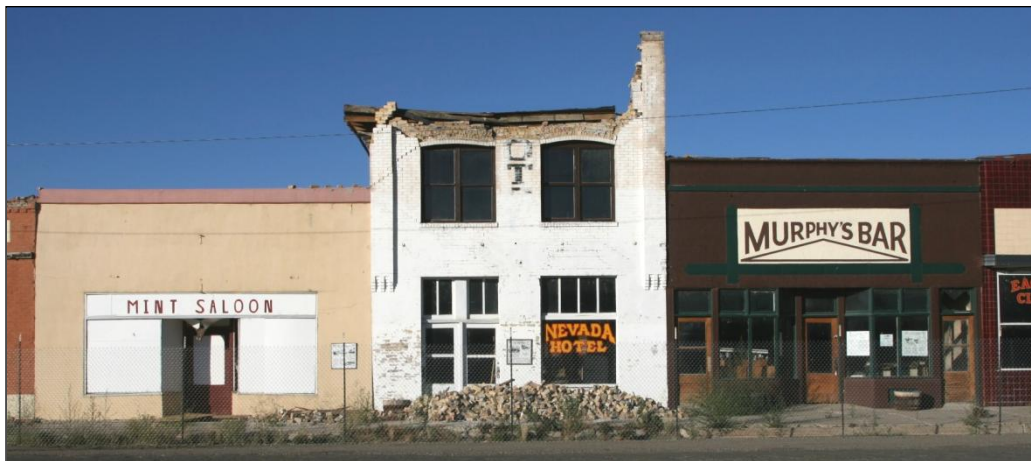
On the front side of the Nevada Hotel, the upper 0.5 to 1 m of parapet and wall fell out onto the sidewalk at the front of the building, including across the entrance (figures 140-144). In the front, the roof has fallen down about 0.5 m, been shifted to the east about 0.5 m, and appears to have come to rest on the ceiling of the second story. The brick headers over the two upper windows were cracked and the eastern one had been tilted out-of-plane and was hanging in a threatening manner over the front door (figure 143). Major cracks are evident starting at the location on the Nevada Hotel where the adjacent buildings brace it and trending upwards into the hotel towards the upper corner of the upper windows (figure 142). These open cracks, the eastern one on the alley side being the most prominent, indicate there was greater drift in the second story of the building than in the first story. However, incipient X-fractures between the upper windows and the lower window and door indicate serious movement occurred in the first floor as well. The door frame was being worked out of its opening in the wall, also indicative of strong ground motion (figure 144).

Figure 140. Nevada Hotel between the Mint Saloon and Murphy's Bar.

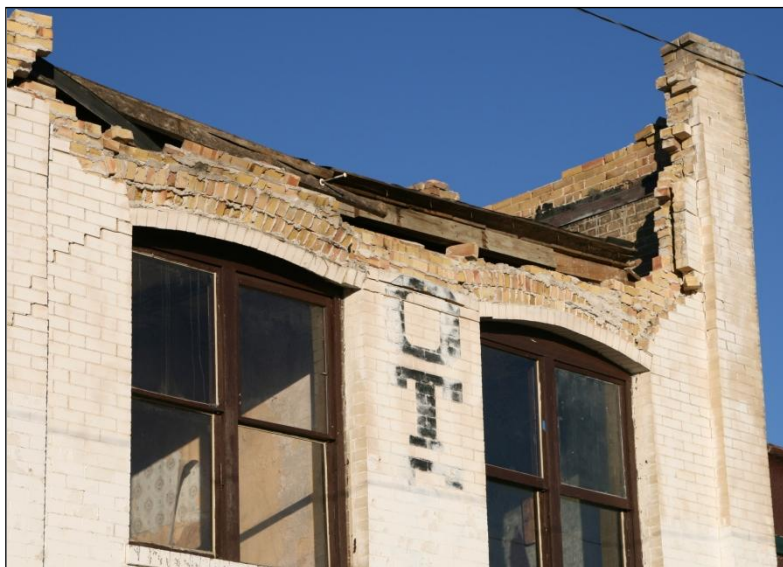
With all this damage and collapse in the front of the building, it is remarkable that no windows were broken in the front, including the moderate-sized plate-glass window that has the hotel's name on it (figures 141 and 144). The lower windows appear to have been protected within their frames. The upper windows were in the central part of the building with the large fractures being outboard of them. The damage was encroaching on these upper windows, and a couple more seconds of shaking likely would have threatened these windows with falling bricks or possibly with their frames falling out altogether.

Figure 141. Upper part of the Nevada Hotel. The roof collapsed down to the second-story ceiling level. The upper part of the front parapet and wall has completely fallen out and several parts were left out-of-plane.

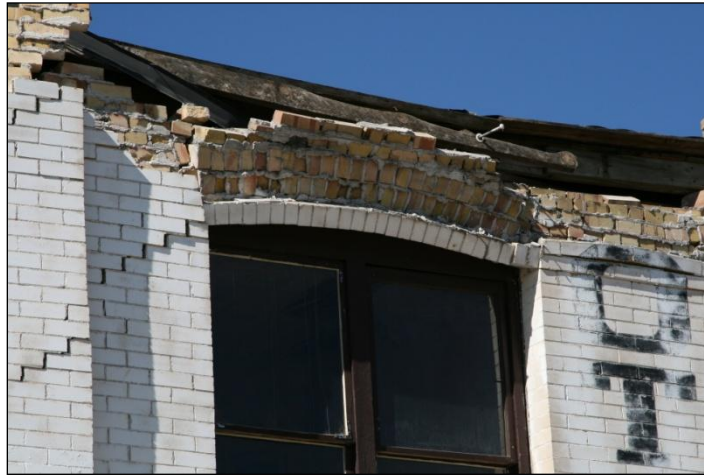
Figure 142. Eastern side of the front of the building showing fallen (and pushed off?) parapet on the eastern side of the building, the roof overhanging in the front, and a large crack coming up diagonally from the adjacent support of the Mint Saloon's false front.

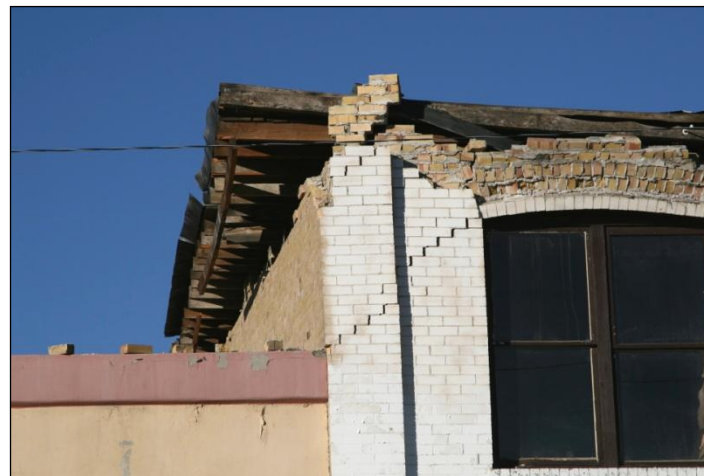
Figure 143. The brick arch over the upper window has lost the outer layer of bricks and is tilted out-of-plane. One of the major cracks comes up to its eastern base.

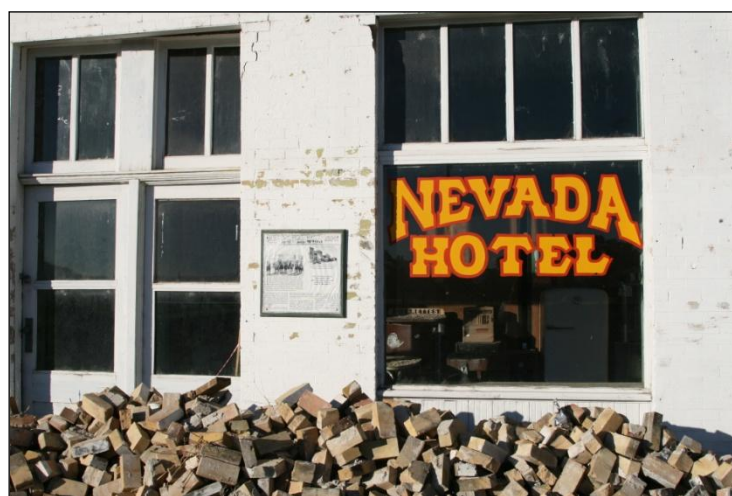
Figure 144. Bottom of the front of the Nevada Hotel showing bricks fallen from above. No windows were broken, but the frame for the windows and doors on the left is coming out of its opening.

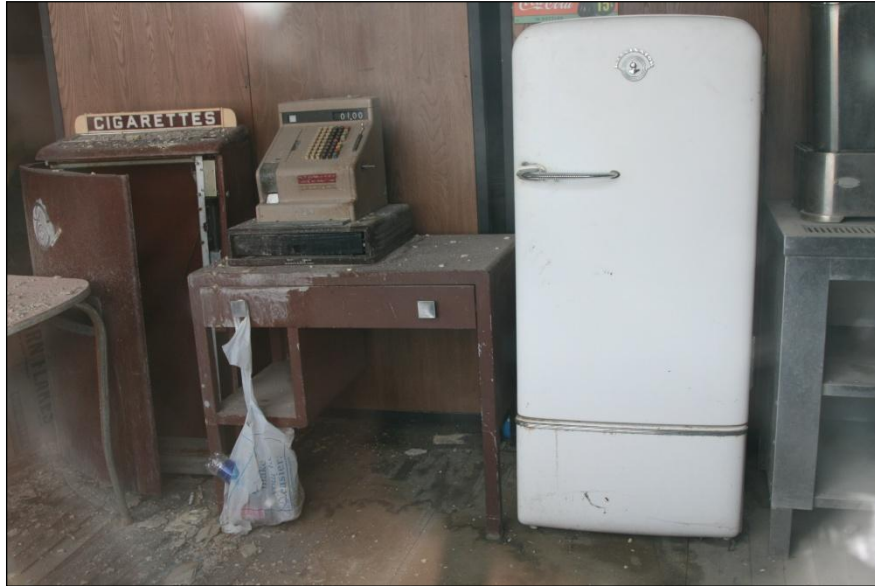
Figure 145. First floor interior of the Nevada Hotel. The refrigerator and cash register did not fall. Most of the interior of the Nevada Hotel was not damaged although the second story could not be inspected.
