Building Damage from the 2008 Wells, Nevada Earthquake

Craig M. dePolo
Nevada Bureau of Mines and Geology
University of Nevada, Reno

2011

ABSTRACT

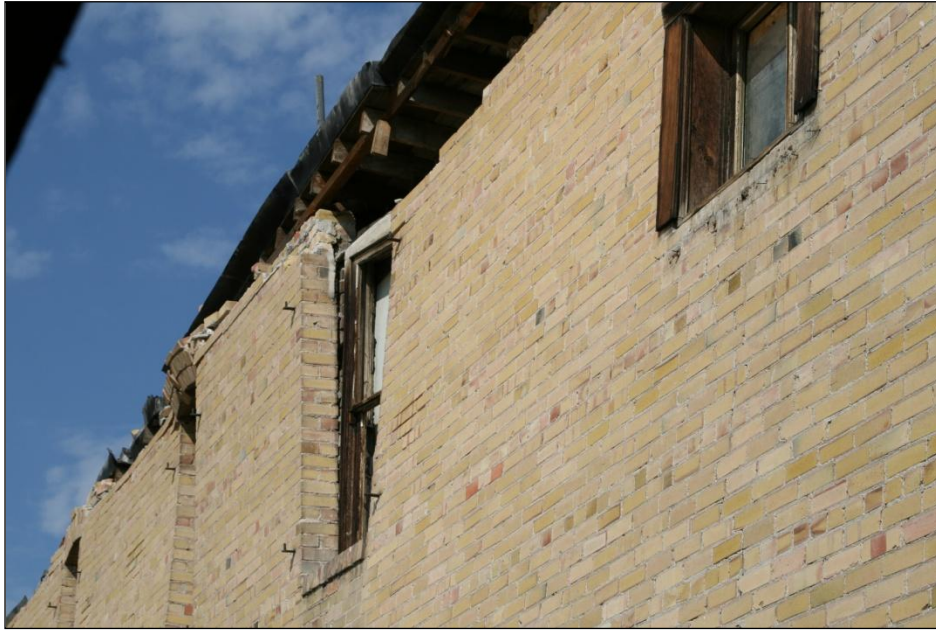
The eastern part of the Nevada Hotel had four second-story windows that were boarded up. The upper parts of the parapet and wall fell down to the second-story ceiling level; these bricks fell onto the western part of the adjacent Mint Saloon's roof. The displaced Nevada Hotel's roof sticks out over its eastern wall about 0.5 m in the front of the building and near the rear of the hotel, the roof has shifted towards the interior of the building in an overall rotational manner. On the eastern side, the brick header of one of the windows is gone and another is tilted out-of-plane and is hanging in a precarious manner (figures 146 and 147). A panel between these two windows is tilted out-of-plane as well, towards the outside of the building. These two windows are in the central part of the wall and are near the pivot point of the roof's rotation along the eastern side.

Figure 147. Close-up of out-of-plane parts of the eastern wall of the Nevada Hotel.

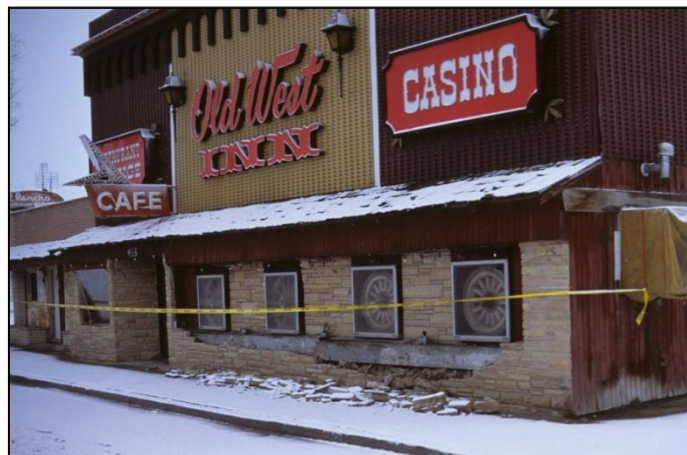
Figure 150. Front of the Old West Inn. Rocks forming a front façade were knocked down.

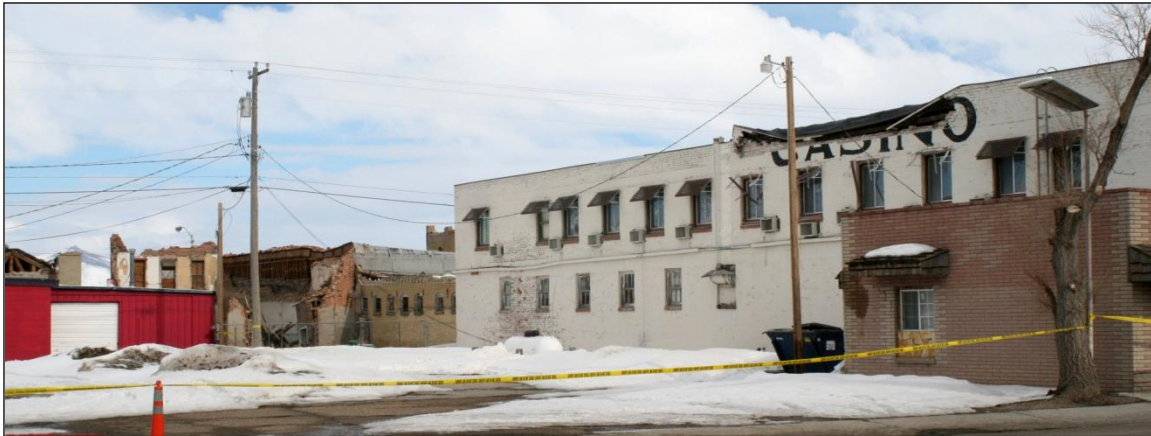
Figure 153. Contrast between the limited damage to the two-story Old West Inn (to the right) and the shell of the collapsed San Marin Hotel (next to the red building on the left). The view is to the northeast.

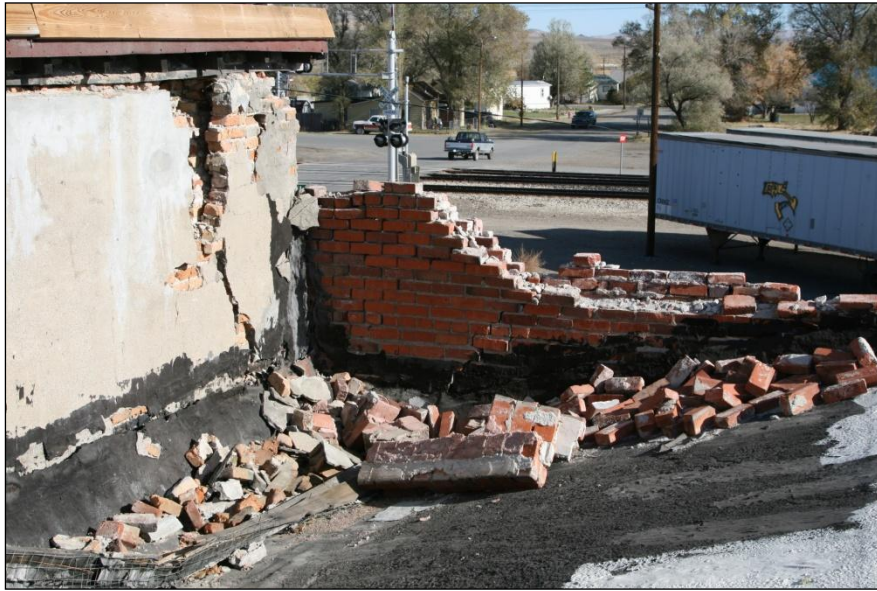
Figures 157a. Fallen bricks from the front of the mercantile and the Bullshead Saloon in the front corner of the store. This corner is where some of the roof and ceiling joist connections failed.

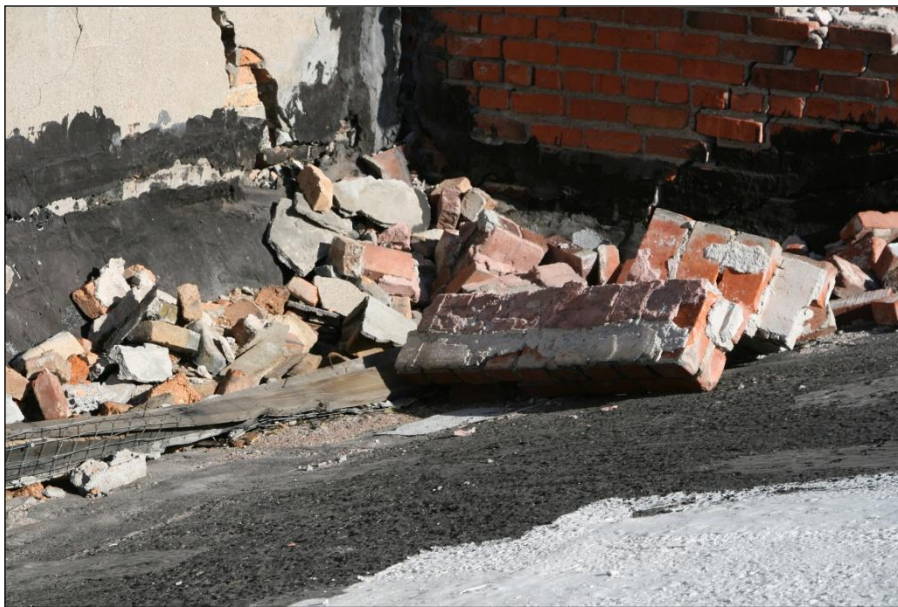
Figure 157b. Close-up of figure 167a.

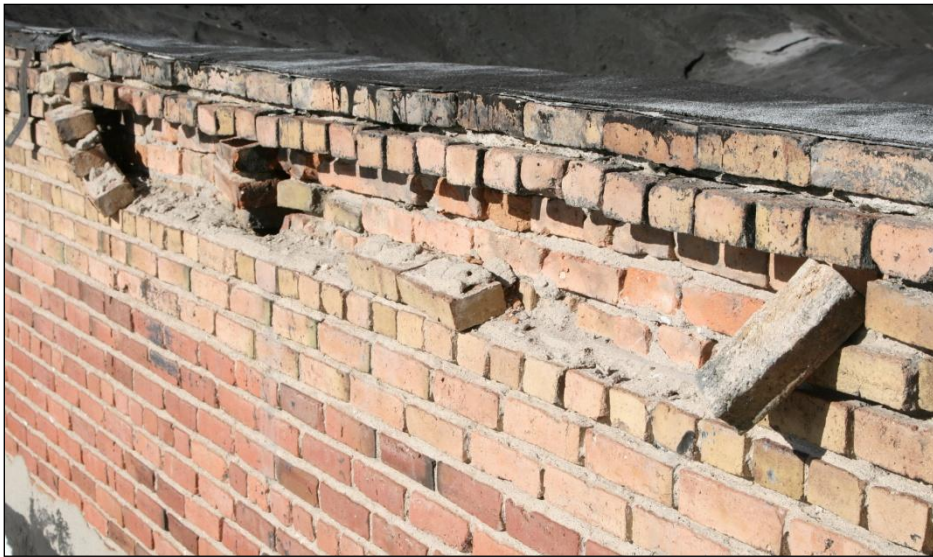
Figure 161. Area where bricks have fallen out near the roof on a side wall. The mortar lies pulverized around the remaining bricks.

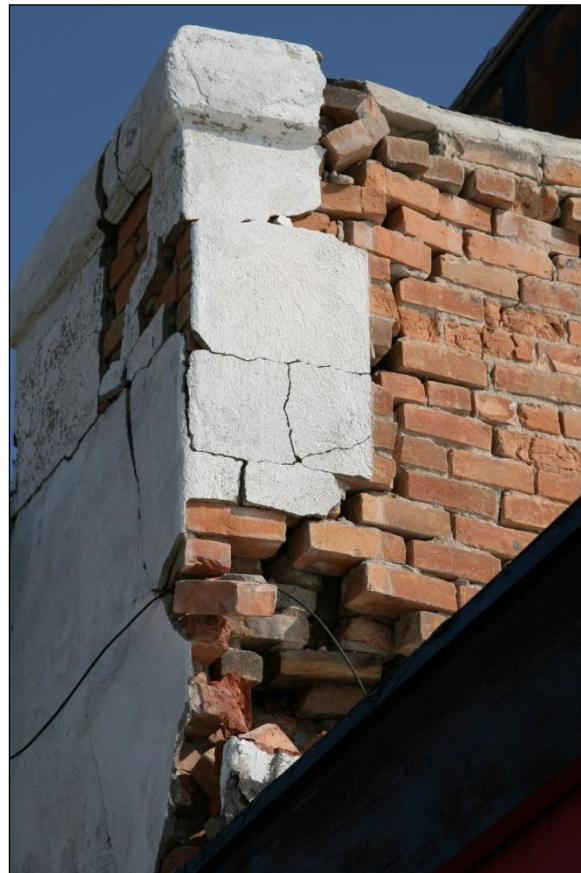
Figure 163. Damage to the southeastern corner of the store.

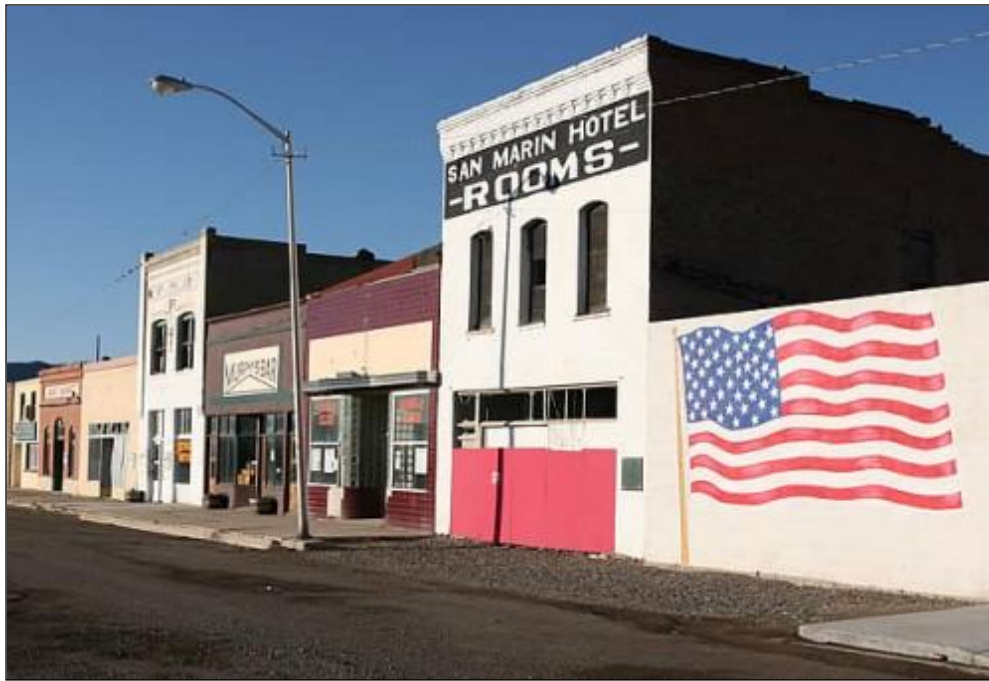
Figure 165. The San Marin Hotel before the earthquake. Photograph by ExploreNevada.com.

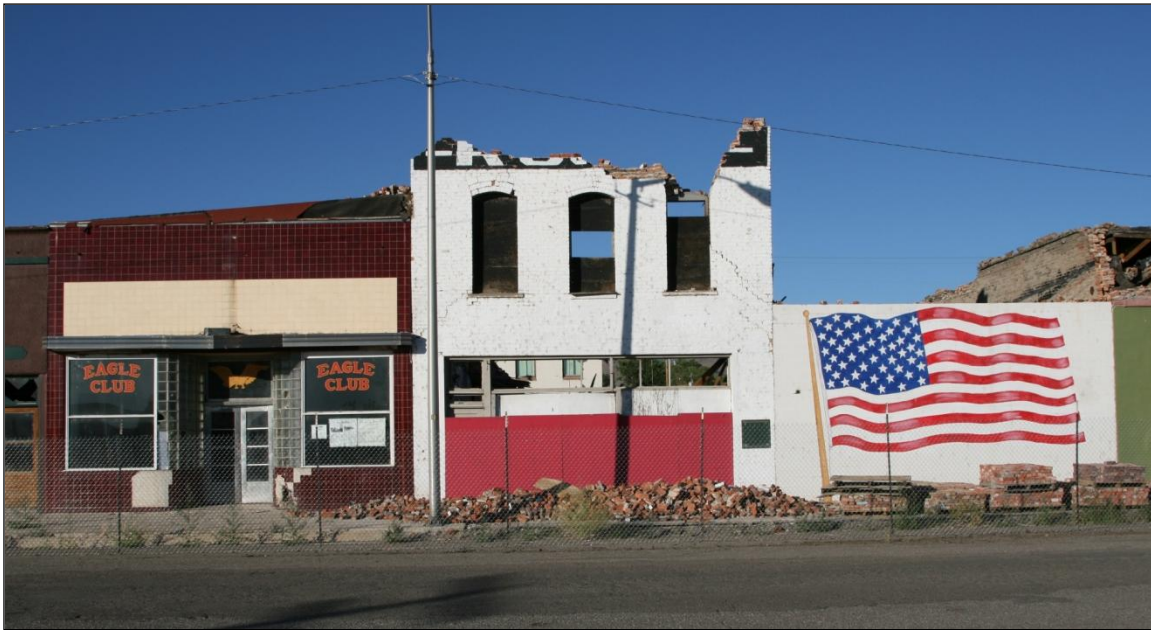
Figure 166. Remaining front of the San Marin Hotel after the earthquake.

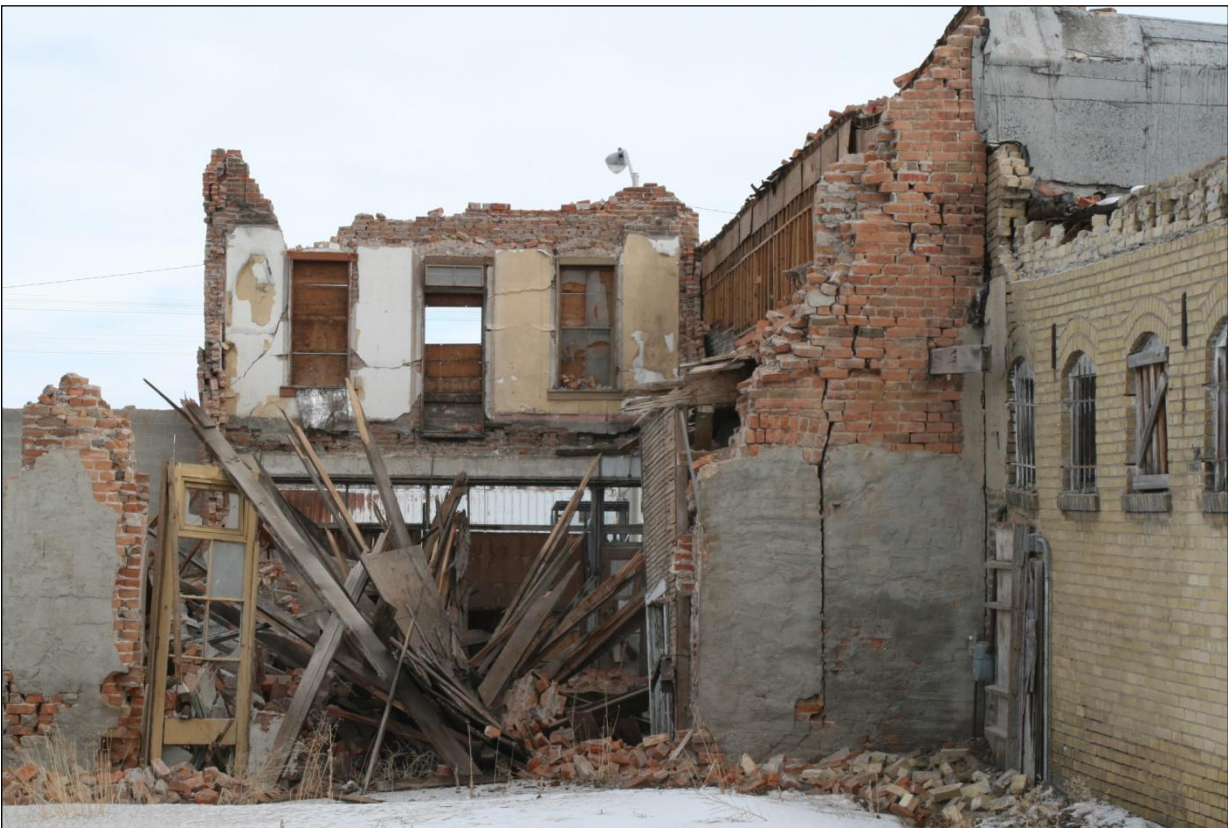
Figure 170. This shows a rear view of the San Marin Hotel.

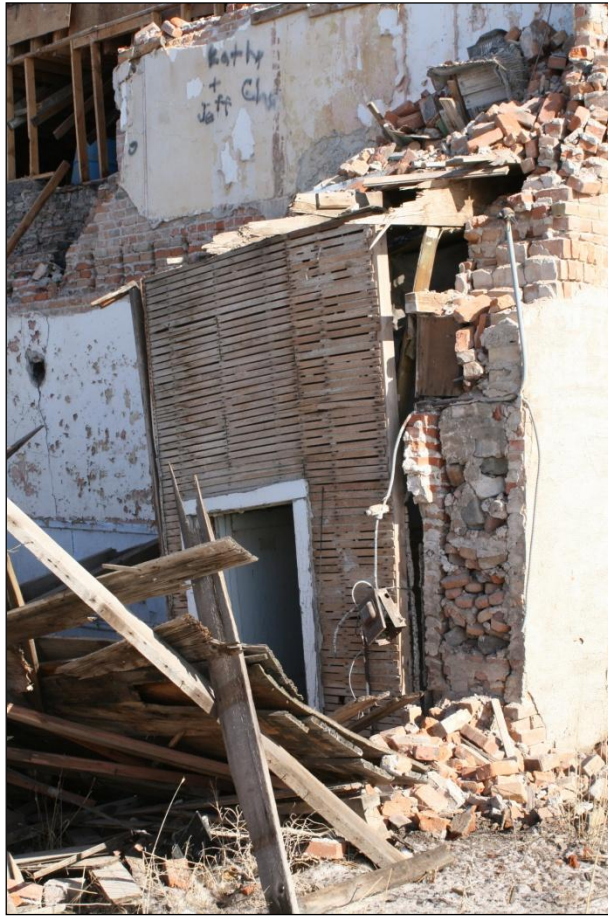
Figure 171. The small room in the back of the San Marin Hotel appears to have been one of the few interior rooms in the hotel. This one of the few potentially survivable spaces in the collapsed building.

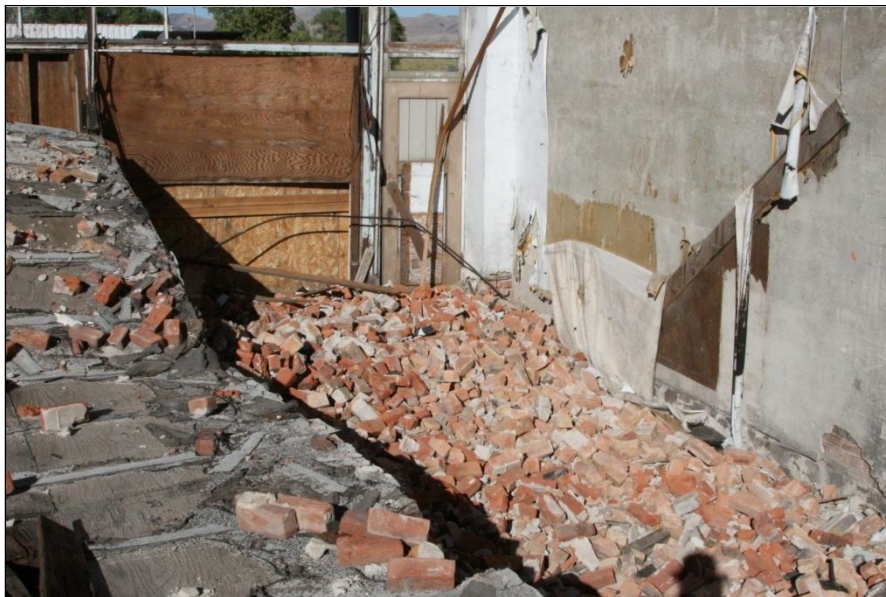
Figure 172. Part of the of the San Marin Hotel first floor not covered by the collapsed second floor and the roof, but completely covered with bricks. The front door (upper center of photo) has fallen bricks on both sides of it.

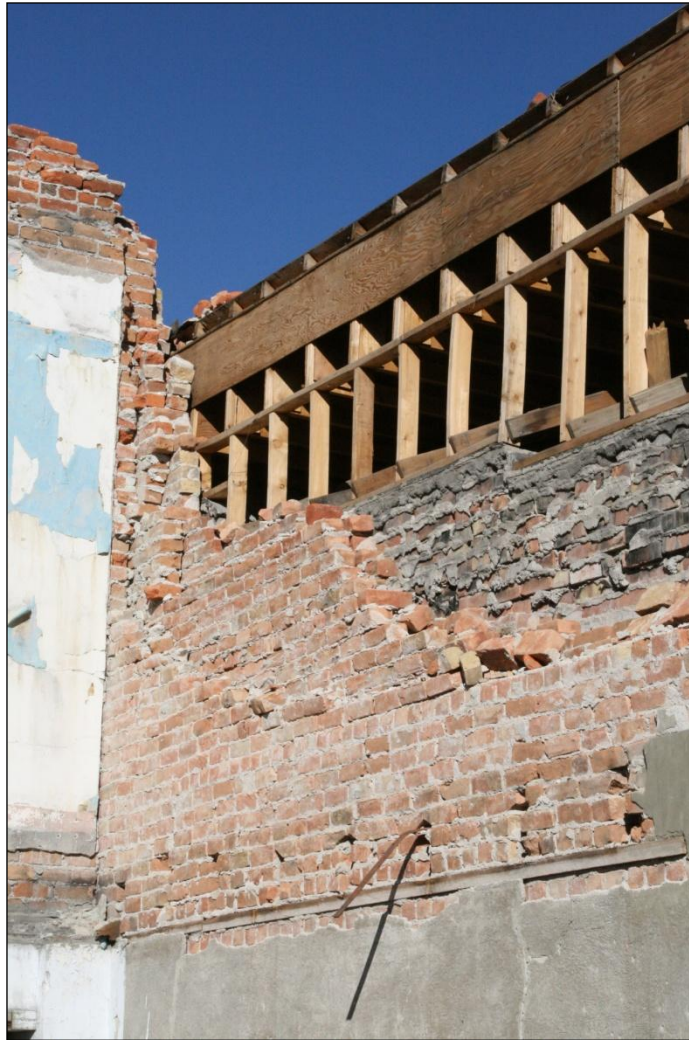
Figure 173. Part of the remaining eastern wall of the San Marin Hotel.

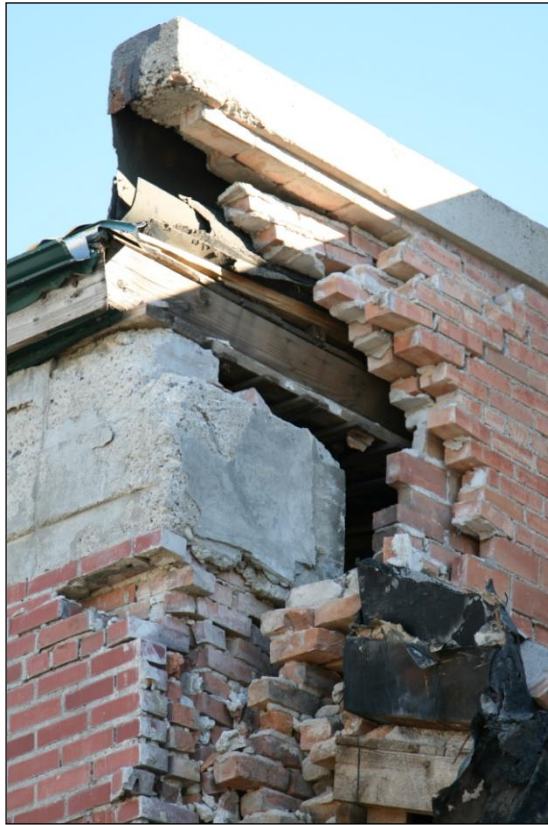
Figure 176. Close-up of where the concrete beam has pounded a hole into the eastern wall of the Wells Chalet and possibly the upper part of the parapet of the Quilici and Sons Mercantile (the tarred area in the lower right was part of the parapet). Note how the crowning bond beam is still in place and the failure did not peel from the top. The remaining surrounding bricks are bowed outwards slightly like they were pushed to the east.

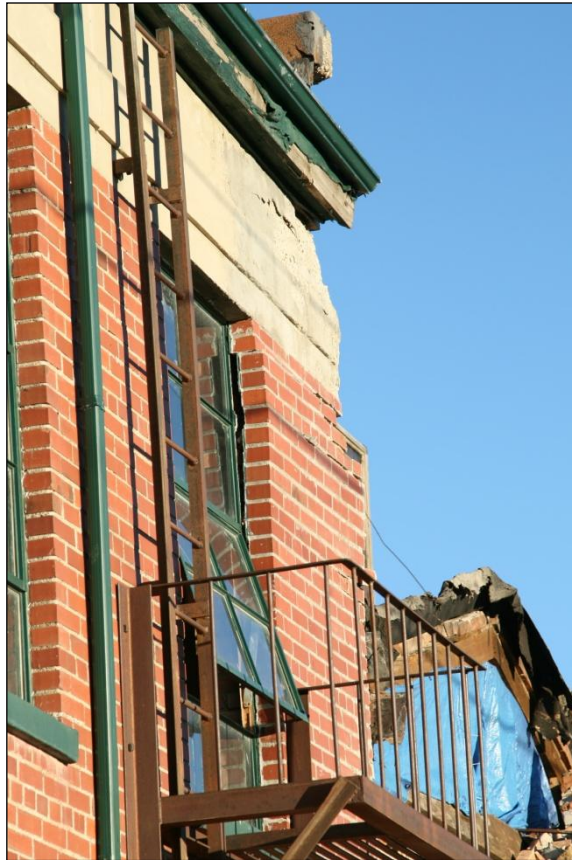
Figure 178. Delaminating brick wall below the eastern end of the concrete beam and next to the window.

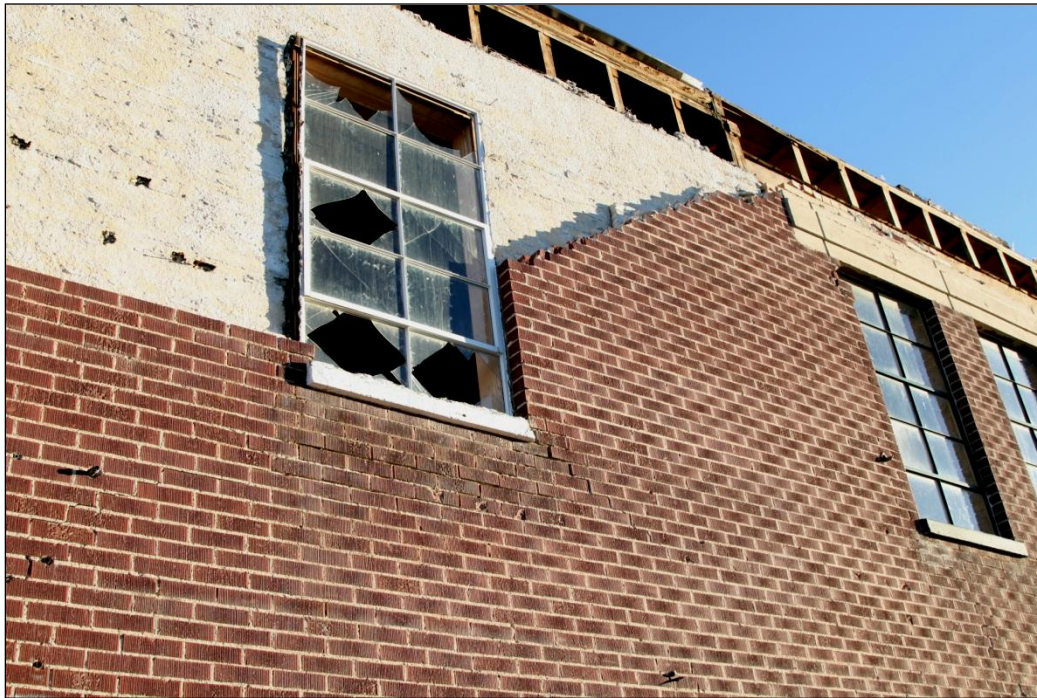
Figure 179. Southern part of the Bullshead Saloon (left) and northern part of the Wells Chalet (to right with the concrete beam near the top). The Wells Chalet appears to be a more rigid building (URM/concrete) versus the more flexible wood-framed Bullshead Saloon. The butted contact also apparently stiffened the edge of the Bullshead.

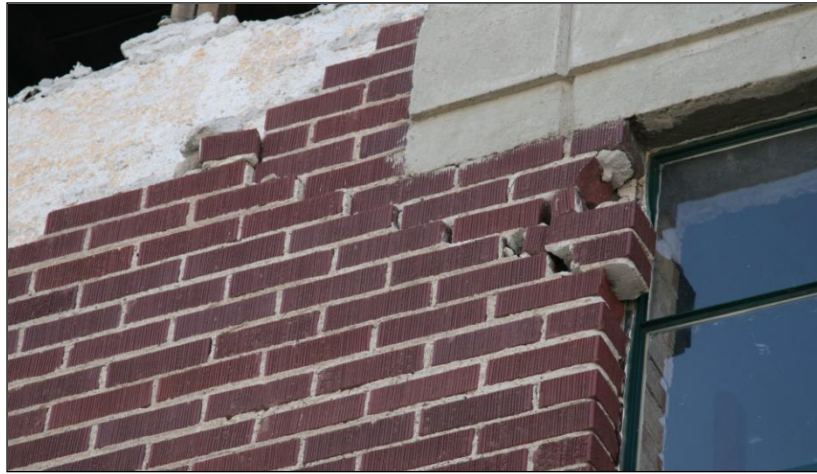
Figure 180. Broken bricks under and near the end of the concrete beam shown above.

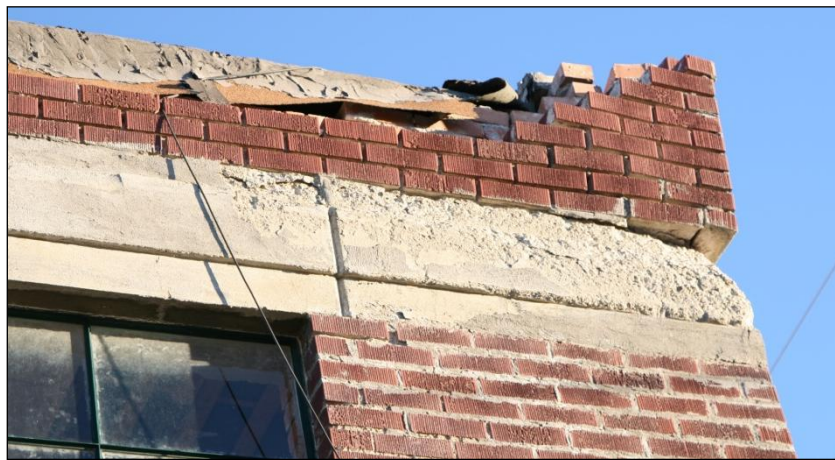
The most spectacular damage to the Wells Chalet was the failure of the crowning bond beam along the western side of the building that crushed a car. The bond beam was on top of a short brick wall built on top of a concrete beam. This bond beam was thrown a significant distance to the west and hit the car, parked outboard of a sidewalk adjacent to the building. Because this is a short wall, the beam did not cantilever out but appeared to have been thrown to the west by a strong eastward pulse.

Figure 181. Upper southwest corner of the Wells Chalet. A short brick wall sat on top of the concrete beam and was capped by a two-rebar reinforced bond beam. This bond beam was thrown off the western side of the building by the earthquake, clearing the sidewalk, and fell on the car, crushing it.

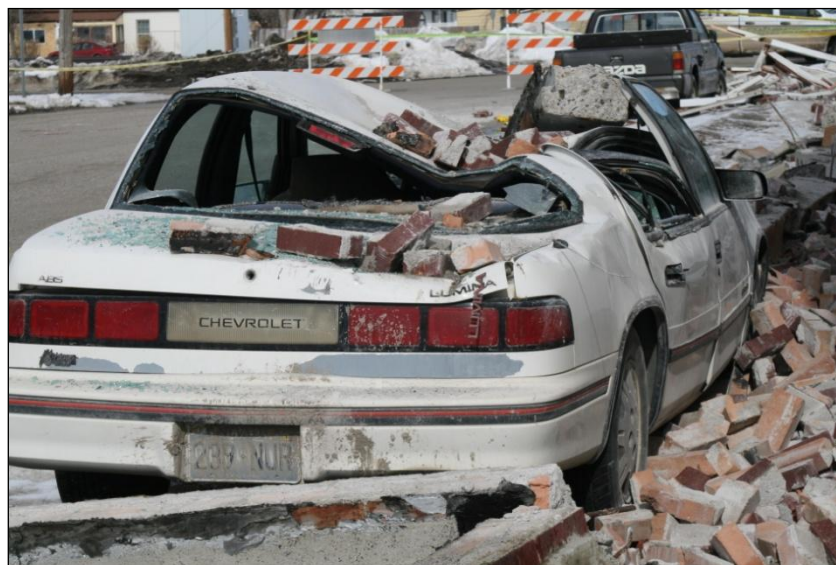
Figure 182. Car crushed by the crowning bond beam that fell from the Wells Chalet. The large bond beam cross section can be seen on the car.

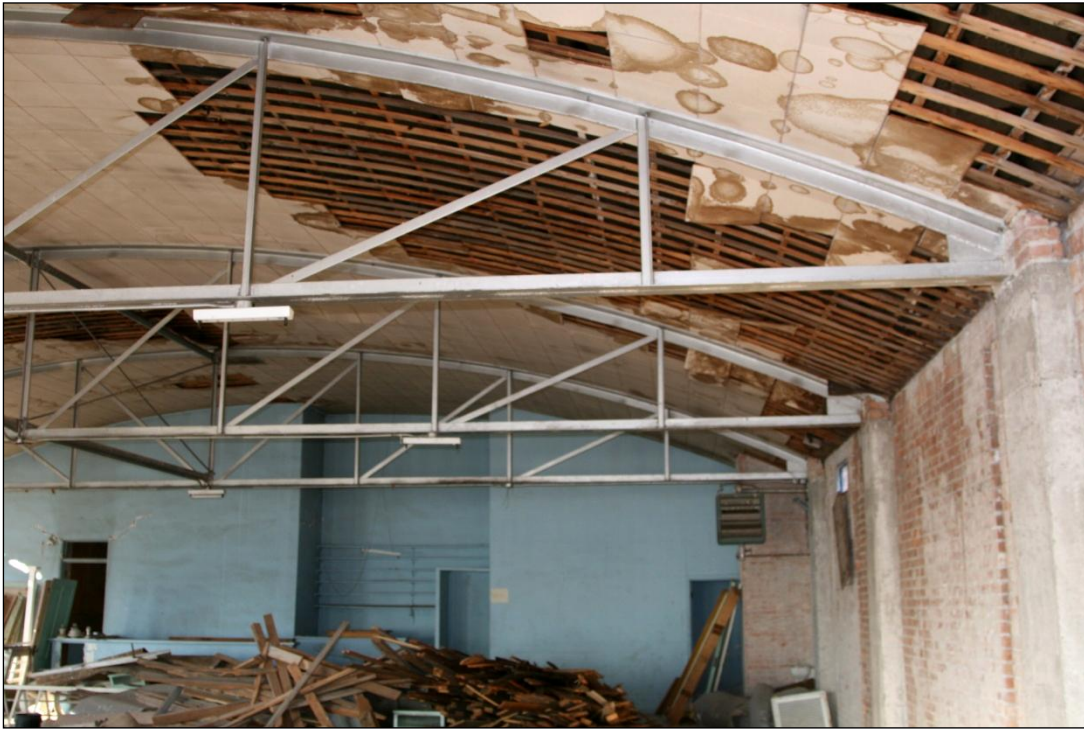
Figure 183. Interior of the second floor of the Wells Chalet showing roofing, steel roof trusses, concrete columns and in the back corner is the chimney shown in figures 184 and 185.

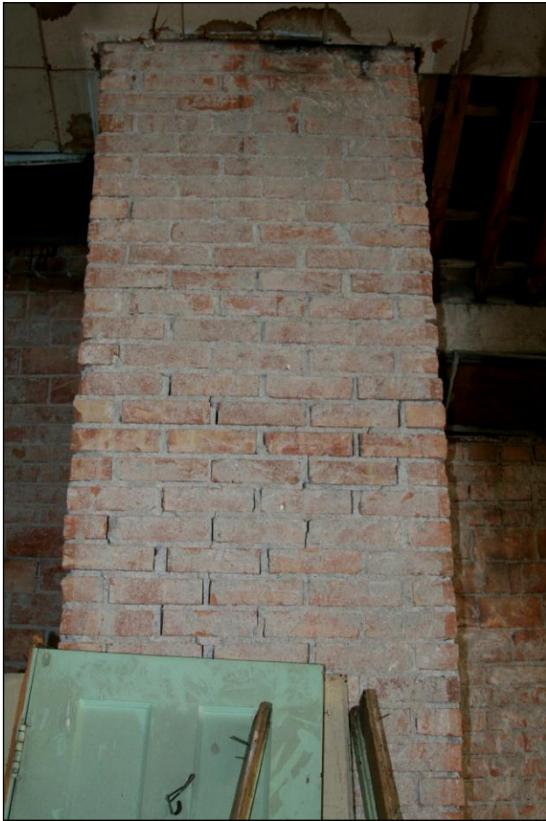
Figure 184. Chimney inside the Wells Chalet that shows cracking consistent with buckling out in the middle (see figure 185).

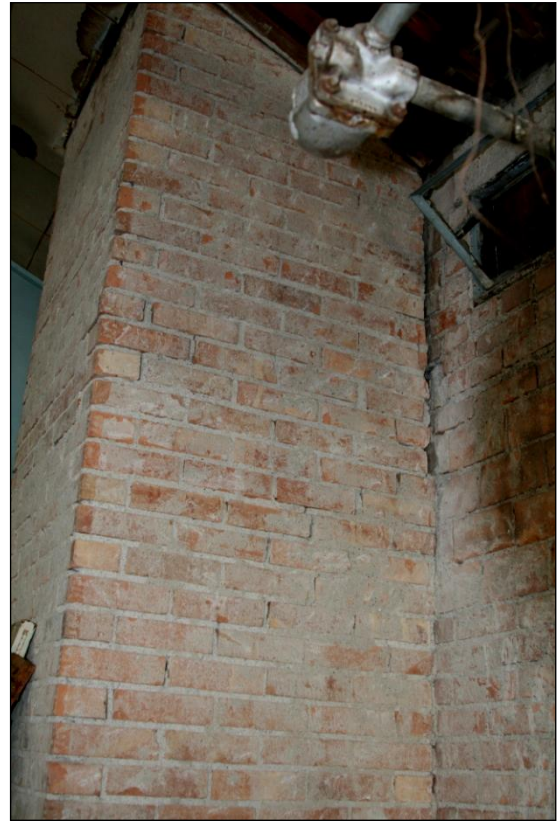
Figure 185. Chimney inside the Wells Chalet that shows cracking and buckling from shaking.
