**Controls on fault-hosted fluid flow; Preliminary results from the Coso
Geothermal Field, CA**

Nicholas C. Davatzes*
Stephen H. Hickman

Paper 144

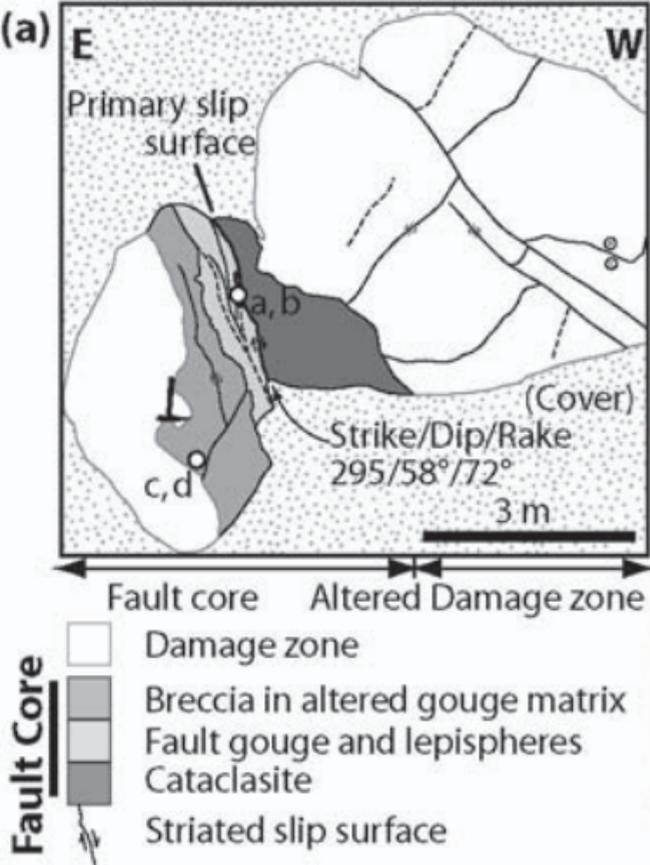
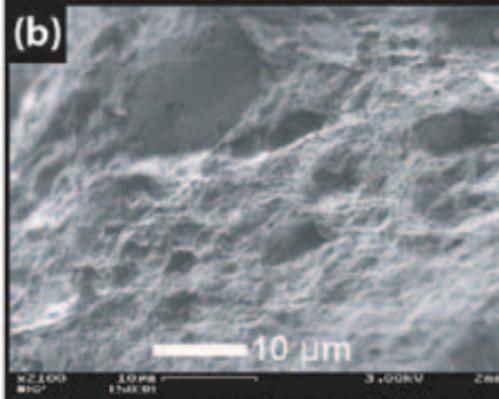
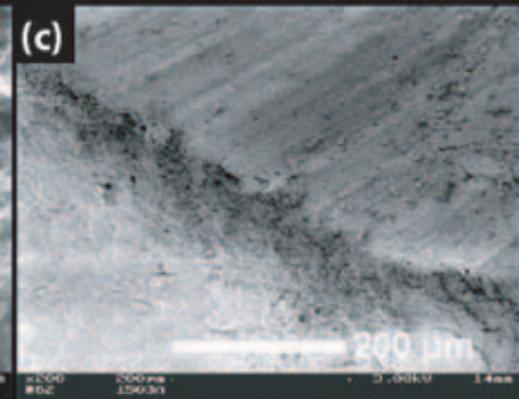
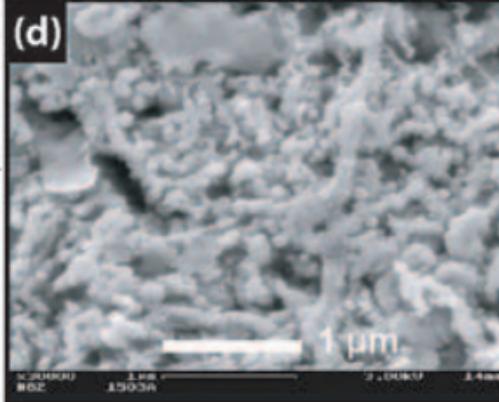
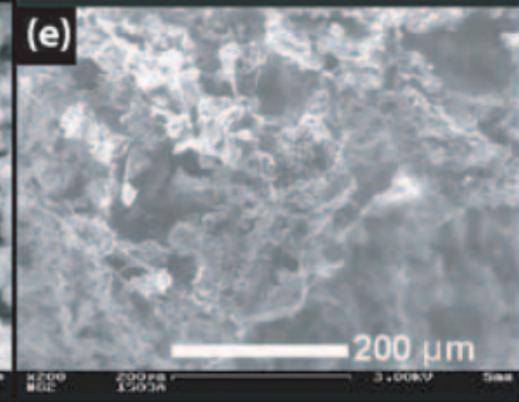
Figure 2

Figure 2: (a) Map of altered kaolinite-rich fault zone (location Figure 1c) distinguishing zones of different deformation and alteration intensity. Scanning Electron Microscope images of (b) foliated kaolinite-rich fault gouge, (c) striated fault slip surface, (d) microspheres and rod-like structures of amorphous silica, and (e) altered breccia clasts.

Furthermore, the mineralogy and texture of the different fault zones identified at Coso (Figures 2, 3, and 4) indicate the role of different deformation mechanisms and structural/geochemical history. For example, faults healed by the precipitation of calcite and related minerals continue to undergo brittle dilation when reactivated and thus regenerate permeability (Figure 3). In contrast, the introduction of chlorite and other sheet silicates such as smectite appear to promote ductility and thereby minimize dilatancy of the fault rock during shear (Figure 4). In the following sections we discuss the relationship of the deformation mechanisms that control fluid flow to the deformation environments defined by the shallow

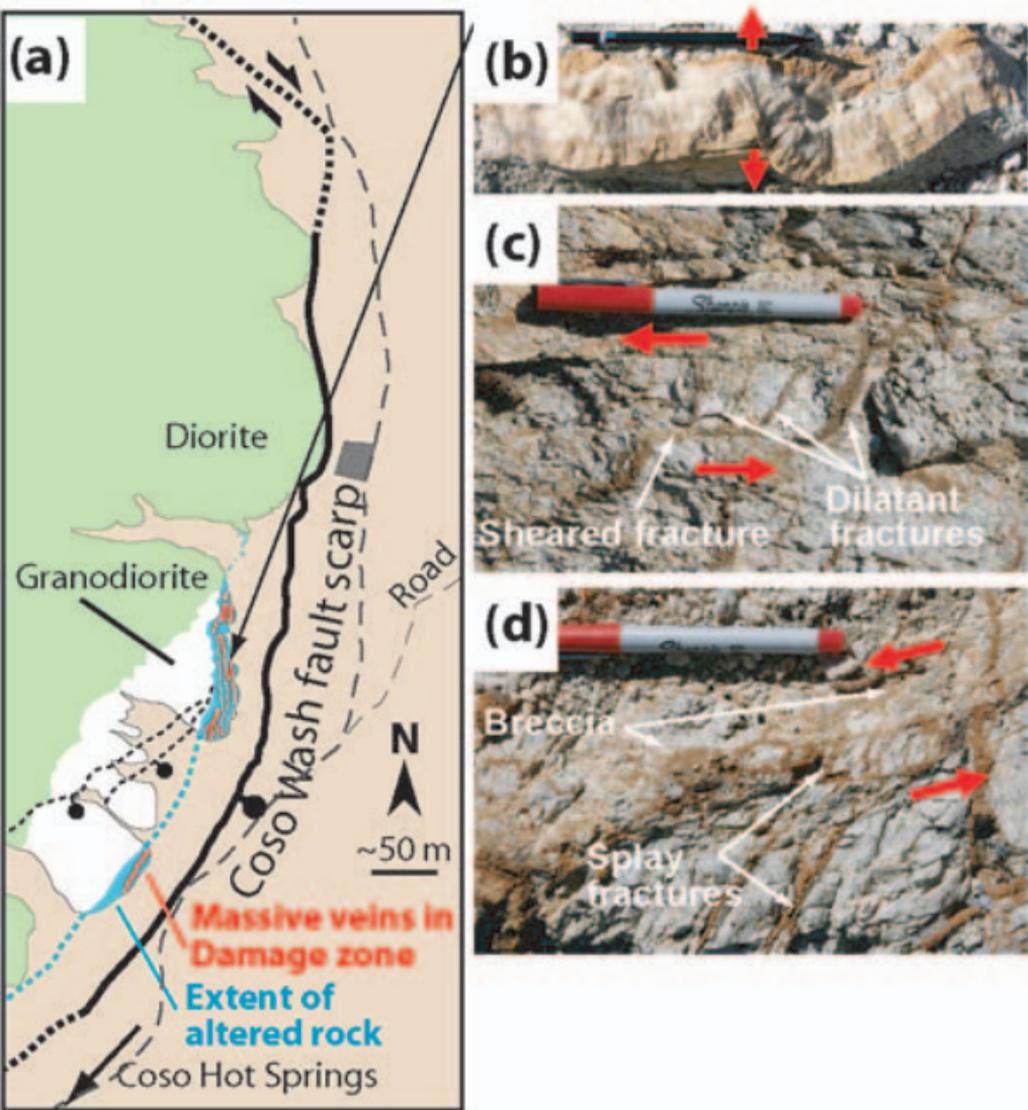
Figure 3

Figure 3: (a) Geologic map of the Coso Wash fault scarp and zones of massive veins and breccia in granodiorite (location Figure 1c). Detailed photos of damage zone structures including: (b) layered carbonate vein, (c) dilatant fractures (splay fractures) localized between sheared fractures, (d) breccia and associated splay fractures.

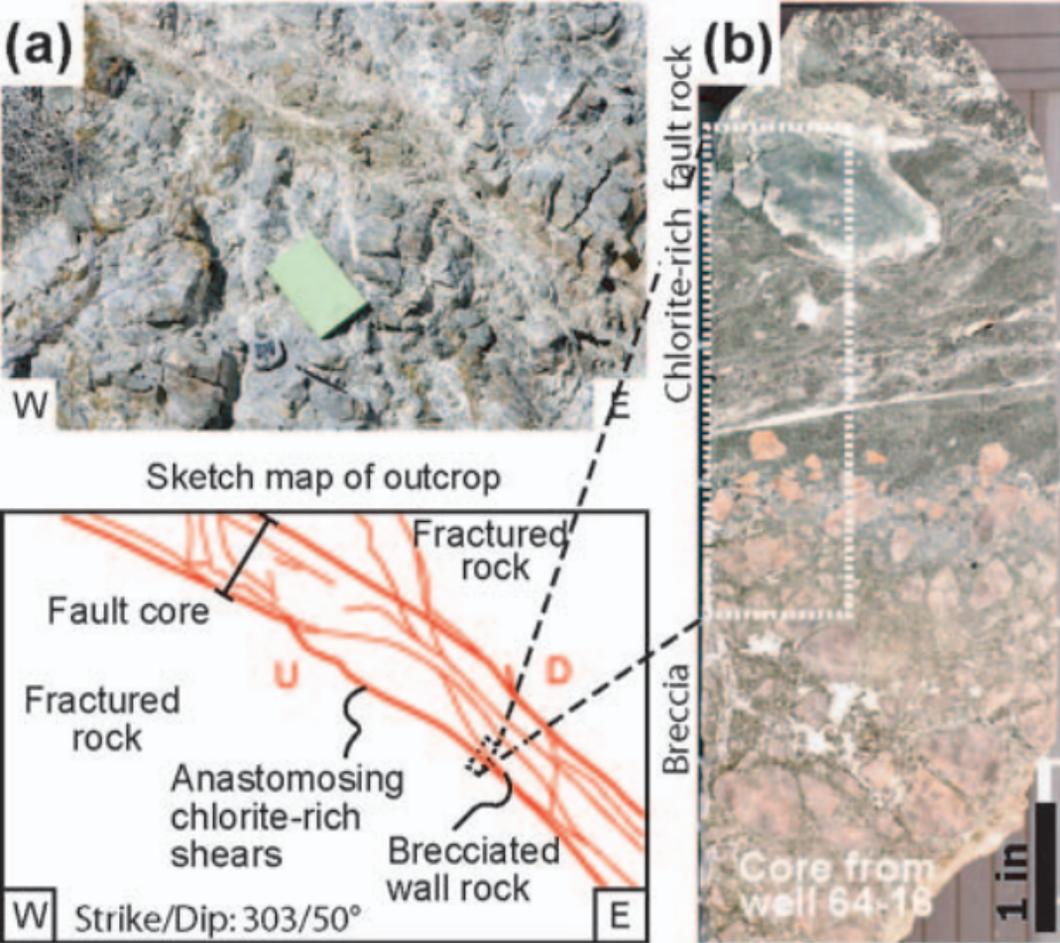
Figure 4

Figure 4: (a) Oblique photograph and sketch map of fault zone rich in chlorite (strike/dip = $\sim 303/50^\circ$) (location Figure 1c). (b) Core from a depth of 679 ft with similar structures from well 64-16.

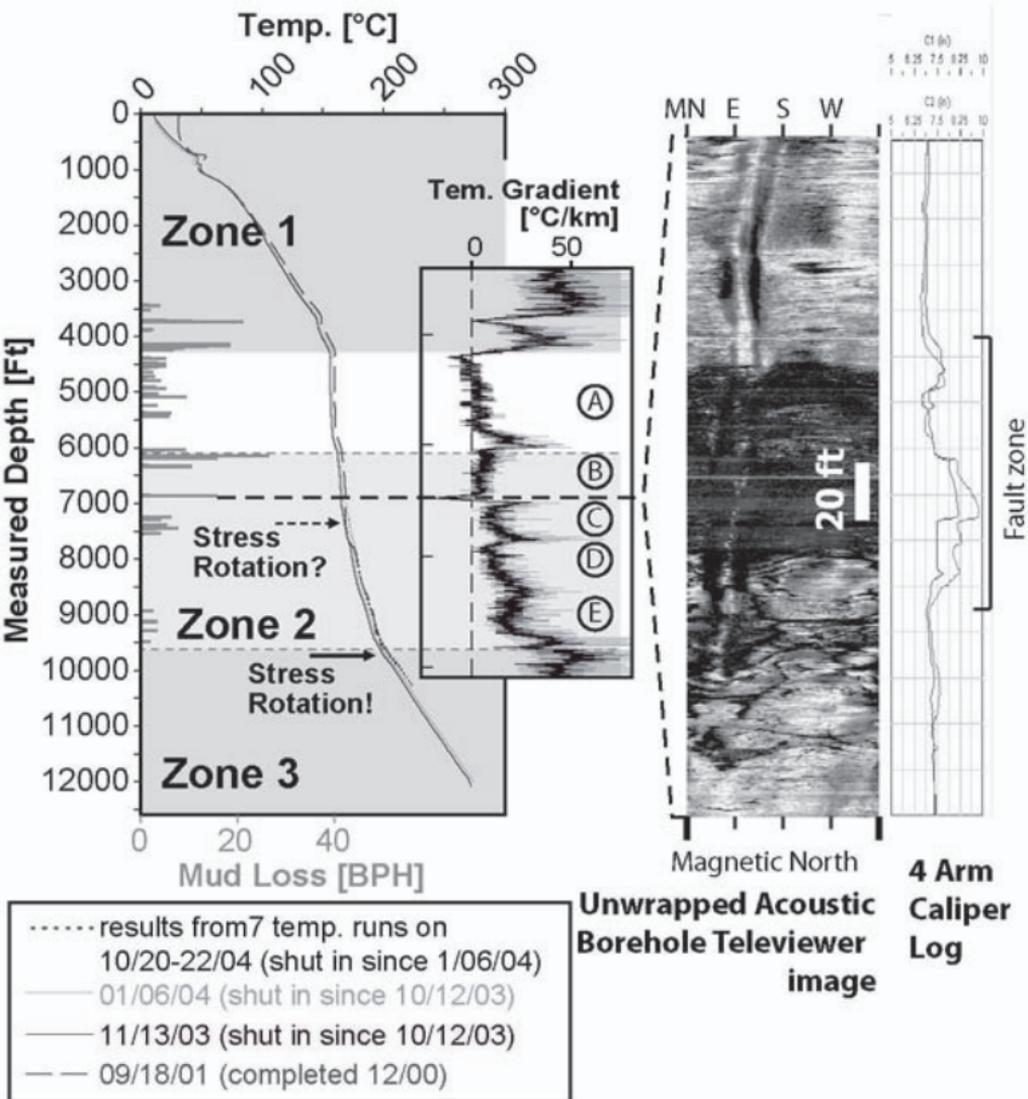
Figure 5

Figure 5: Repeat temperature profiles measured in well 58A-10 located in Coso Wash (location Figure 1c), mud losses while drilling (spikes), stress rotations (Davatzes and Hickman, 2005), and unwrapped borehole televiewer image and caliper log of fault zone at 6900 ft measured depth.

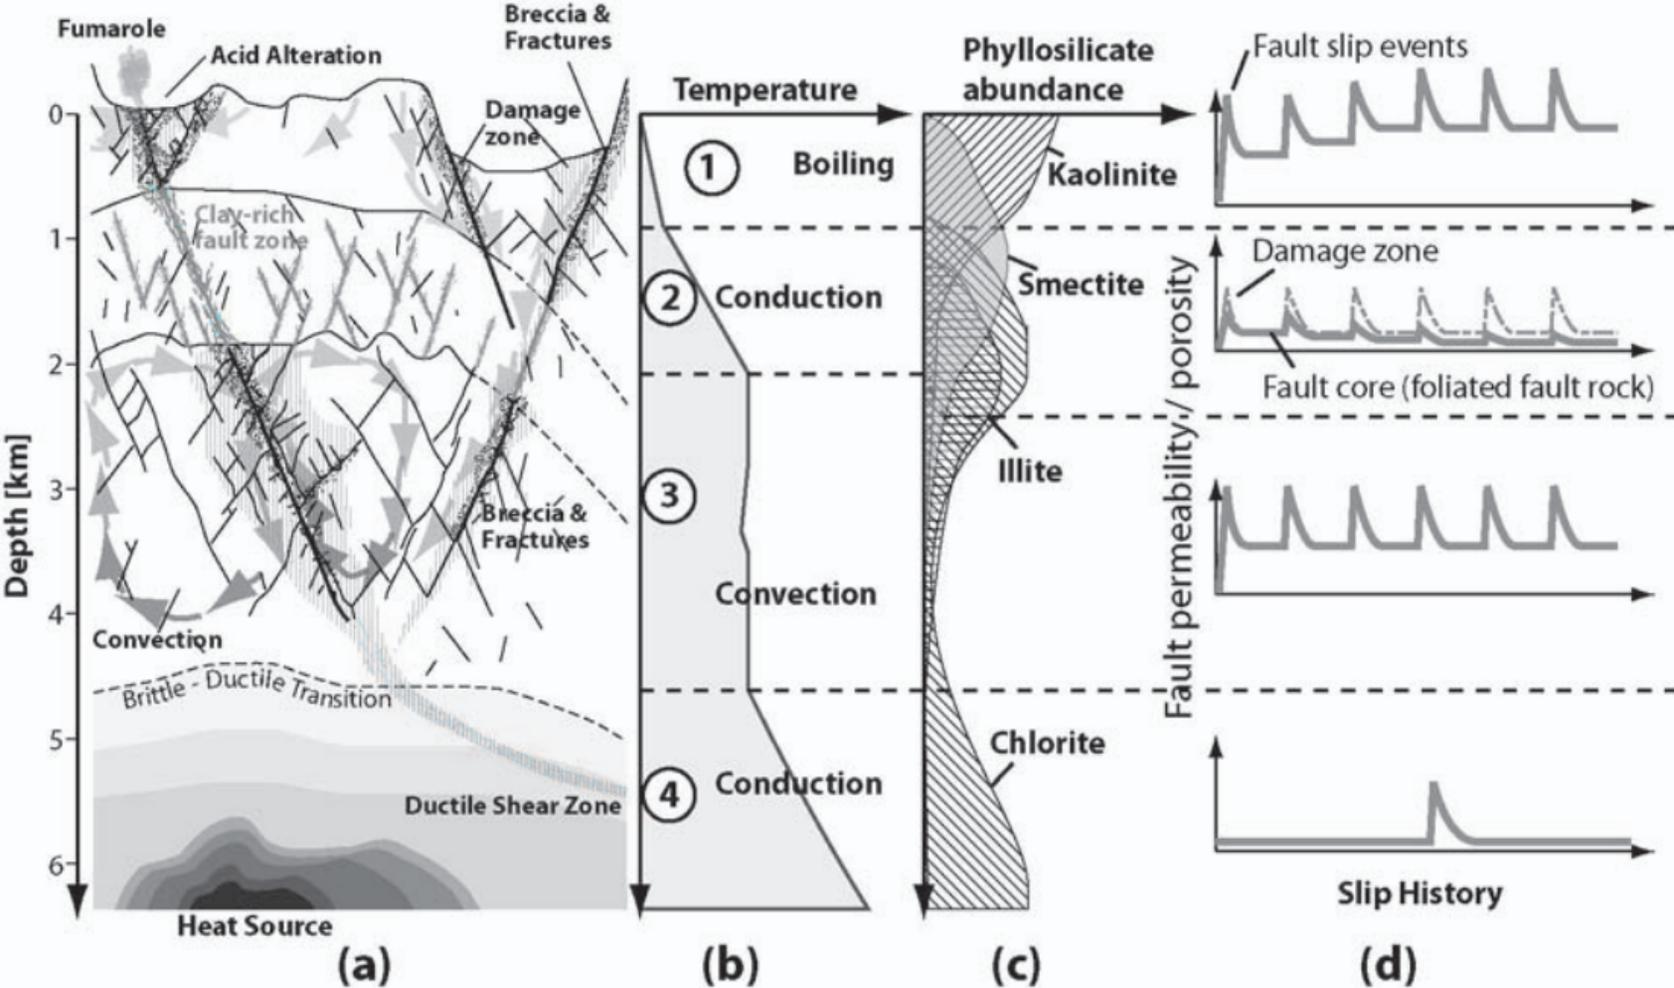
Figure 6

Figure 6: Conceptual model of fluid flow along faults in a geothermal system. The approximate distribution of alteration clay phases follows the work of Lutz *et al.*, (1996), Moore *et al.* (2004), and Kovac *et al.* (2005).

ground water system, clay-rich caprock, reservoir interval, and partial melt that define the Coso Geothermal System. This discussion is indexed to the four zones shown in Figure 6b.

Zone 1. Shallow groundwater flow: In the shallowest zone, groundwater flow circulates through a network of diffusely distributed fractures associated with active faulting and dilatant failure facilitated by low confining stress. Rising geothermal fluids or boiling in areas of high heat flow and slow recharge exsolve gases that can mix with shallow groundwater, potentially lowering the pH and promoting mineral dissolution (Facca and Tonani, 1967). Dissolution of major rock-forming minerals such as feldspar, plagioclase, hornblende, pyroxene and biotite should initially increase fault zone permeability. This overall gradual increase in permeability will be augmented by sudden permeability increases induced by dilatancy accompanying episodic fault slip (spikes in Figure 6d).

Zone 3. Reservoir zone: The reservoir zone is dominated by brittle fracture, brecciation, and cataclasis. Healing primarily occurs by the precipitation of calcite or silica (potentially promoted by convection). In general, the near absence of clays and other phyllosilicates in the reservoir zone prevents the formation of a persistently low-permeability fault core. Thus, across-fault as well as along-fault permeability will be regenerated by periodic fault slip (Figure 6d). In detail, reduced grain size in the fault core due to cataclasis increases the area of fresh mineral surfaces and the rate of chemical reactions and precipitation on those surfaces. This suggests that the core of reservoir faults will heal faster than the damage zone during the inter-seismic period and thus

produce transient across-fault barriers or low-permeability zones (Byerlee, 1993). Consequently, convection can be temporarily confined within isolated damage zones resulting in small steps in temperature gradient (shown diagrammatically in Figure 6b), even though these transient seals will be periodically ruptured so that the permeability within the reservoir remains generally high.
