COMPARISON OF ACOUSTIC AND ELECTRICAL IMAGE LOGS FROM THE COSO GEOHERMAL FIELD, CA

Nicholas C. Davatzes and Steve Hickman

ABSTRACT

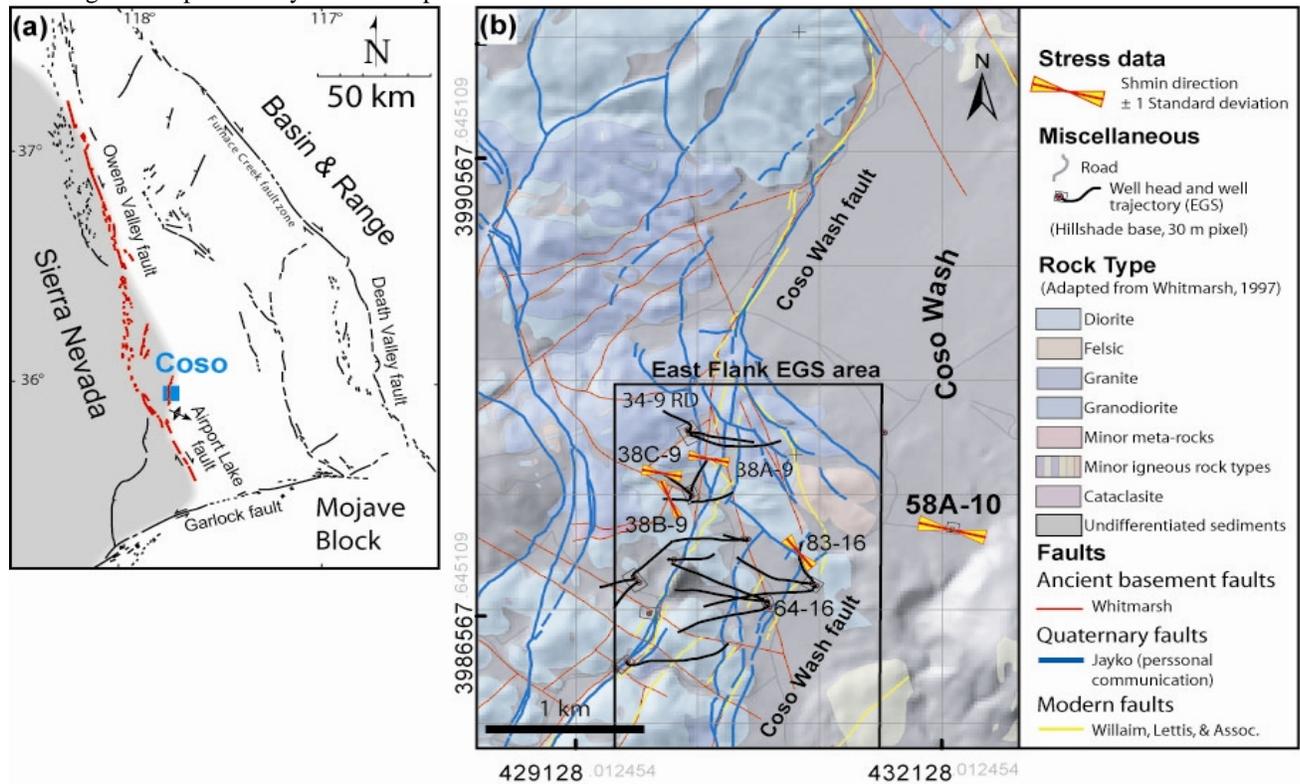
Figure 1: (a) Tectonic map of southern portion of Eastern California Shear zone modified from Unruh et al. (2002). (b) Simplified geologic map of basement crystalline rocks in the Coso Geothermal Field. Faults of different ages are shown, as are measured orientations of the minimum horizontal stress (S_{hmin}) from induced structures in well 58A-10 and based on observations by Sheridan and Hickman (2003) from wells 83-16, 38B-9, 38C-9, and 38A-9.

Well 58A-10 is located in Coso Wash adjacent to the exploited geothermal field (Figure 1b), but outside the region impacted by current production or

The average azimuth of S_{hmin} is consistent with the local orientation of the Coso Wash normal fault just to the west of the well and another similarly striking, but west dipping normal fault to the east (Figure 1). Inside the East Flank (boxed area in Figure 1), stress orientations show greater heterogeneity between wells separated by relatively short distances, presumably because of the proximity of active faults.

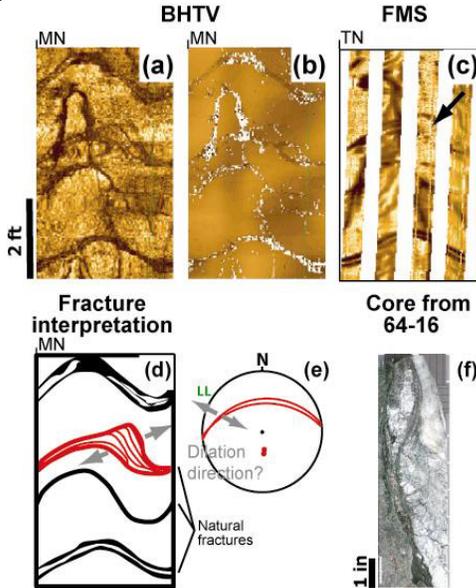
Figure 2: Natural fractures in BHTV (a) amplitude, (b) travel time, and (c) FMS image logs from a measured depth of 9857 ft. The BHTV and FMS logs are oriented with respect to magnetic North (MN) and true (TN), respectively, with a magnetic declination at this site of 14°E. Each image progresses from North, then through East, South, West, and back to North. (d) Sketch of natural fracture geometry and texture of fault rock seen in Figures 1a through 1c. (e) Stereogram of natural fracture colored red in (d). The gray arrows indicate the dilation direction inferred from the texture of the natural fracture. (f) Similar geometry to (a-d) is visible in core from 990 ft measured depth in well 64-16 (Figure 1). In this figure and all subsequent figures brighter images in the BHTV amplitude indicate greater signal strength and in two-way travel time indicate shorter times. Brighter images in FMS indicate lower conductivity. White in travel time data indicates signal loss.

In well 58A-10 both types of image logs revealed natural fractures with varying thickness or slightly non-planar geometry (Figure 2). For example, the fracture visible at center-depth in Figures 2a, b, and c has a large asperity along its surface. The basal trace is the most nearly sinusoidal, and successively less planar segments (less sinusoidal) in the un-wrapped image are associated with the “descending” limb of the sinusoid. The shape of the asperity suggests successive opening or shearing along multiple surfaces, possibly representing multiple crack-seal events (Figure 2d). Either geometry indicates apparent extension consistent with oblique normal slip across this fracture (Figure 2e). This geometry is similar to core from well 64-16 (Figure 1) from the East Flank of the field (Figure 2f), which contains multiple shear zones of foliated chlorite-smectite surrounded by brecciated host rock.

The BHTV clearly reveals fine scale geometry of the structure in Figure 2. The FMS log reveals less of the internal structure, but indicates variation in the conductivity of the fracture where more resistive zones are bright and more conductive zones toward the margins of the fracture are dark. In the BHTV image the locations corresponding to higher conductivity coincide, with signal loss (white areas in the travel time data) indicating a rough or recessed surface. Both the variation in the loss of data and varying conductivity indicate heterogeneous physical properties within the fracture that might be related to porosity production accompanying slip, the distribution of minerals with different conductivity, or preferential erosion of the fracture and adjacent wall rock during drilling.

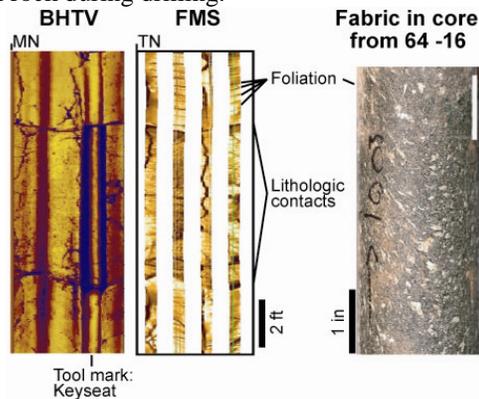
Figure 3: BHTV amplitude and FMS image logs of intervals containing two transitions in rock type indicated by changes in image log character and changing depth of wear caused by rubbing of the drill string (tool marks). The upper rock type contains a foliation, which is only visible in the FMS log and is similar to fabric visible in core from well 64-16.

The depth interval above the first rock type transition at the top of the images in Figure 3 is also distinguished by a pervasive set of sub-parallel sinusoids only visible in the FMS image. This type of

nearly sub-parallel (over discrete depth intervals) and uniformly spaced planar structure consisting of alternating dark and bright bands characterizes broad regions of the FMS image log. Caliper logs indicate that these structures have little impact on the borehole wall geometry, consistent with their absence in the BHTV log (Figure 3). Crosscutting relationships with natural fractures always indicate that these structures are older. In addition, the boundaries of these regions generally coincide with fault zones and/or changes in image log character (Figure 3) consistent with changing rock types that are corroborated by the cuttings log (Figure 4). Most importantly, these characteristics are similar to core and surface outcrops elsewhere in the field that contain non-brittle fabrics (Figure 3). Therefore, we interpret these structures as non-brittle fabrics such as foliation that can be distinguished from natural fractures in image logs because of their consistent geometry (attitude and spacing) and absence in the BHTV log.

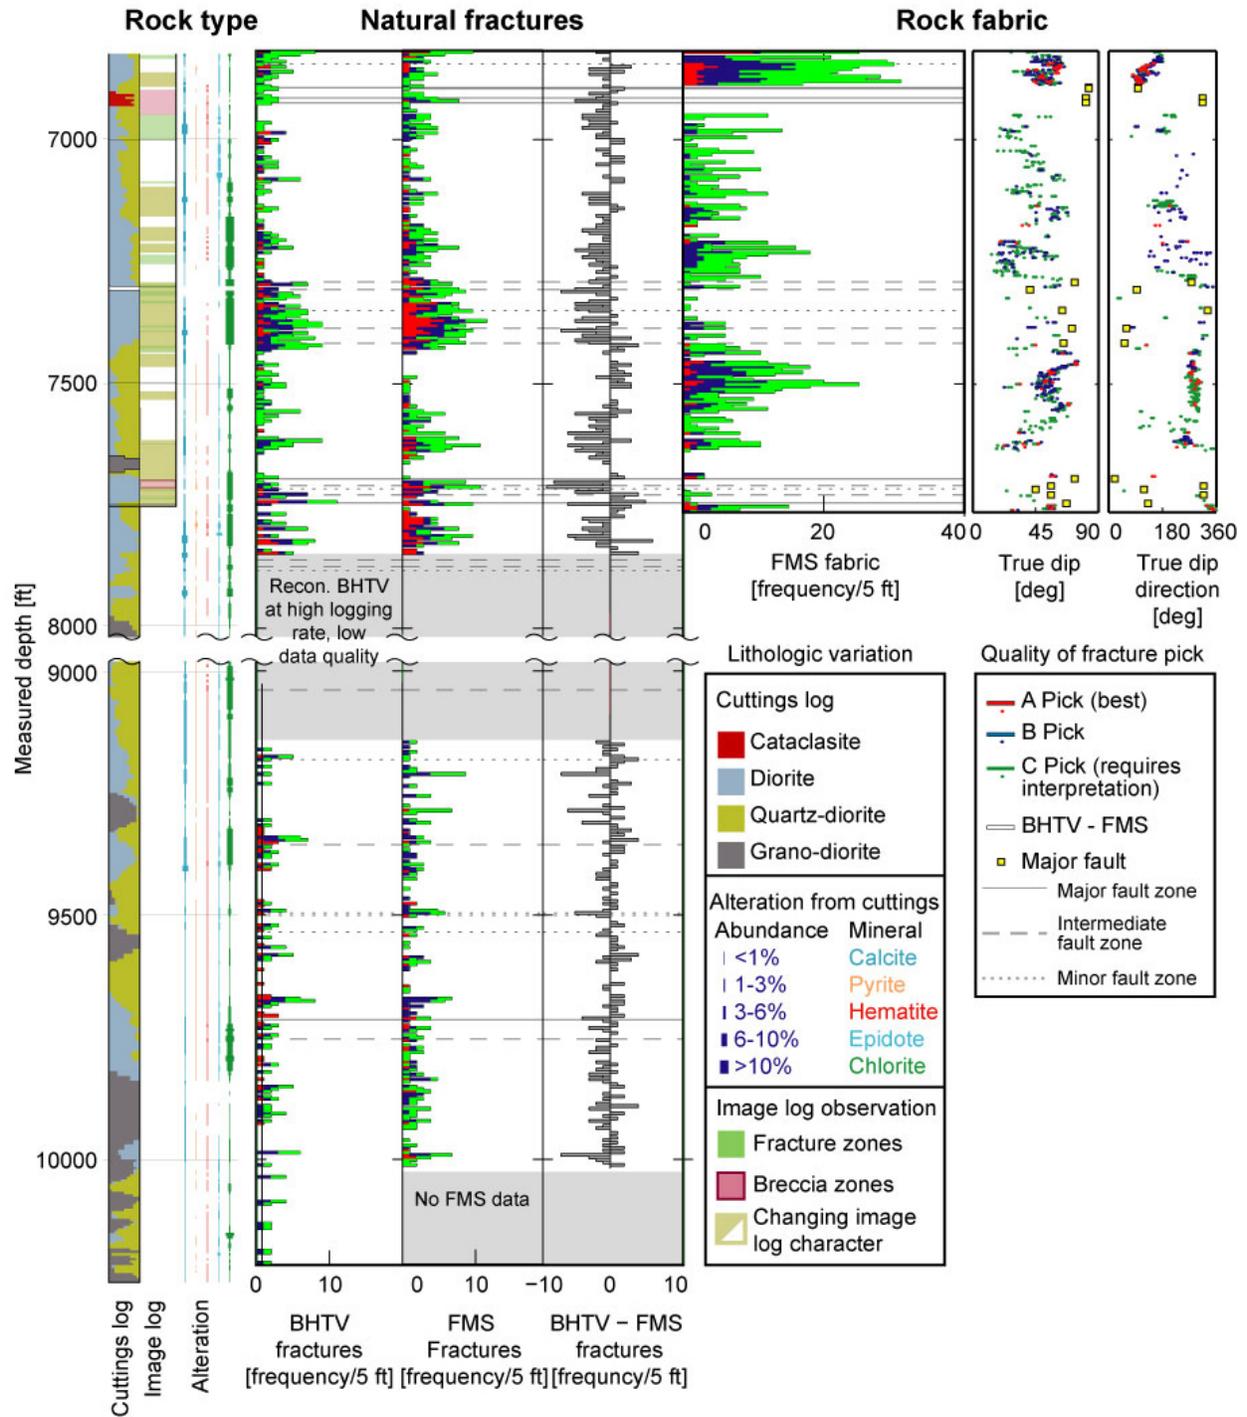
Figure 4: Plots of rock type variation indicated by the cuttings log and changes in image log character (as in Figure 3), natural fracture frequency, fabric frequency and true fabric orientation corrected for borehole deviation in the logged interval of well 58A-10 from 6820 to 10238 ft. Alteration was logged from the cuttings during drilling as part of the cuttings log.

Comparison of FMS and BHTV logs from the same interval revealed differences in the populations of natural fractures and other planar structures imaged by the two techniques (Figure 4). In general, fabric elements comprise more than 50% of all planar structures measured in the FMS log, and locally approach 100%. This subset of planar structures shows consistent orientations over short depth intervals but systematic changes in dip and dip direction with depth (Figure 4). At any given depth, the orientation of foliation is clearly distinct from the orientations of the natural fracture population (Figure 5).

The residual fracture population left by subtracting these fabric elements from the total FMS data set is similar to the fracture population interpreted solely from the BHTV image log in frequency distribution (Figure 4) and orientation (Figure 5). However, the FMS data still indicates more fractures than the BHTV (Figure 4). Both data sets suggest that most fractures are associated with distinct zones of image log character, suggesting that there is a correlation between fractures density and specific rock types or alteration recorded in the cuttings log.

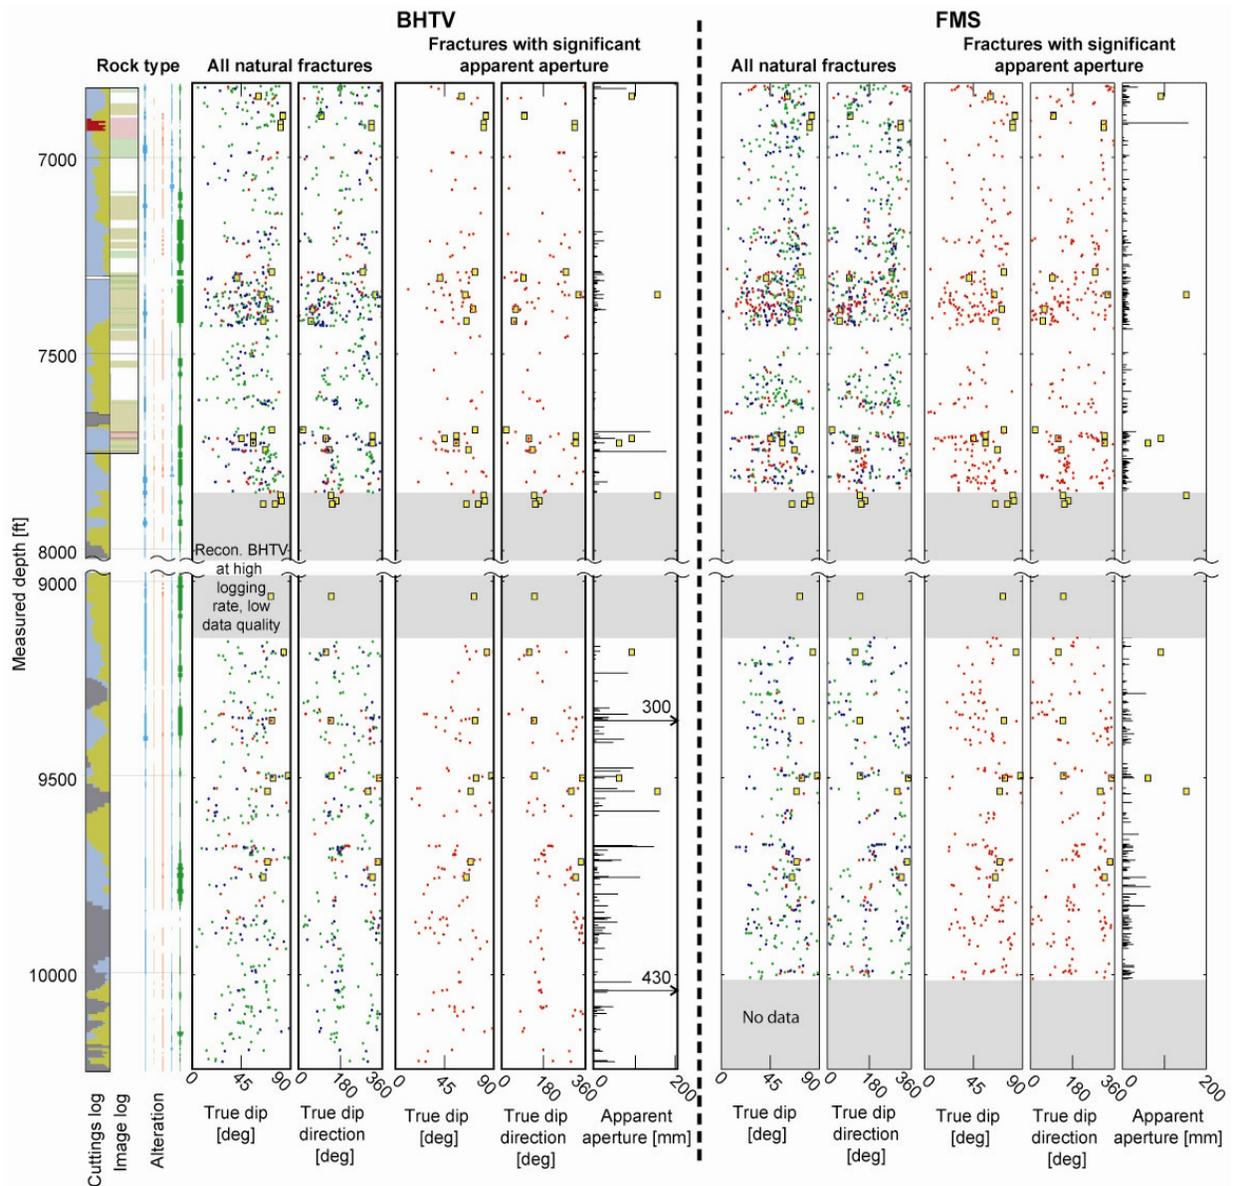
Figure 5: Natural fracture true dip and true dip direction for all fractures and for those with greater than 5 mm apparent aperture from FMS and BHTV logs for the interval from 6800 to 10238 ft. (5 mm is roughly equivalent to the minimum resolution of the FMS and BHTV.) Major faults are plotted as yellow boxes.

significant apparent aperture than the BHTV (Figure 5). In FMS data this “thickness” is a function of both the relative conductivity and the actual thickness of material defining the structure. The measured thickness could thus reflect the local mineralogy or fluid chemistry associated with the structure. In BHTV data this thickness is a function of the geometric irregularity of the borehole wall at its intersection with the structure and the footprint of the acoustic beam. Thus, FMS and BHTV estimates of apparent aperture do not directly measure the aperture or thickness of a fracture zone and are not directly comparable. Consequently, apparent aperture only provides insight into the relative importance of fractures and most likely over-estimates true thickness or aperture.

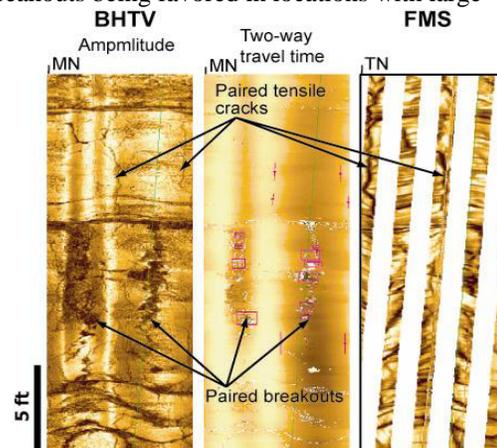
Figure 6: BHTV amplitude and two-way travel time, and FMS image logs of intervals containing borehole wall tensile fractures and breakouts.

Borehole wall tensile fractures are common in both BHTV and FMS image logs of well 58A-10 (Figure 6). We identified this type of borehole wall failure in logged intervals where tensile fractures occurred as paired vertical lineations 180° apart or as an echelon lineations 180° apart.

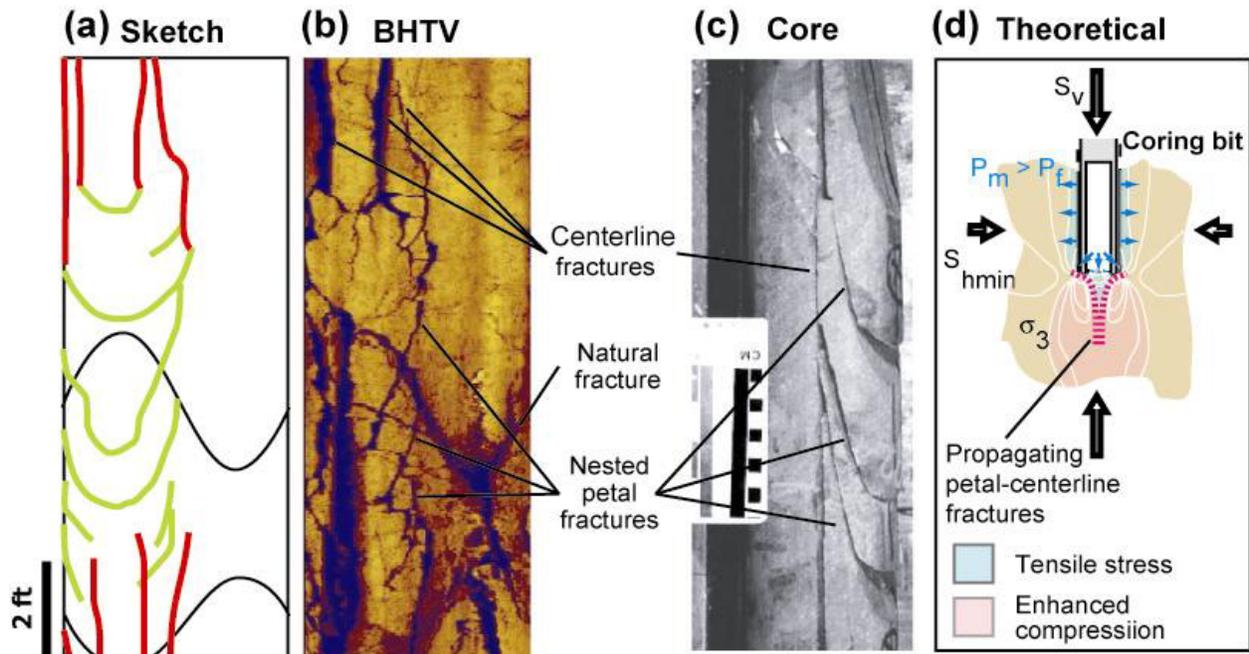
Figure 7: (a) Sketch of petal (green) and centerline (red) fractures visible in (b) borehole televiwer image log at ~7000 ft measured depth from well 58A-10. (c) Petal-centerline fractures are commonly observed in core (modified from a photo by Al Lacazette, www.naturalfractures.com). (d) Cartoon of stress concentration around the bottom of a borehole subjected to a mud pressure in excess of the formation pressure based on studies by Li and Schmitt (1997, 1998).

In image logs petal fractures appear as smoothly curving chevrons (pointing up or down). The tips of the chevrons merge with pairs of centerline fractures oriented parallel to the borehole axis (Figure 7a and b) consistent with examples in core (Figure 7c). Whereas the symmetrical stress concentration around the borehole free surface causes classic borehole wall tensile fractures to form 180° apart, petal-centerline fractures propagate through intact rock ahead of the drill bit as opening-mode fractures that open in the local direction of the least compressive principal stress (Figure 7d). The resulting fracture plane strikes parallel to S_{Hmax} , but does not necessarily lie along the borehole axis. Thus, once the bit has drilled through the induced fracture, the petal-centerline fracture will have variable azimuthal spacing along the borehole wall. The orientation of S_{hmin} can then only be reliably estimated by calculating the average azimuth of pairs of centerline fractures or paired measurements on both limbs of petal fractures.

natural fractures in an FMS log. The potential for such misinterpretation is exacerbated where these fractures are nested (Figures 7b and c). Practically, use of an FMS log alone is thus prone to increased scatter in measured orientations of S_{hmin} . Using a BHTV log and applying the same averaging technique to all tensile fractures, including those produced by borehole wall failure, helps limit this pitfall.

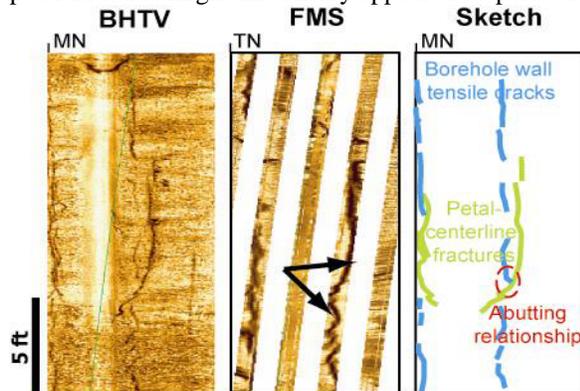
Figure 8: BHTV and FMS image logs of classic borehole tensile cracks (blue) abutting against a petal-centerline fracture (green). The abutting relationship circled in red in the sketch confirms that the petal-centerline fractures formed before the tensile failure of the borehole wall. This relationship is not visible in the FMS image, where one could easily

mistake a petal-centerline fracture for a true borehole wall tensile crack (arrows).

In FMS images, pairs of centerline fractures are unlikely to be completely imaged because they need not form 180° apart and FMS pads are spaced at 90° increments (although greater coverage in other electrical imaging tools will reduce this limitation). As a result, centerline fractures spaced less than 180° could be misinterpreted as classic borehole wall tensile fractures (FMS image in Figure 8). Similarly, petal fractures might mistakenly appear to be parts of

Figure 8 illustrates an example where such confusion is likely in the FMS. This example also reveals an abutting relationship visible in BHTV log that confirms that classic borehole wall tensile fractures form after petal fractures.

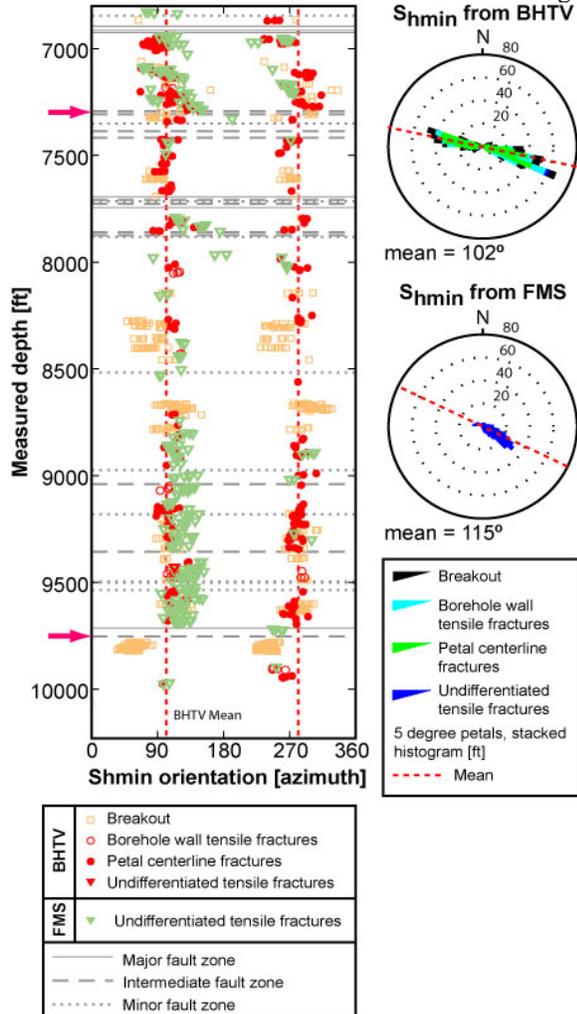
Figure 9: Orientation of S_{hmin} as a function of depth. The means S_{hmin} orientation shown as dashed red line in the depth section is derived only from analysis of the BHTV logs. Red arrow shows location of a significant stress rotation possibly related to slip on one or more active faults observed at this depth.

Analysis of breakouts, pairs of borehole wall tensile cracks and pairs of petal-centerline fractures from the BHTV logs (Figure 9) indicates that S_{hmin} near well 58A-10 is oriented along an azimuth of $102^\circ \pm 18^\circ$. A large proportion of the tensile fractures evident in these BHTV image logs are interpreted as petal-centerline fractures. Our analysis of the BHTV data shows that petal-centerline fractures provide comparable stress orientations to breakouts and borehole wall tensile fractures (summarized in Figure 9). In contrast, the FMS data shows considerably more scatter and fewer picks because of the poor azimuthal coverage of the borehole wall and the inability to distinguish petal-centerline fractures from borehole wall tensile cracks. The FMS mean S_{hmin} direction also departs by 13° from the BHTV analysis. Careful calibration (not presented here) between the logs demonstrates that they are well oriented with respect to each other. Thus, this difference is probably a result of the sampling bias resulting from FMS pad spacing and the much smaller population sampled (including lack of breakouts).

The depth distribution of induced structures visible in the BHTV data also shows one prominent stress rotation at ~9750 ft near the locations of several large

faults visible in the image logs (arrow in Figure 9). Other less prominent stress rotations, such as the potential rotation at ~7350 ft, are evident, but do not stand out as clearly from the scatter. These rotations probably indicate active slip on faults nearby or intersecting the borehole.
