Effects on Geothermal Features Following the February 21, 2008 Wells, Nevada Earthquake

Chris Sladek

Department of Geological Sciences, University of Nevada, Reno, Nevada

2011

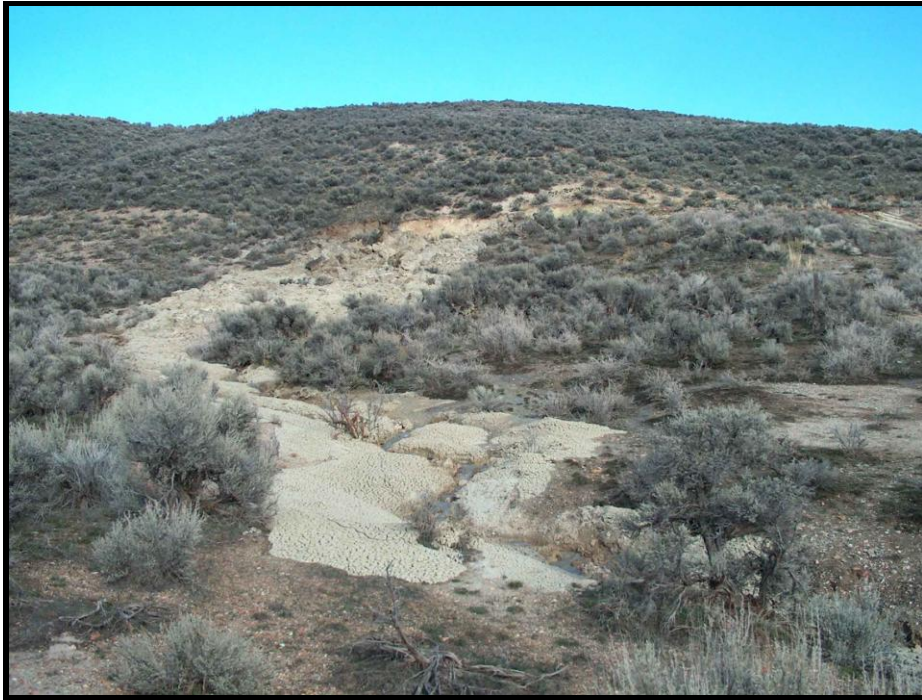
Figure 2. View looking east at the mudslide on the west side of the Snake Mountains. The scarp strikes roughly north-south for approximately 50 meters, and debris and mud extend for approximately 140 meters below the scarp. Warm springs issue from the foot of the scarp.

W-7: A series of warm springs approximately 200 meters northeast of the travertine springs mentioned above. A small mudslide (figures 2 and 3) recently occurred here exposing numerous springs in the scarp. It is uncertain if these springs are new or a better exposure of existing springs. The scarp is approximately 50 meters long and dips approximately 45° to the west. Debris extends approximately 70 meters downslope with mud in the drainage axis extending an additional 70 meters. Iron staining is present around the spring orifices and outflow zones of the scarp face. Spring temperatures are approximately 34 °C, and the flow rate is approximately 40 l/min. The lack of grass in the wet areas and the presence of arid-climate vegetation, such as sage and grass, only on displaced debris blocks, as well as the lack of algae around the spring orifices and outflows, suggest a recent nature to the feature. Although there is evidence of recent activity here, satellite and air photo images indicate there were likely seeps or a sapping feature in this location prior to the earthquake.

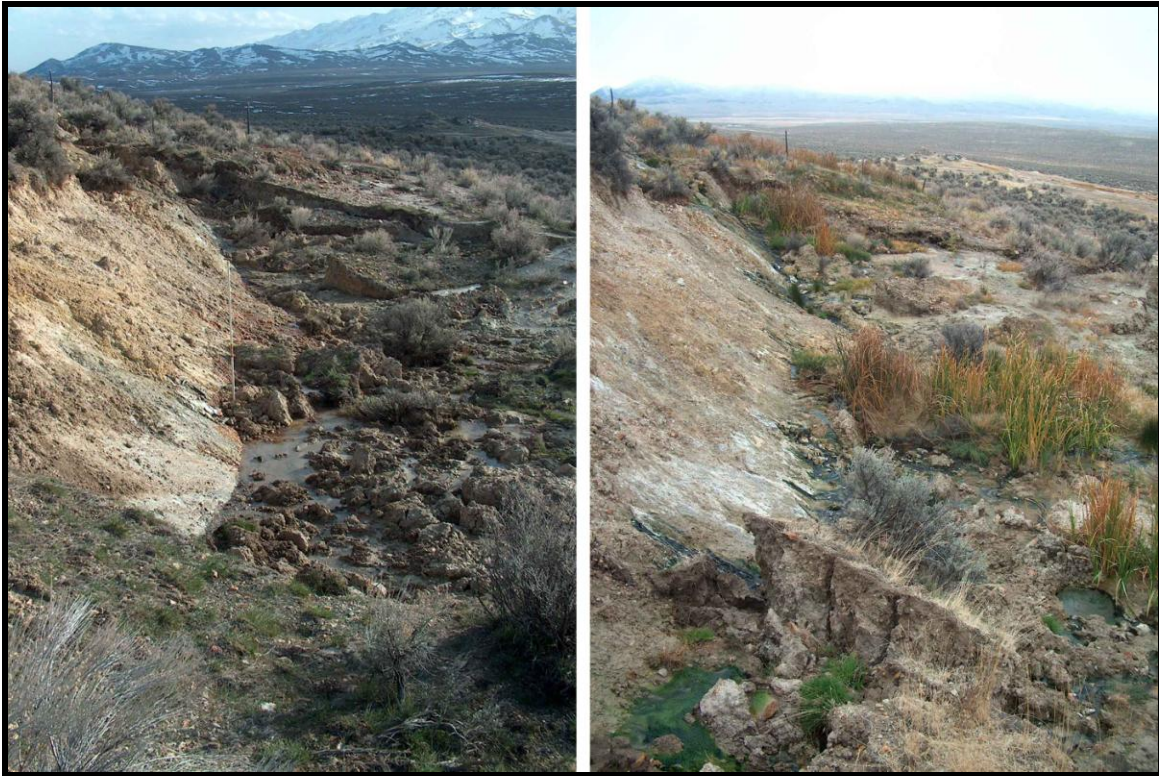
Figure 3. Views along mudslide scarp slide looking south. Left view is from March 2008, and right view is from November 2008 showing growth of cattails and algae. Scarp height is approximately 4 meters and length is approximately 50 meters. Numerous small springs and seeps issue from argillically altered rock in the scarp face and several springs percolate up through the mud at the toe of the scarp. The images show a significant change in vegetation from March to November. The lack of dead cattails and grass, and the absence of algae in the warm spring waters suggest the recent nature of the mudslide.

The sites visited in November appear to have experienced no significant changes since the March visit with the exception of some minor changes at the mudslide area. Communications with BTI personnel indicated that they had not seen a significant temperature change. At the time of the November visit, BTI was using the well for supplying the truck wash but not for heating purposes yet. The temperature of the Reynolds Ranch well was similar to the temperature measured in March, 2008. Water chemistry for water samples collected from the Reynolds Ranch well in March and November are also similar (table 1). Data from the data logger placed in Threemile Spring indicate a gradual increase of 1.6°C between March and November with no temperature excursions. This gradual increase in temperature is most likely due to seasonal shift. The water discharge rate at the mudslide area is similar to the rate in March, but the temperature of springs at the mudslide area appears to have increased by approximately 15 °C. However, temperature measurements and samples were collected from different orifices than in March due to difficulties with access (deep mud at the scarp face). Geothermometer temperatures are also higher for the samples collected in November than for March, and there is a significant disagreement between the silica and cation geothermometers for both the March and November samples. The iron concentration has decreased by a factor of approximately 7 from March to November, and minor changes in other element concentrations have occurred (table 1). Gas bubbling can be seen in several of the spring orifices and is at a rate of several liters per minute, based on the size and rate of bubbling. Gas was less apparent in March, but may have been because of the general lack of pools to observe bubbling in at the toe of the scarp. Significant changes in vegetation have also occurred at the mudslide area (figure 3). Spring orifices are marked by green algae and cattails have vegetated some areas at the scarp. Cattails were also noted sprouting down gradient of the scarp in the mud flow area; as with the scarp area, no cattails were noted in this area during the first visit in March. Some minor additional sloughing has also occurred at the scarp.
